**Marumsco Creek and Farm
Creek Watershed Stream
Corridor Improvement Projects**

MARUMSCO CREEK AND FARM CREEK WATERSHED MANAGEMENT PLAN

Stream Corridor Improvement Project

Project ID: 905-SCIP-01

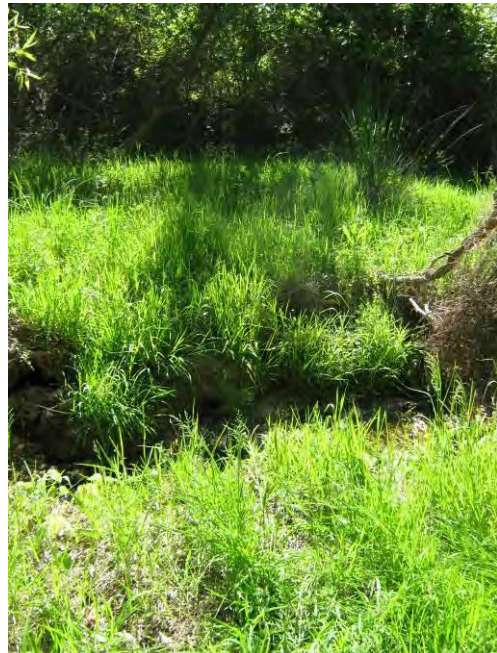
2B-905-34TR & 2B-905-35-TR

Trash (2B-905-34TR and 2B-905-35TR)

Trash and debris dumping areas observed along the upper portion of the project reach. Observed trash includes tires, metal tanks, and yard waste. Total volume of trash is estimated to be less than 5 truck loads.

Illegal Dumping. Tires, tanks and yard waste found in the stream and on the right bank.

The project concept also incorporates trash and debris clean up and removal in the vicinity of the stabilization site and at the dumping sites. Properties owners should be notified of the dumping and advised to develop prevention measures for their property.

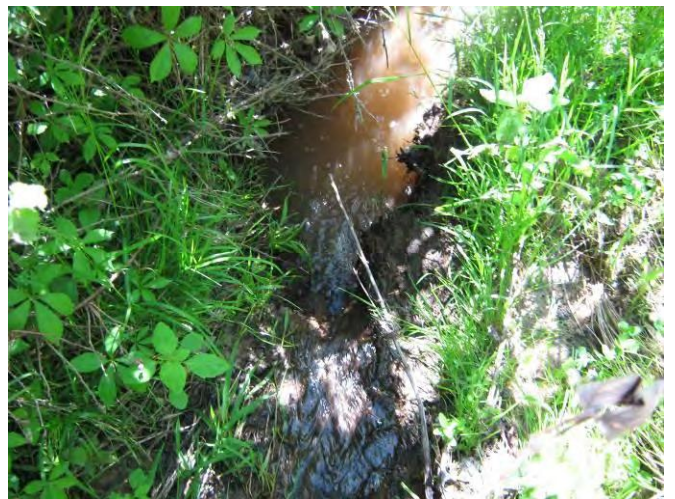
2B-905-36IB

Lack of vegetation on both left and right streambank is affecting the stream buffer along a reach length of 1,000 feet. Lack of buffer is impacting the bank stability and water quality within the stream.

Lack of vegetation on both banks.

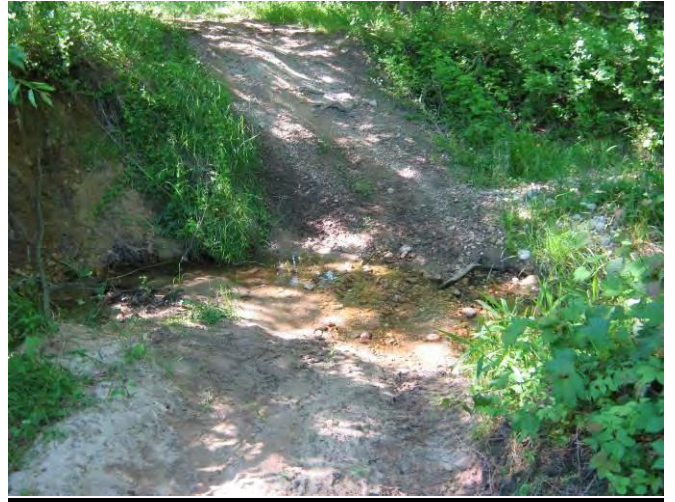
2B-905-37ER

Severely degraded reach of stream is experiencing head cutting, widening, and bank failure with erosion attacking both banks. An ATV crossing in the middle of the reach

has also destroyed both the bed and the banks of the stream. Current erosion has affected 550 linear feet of right streambank and 750 linear feet of the left streambank with bank erosion heights in excess of 3-feet.

Multiple small headcuts developing into channel widening and large bank mass wasting. 3-foot high bank erosion on left and right banks along a total reach length of 500 ft.

The project concept for stabilization of this reach of stream involves stabilization of the channel bed and channel banks through use of constructed in-stream structures , bank grading and bank plantings. The reach upstream of the ATV crossing will be stabilized using bank grading, bank plantings, and log structures to stabilize the headcutting. The reach downstream of the ATV crossing including the ATV crossing will be restored using bioengineering and larger in-stream structures. Associated channel bank grading and floodplain creation / re-connection will decrease the erosional stresses created by concentrated flows in the main channel.

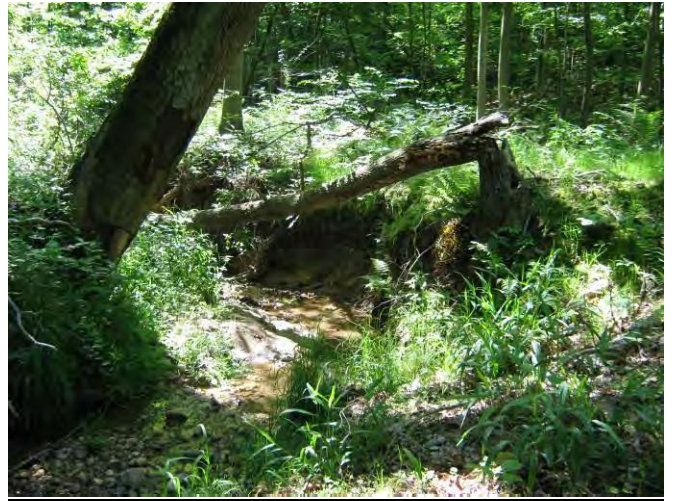
2B-905-38MI

ATV crossing destroying bed and banks.

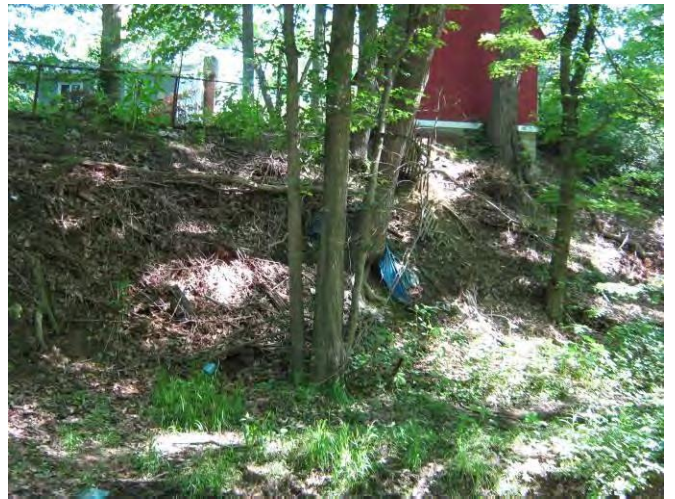
2C-905-54TR

Illegal dumping. Appliances found in the stream.

The project concept also incorporates trash and debris clean up and removal in the vicinity of the stabilization site.

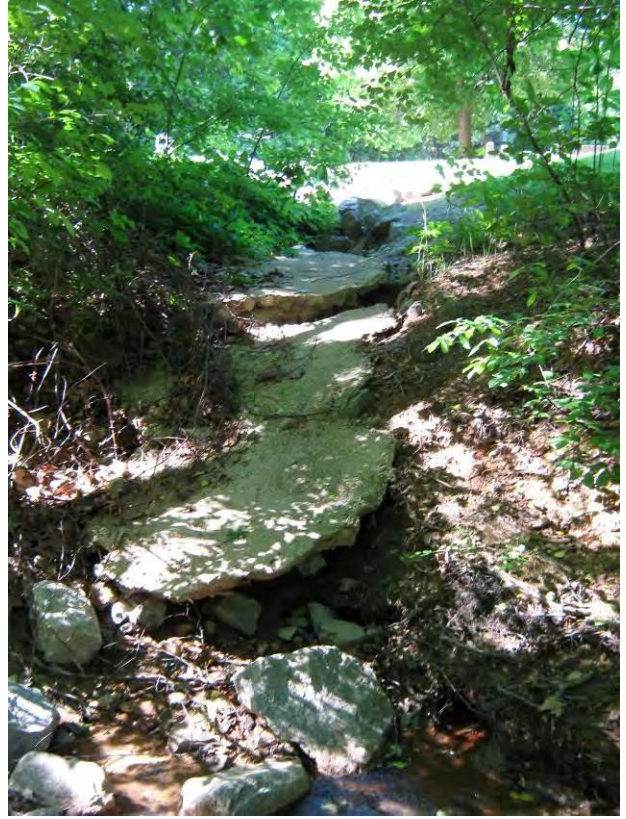
2C-905-59TR

Illegal dumping. Yard waste found in the stream and on the riparian area on the left bank.

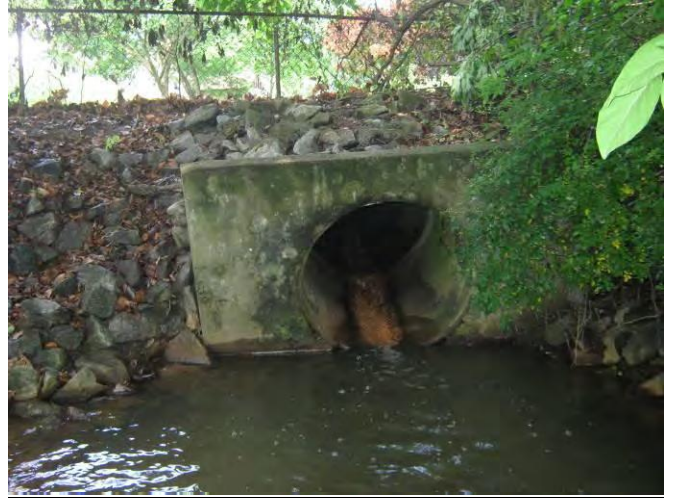
3C-910-117OT

Storm drain outfall foundation is undermined and is slumping into the channel bed. The joint between the RCP stormdrain pipe and endwall is broken. There is also erosion around and behind the endwall. Continued undermining of endwall foundation will result in complete failure of the endwall structure adversely impacting the stream and progressively deteriorating the storm drain system through formation of sinkholes and further pipe related failures..

Outfall foundation undermined and failing.
Bank erosion around the outfall.

Stabilization of the storm drain outfall will be incorporated into the stream stabilization design. The existing endwall will require replacement and resetting of broken pipe segments. Localized grading and stabilization around the reset endwall will be required to complete the repair.

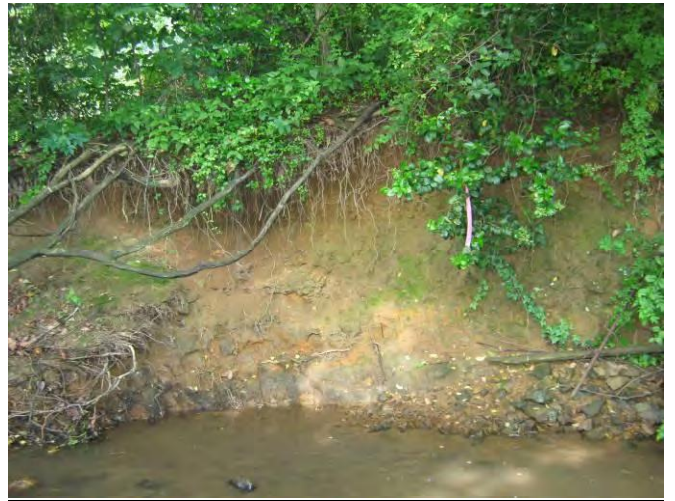
3C-910-116ER

This reach of stream is experiencing bank erosion with erosion attacking the right bank. Current erosion has affected 40 feet of the right streambank with average bank heights of 4-feet.

Bank failure. 4-foot high erosion observed
along a reach length of 40 ft on the right
bank.

The project concept for stabilization of this reach of stream involves stabilization of the right channel bank through use of constructed in-stream structures, bioengineering and bank grading.

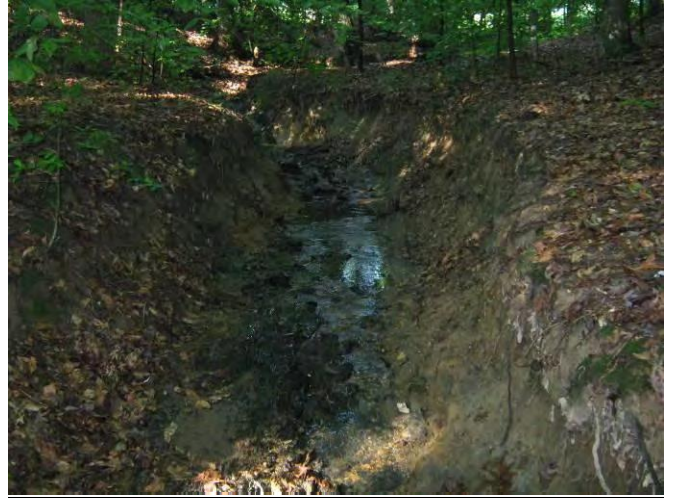
3C-910-103ER

Bank erosion and widening observed. 4-foot high erosion observed on the left bank along a length of 230 ft. 4-foot high erosion observed on the right bank along a total reach length of 240 ft.

The project concept for the stream involves stabilization of the channel bed and channel banks through use of bank grading and constructed in-stream structures. The stabilization will involve grade control measures to stabilize and eliminate headcutting.

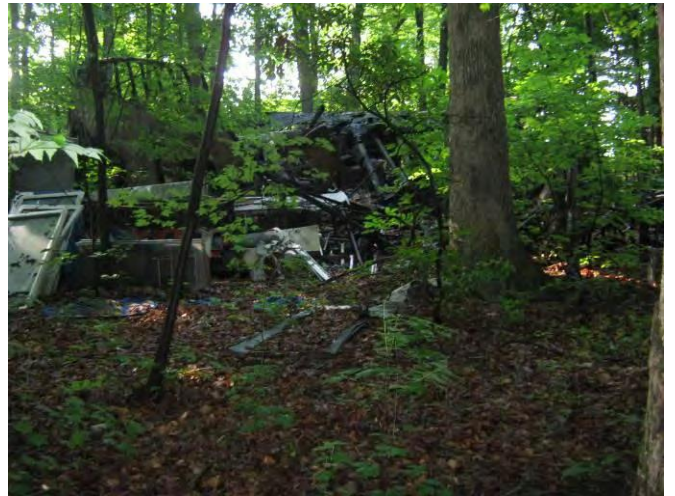
3C-910-102TR & 3C-910-104TR

A large dump site for construction related waste was observed along the upper reaches of the tributary. Dump site was observed on the property at 1710 Horner Road. In other areas, significant amounts of trash and debris were observed. Observed trash is residential and industrial in nature, including floatables, plastic waste, tires, appliances, automotive waste, construction waste, scrap metal and yard waste. Total volume of trash is estimated to be more than 24 truck loads.

Illegal dumping. Tires, appliances, automotive waste, construction waste, metal, plastic waste found in the stream and on the right bank. Dump Site is behind 1710 Horner Road.

The project concept also incorporates trash and debris clean up and removal in the vicinity of the stabilization site.

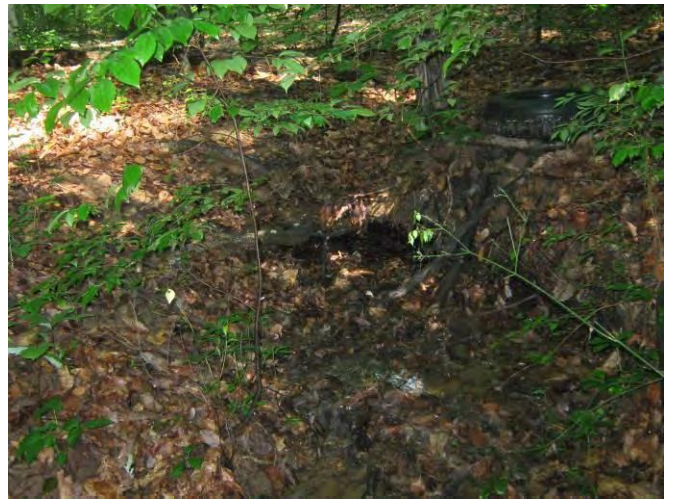
3C-910-107ER

The northern tributary is experiencing headcutting and progressive bed degradation. Current the headcut produces a 1-foot drop and shows evidence that it is a long term / progressive headcut.

Headcutting in the tributary. Potential long-term excessive sediment source for the stream.

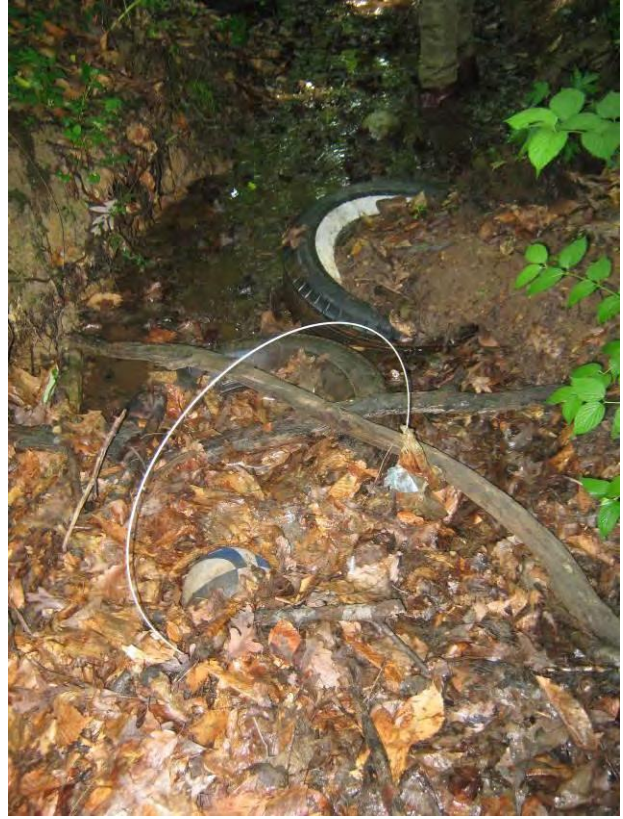
3C-910-106TR

Illegal dumping. Tires and metals found in the stream and on the riparian area.

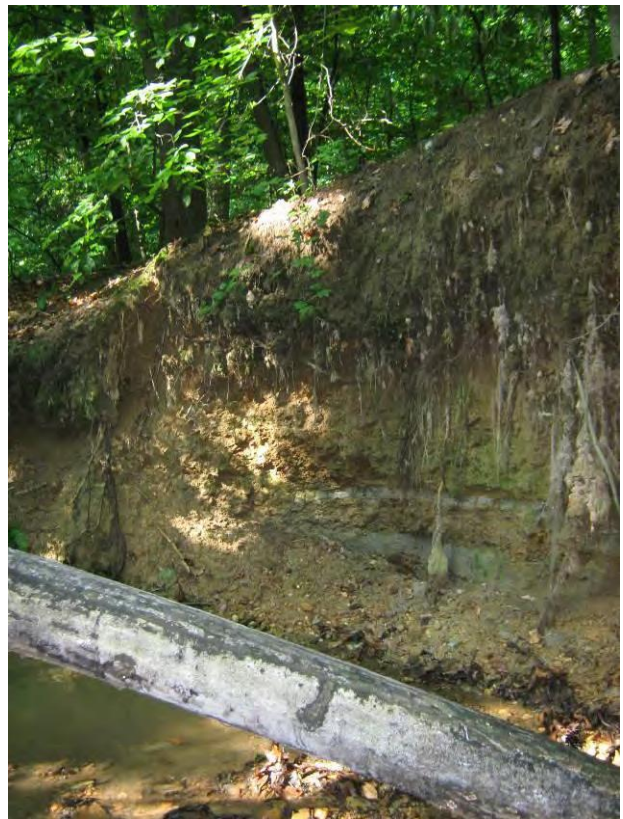
3C-910-108ER

Headcutting and bank widening observed. 5.5-foot high erosion observed on the left bank along a total reach length of 320 ft. 5.5-foot high erosion observed on the right bank along a total reach length of 380 ft.

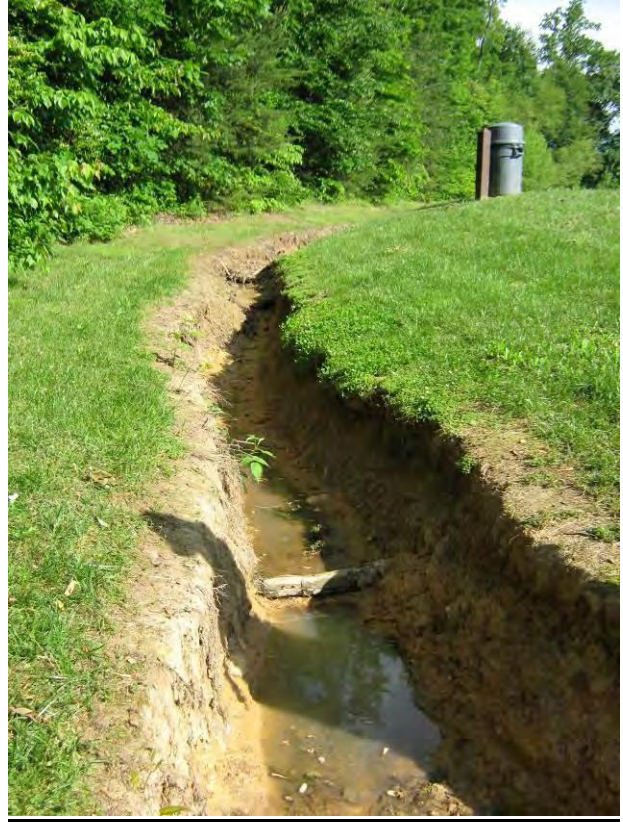
4B-910-03ER

Moderately degraded reach of stream is experiencing both head cutting and widening with erosion attacking both banks. Current erosion has affected a 100 feet of both the right and left streambanks with bank heights in excess of 1-foot.

Bank widening and headcutting. 1-foot high erosion observed on the left bank and right banks along a total reach length of 100 ft.

The project concept for stabilization of this reach of stream involves stabilization of the channel bed and channel banks through use of bank grading and log grade controls. Associated channel bank grading and floodplain creation / re-connection will decrease the erosional stresses created by concentrated flows in the main channel.

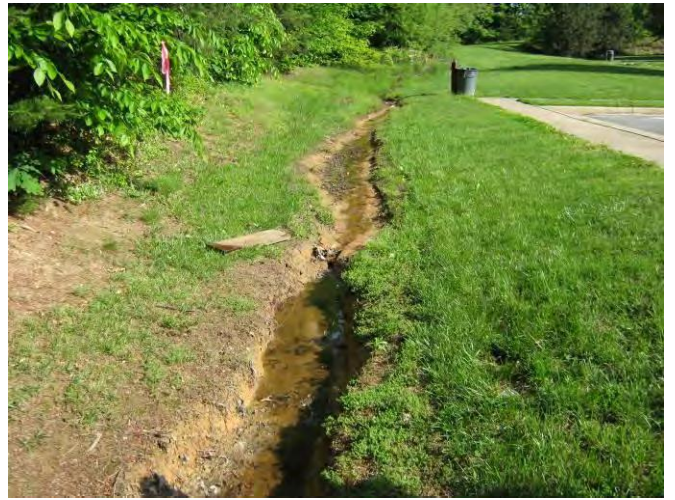
4B-910-01IB

Lack of woody vegetation has impacted the stream buffer along the entire reach of the project area. Currently turf/lawn occupies the left and right stream buffer zones.

Lack of vegetated buffer. Absence of woody vegetation is impacting the stability of the streambanks and water quality within the stream.

The project concept for restoration of stream buffer involves active reforestation along both banks on the entire reach of the stream in the project area.
