**Marumsco Creek and Farm
Creek Watershed Stream
Corridor Improvement Projects**

MARUMSCO CREEK AND FARM CREEK WATERSHED MANAGEMENT PLAN

Stream Corridor Improvement Project

Project ID: 910-SCIP-06

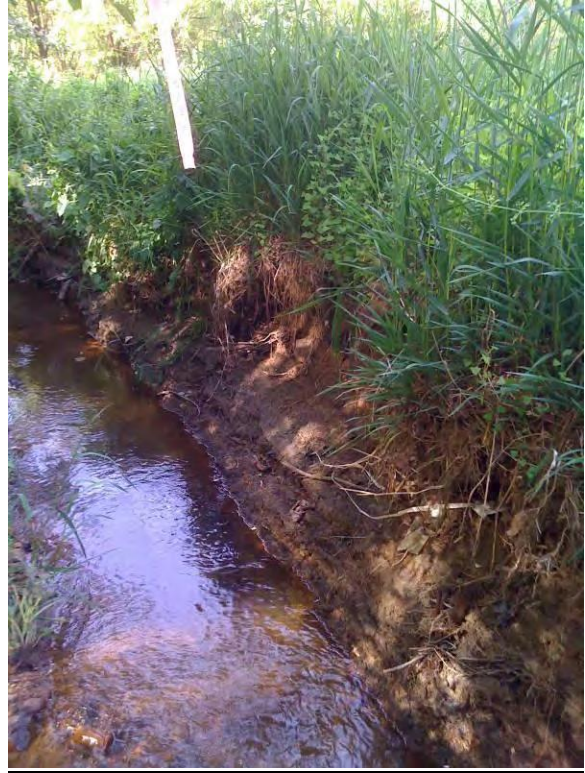
4D-910-42ER

Channel Erosion (4D-910-42ER, 4D-910-46ER)

Channel erosion in the project area is divided in two parts. The upper reach of the project is experiencing minor bank erosion. Erosion has currently affected 20 feet of the left streambank and 80 feet of the right streambank with average bank heights of 3-feet.

Eroding banks along the upper portion of the project reach. Average of 3-foot high erosion observed on left and right banks along a total reach length of 20 ft on the left bank and 80 ft on the right bank.

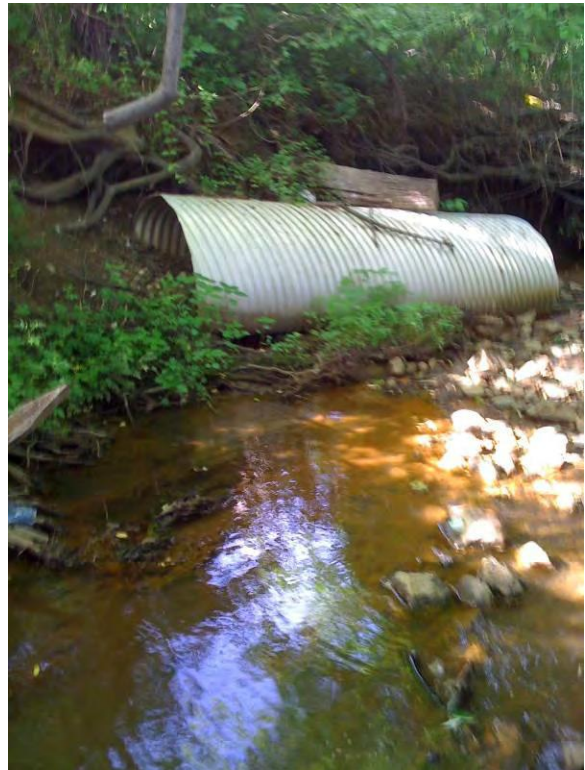
4D-910-45TR

Moderate quantities of metal scrap were observed along the lower portion of the project reach. Observed trash is mostly industrial in nature. Total volume of trash is estimated to be less than 1 truck load.

Failed metal culvert pipe or stormdrain pipe. Source of pipe is unknown. Pipe is creating a jam and collecting trash and debris.

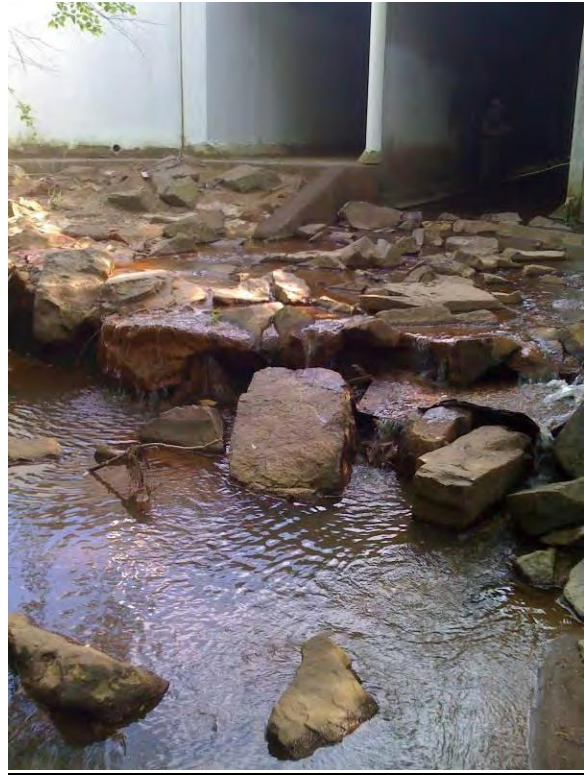
4D-910-44SC

The stream crossing culvert outfall under Marys Way is located at the head of the lower reach of stream. Head cutting has caused undermining of the grouted riprap apron at the culvert outfall. Progressive erosion will continue to degrade and break apart the apron. Additionally, the undermined apron is providing a barrier to fish passage.

Grouted riprap apron downstream of the Marys Way culvert stream crossing. Apron is undermined and breaking apart. Headcutting at the apron has created a fish migration blockage.

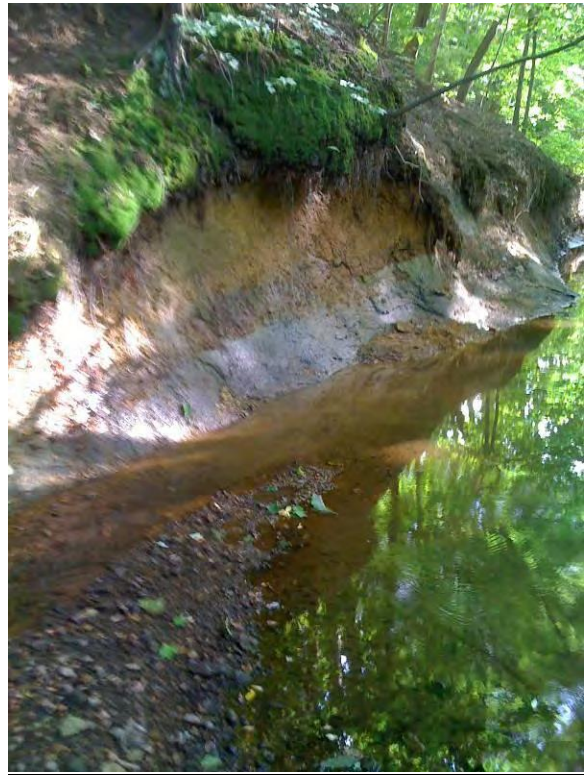
4D-910-46ER

The lower reach of the project area is severely degraded and is experiencing bank failure with erosion attacking both banks. Current erosion has affected 210 feet of right streambank with bank heights in excess of 8-feet and 80 feet of the left streambank with bank heights in excess of 5-feet.

Bank erosion along the lower project reach. Average of 5-foot high erosion observed on the left bank along a total reach length of 80 ft. Average of 8-foot high erosion observed on the right bank along a total reach length of 210 ft.

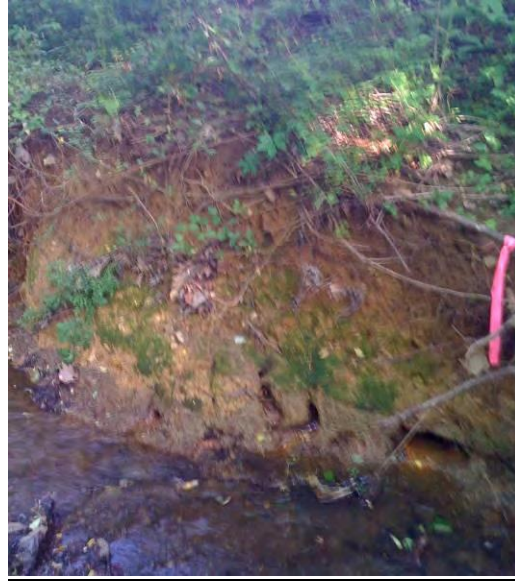
3D-910-42ER

Severely degraded reach of stream is experiencing bank failure with erosion attacking both banks. Current erosion has affected 140 feet of the right streambank with bank heights in excess of 6-feet and 100 feet of the left streambank with bank heights in excess of 8-feet.

Bank failure. 8-foot high erosion observed on the left bank along a total reach length of 100 ft. Average of 6-foot high erosion observed on the right bank along a length of 140 ft.

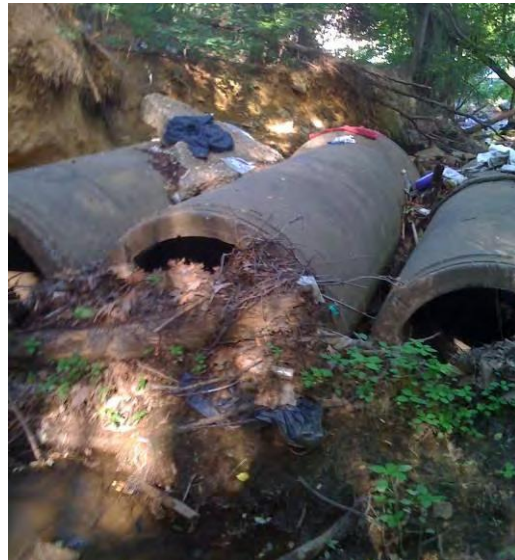
3D-910-51TR

Squatting area identified along the lower reach of stream. Squatters have left a significant quantity of trash and debris observed along the lower portion of the project reach. Observed trash is residential and industrial in nature, including floatables, tires, appliances, mattresses and scrap metal. Additionally, three RCP culvert pipes that are not currently serving any purpose are blocking the main flow channel of the stream. Total volume of trash is estimated to be less than 9 truck loads.

Illegal dumping. There is evidence of squatting. Plastic, clothing, metal, yard waste, and 3 RCP culvert pipes were found in the stream and on the riparian area.

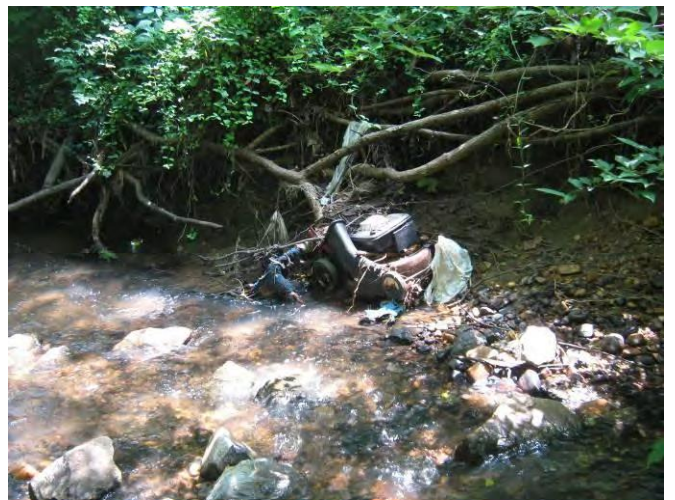
3D-910-140TR

Illegal dumping. Plastic waste, tires, appliances, yard waste, metal and mattresses found in the stream.

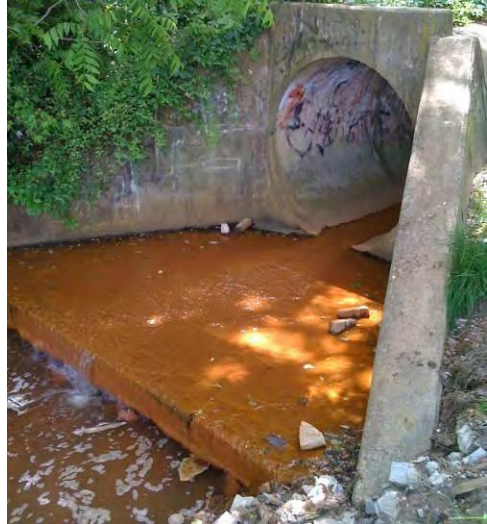
4C-910-22SC

Culvert outfall is located at the head of the degraded reach of stream. Concrete apron is undermined and provides a barrier to fish passage. Erosion and scour hole immediately downstream of the undermined apron observed. Orange staining and sheen was also observed on the outfall apron.

Concrete apron is undermined.

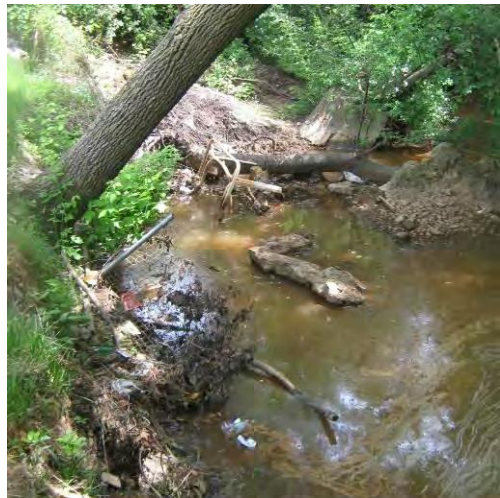
4C-910-23TR

Significant quantities of trash and debris observed along the entire portion of the project reach. Observed trash is residential and industrial in nature, including plastic, construction, metal, and yard waste. Total volume of trash is estimated to be less than 4 truck loads.

Plastic waste, construction waste, yard waste and metal found in the stream and on the riparian area on the left bank.

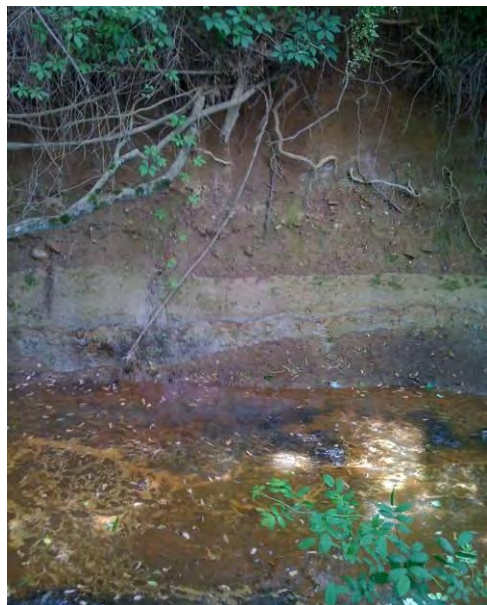
4C-910-24ER

Degraded reach of stream is experiencing widening with erosion attacking both banks. Current erosion has affected a 295 linear foot reach of right streambank and 40

Infrastructure Protection – Erosion advancing towards the existing commercial property has the potential to eventually undermine the commercial property and increase the potential for damage to the public.

Bank widening. Erosion towards commercial property. 4-foot high erosion observed along a total reach length of 40 ft on the left bank and 295 ft on the right bank.

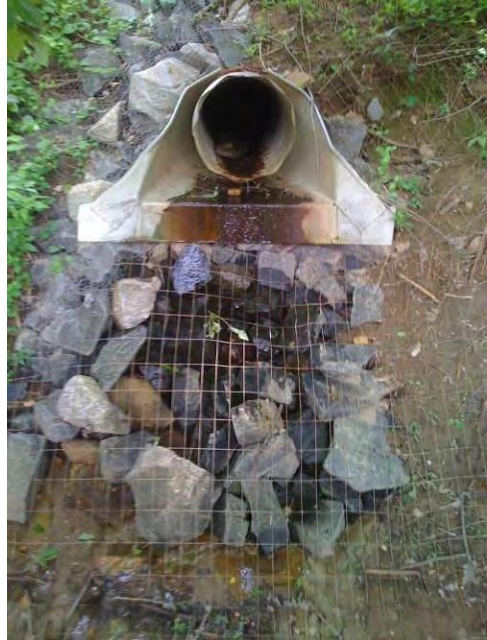
4C-910-25OT

Storm drain outfall at the right overbank of the degraded reach of stream. Corrosion of the corrugated metal pipe and corrugated metal apron was also observed. The outfall is perched above the streambed and shows evidence of fast erosion. Currently the outfall is stabilized with riprap and wire mesh. This protection is not anticipated to be a long term, sustainable retrofit.

Rusting corrugated metal pipe outfall.
Riprap slope protection held in place with
wire fencing.

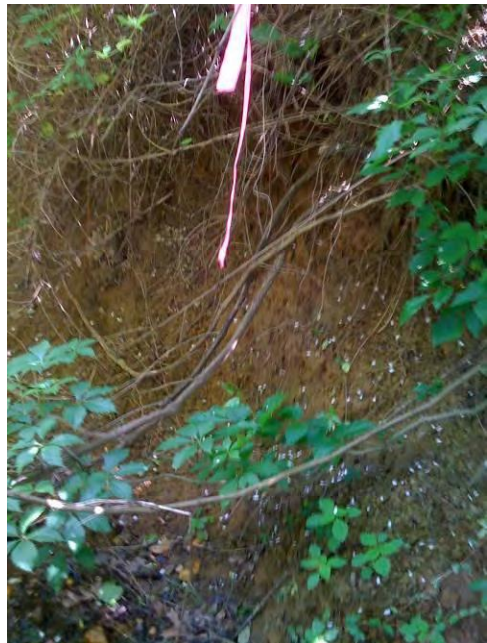
4C-910-30ER

Degraded tributary of stream is experiencing widening with erosion attacking both banks. Current erosion has affected a 40 linear foot reach of right streambank with bank height in excess of 5-feet.

Bank widening. Average of 5-foot high
erosion observed along a total reach length
of 40 ft on the right bank

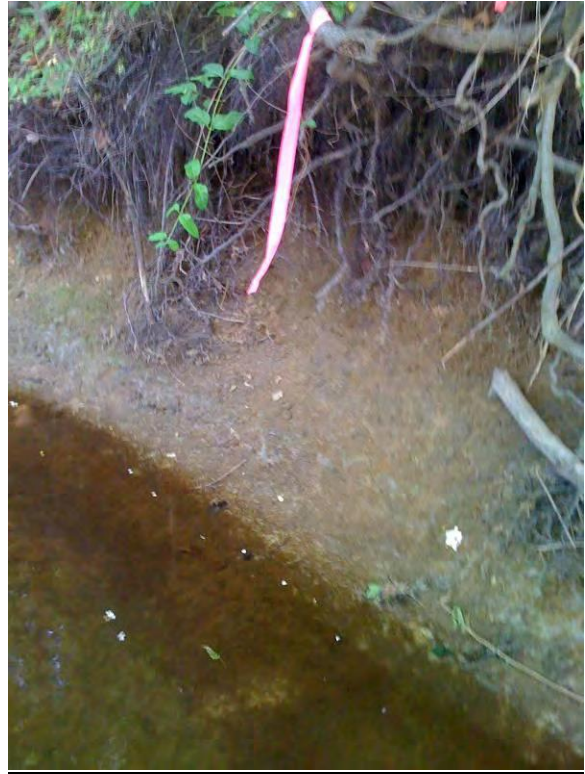
4D-910-36ER

Severely degraded reach of stream is experiencing bank failure with erosion attacking both banks. Current erosion has affected a 150 linear foot reach of right streambank and 100 linear foot reach of the left streambank with bank heights in excess of 4-feet.

Average of 4-foot high erosion observed along a total reach length of 100 ft on the left bank and 150 ft on the right bank.

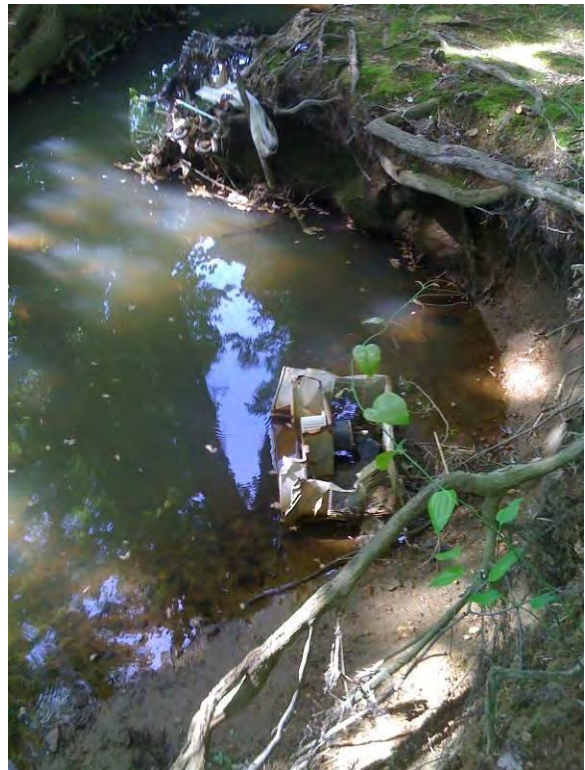
4D-910-37TR

Significant quantities of trash and debris observed along the entire project reach. Observed trash is residential and commercial in nature, including floatables, plastic, tires, appliances, yard waste, and scrap metal. Total volume of trash is estimated to be less than 4 truck loads.

Appliances, metal waste, plastic and paper floatables are found throughout this reach of stream.

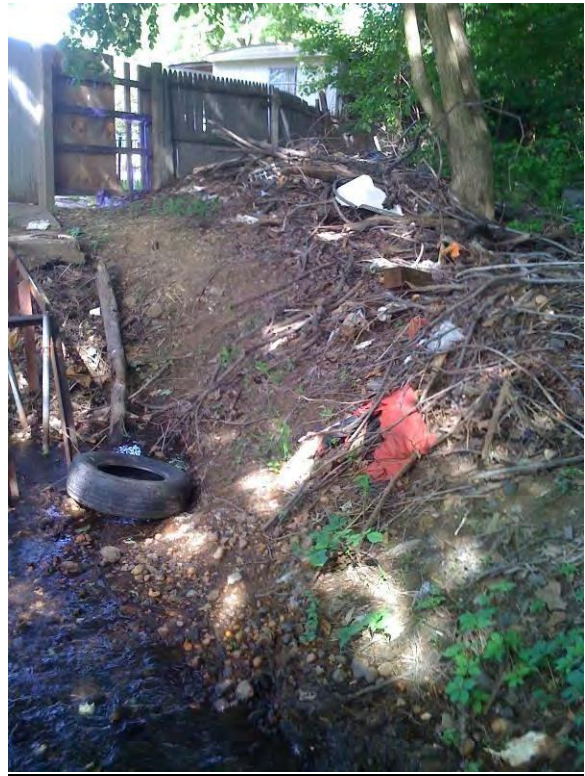
4D-910-38TR

Plastic waste, appliances, tires and yard waste found in the stream and on the right bank near the trash racks.

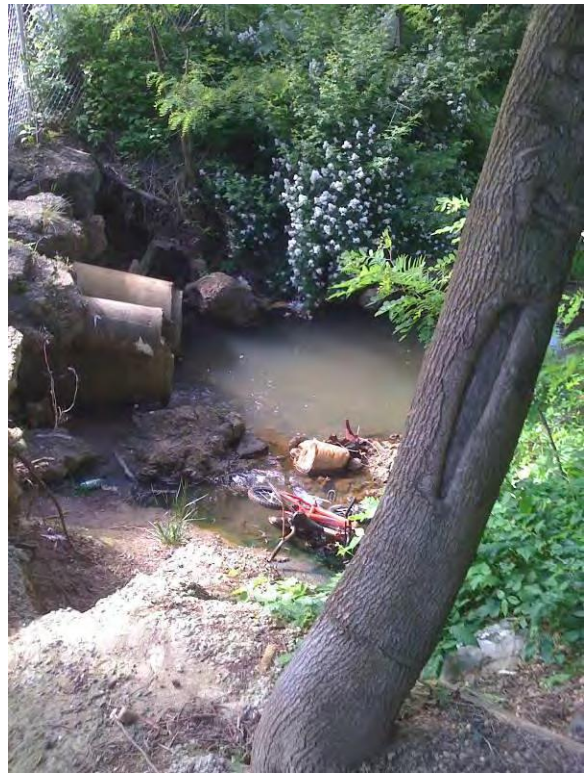
4D-910-39SC

Inlet and outfall of the culvert crossing of the stream are cracking and failing. The culvert is part of the Griffin Drive mobile home community and serves to convey Tributary A below the development. There is significant undermining and erosion at the outfall.

Infrastructure Maintenance – The culvert outfall is currently undermined and in need of maintenance to prevent failure. Failure of the outfall can potentially lead to further deterioration of stream channel and loss of property.

Erosion around the outlet of the stream crossing.

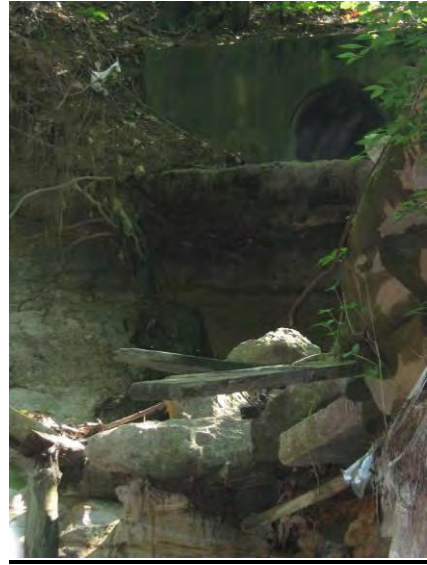
Storm drain outfall at the head of the degraded reach of stream. Severe head cutting has caused undermining of the endwall foundation for the outfall, and the outfall currently is perched approximately 7 feet above the channel bed. Continued erosion will cause the endwall to fail.

Infrastructure Maintenance – The storm drain outfall is currently undermined and in need of maintenance to prevent failure. Failure of the endwall can potentially lead to a chain reaction destabilization of the storm drain pipe system with pipes breaking, joints separating and sinkholes forming.

Undermined outfall, currently perched 7-feet above the streambed.

Stabilization of the storm drain outfall 4D-910-168OT will be achieved by extending the storm drain system and backfilling the existing degraded channel. The extended storm drain system will have a new outfall located near the existing tributary confluence.

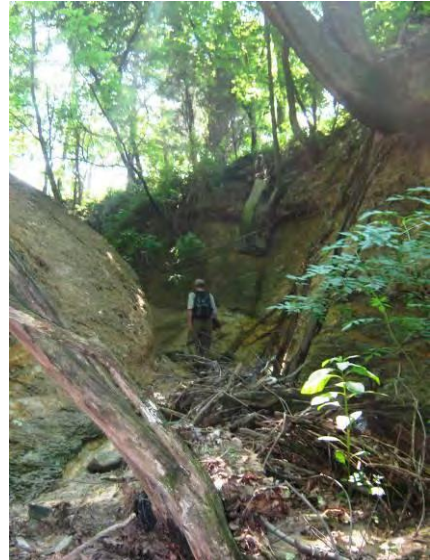
Severely degraded reach of stream is experiencing both head cutting and widening with erosion attacking both banks. The channel bed and banks are characterized by a dense sand substrate that will continue to allow for moderate to high erosion rates. Current erosion has affected the reach of stream with banks in excess of 20-feet in height.

Highly erodible soil. Massive headcuts and bank widening. Significant sediment source along with sediment deposition downstream. Average of 20-foot high erosion observed along a total reach length of 150 ft on the left and right bank.

The stabilization of reach 4D-910-169ER involves backfilling the existing channel with 20-foot high banks and installing a new storm drain system connecting existing storm drain outfall (4D-910-168OT). The extended storm drain system will replace the degraded stream reach. The new storm drain system consists of an undetermined size and length of pipe, a manhole located near the existing manhole 4D-910-170UT, and an energy dissipating outfall structure at the confluence of the two existing streams.

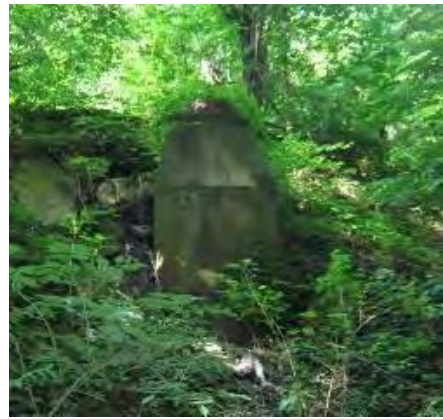
4D-910-170UT

Abandoned storm drain manhole stack located along severely degraded stream reach. Erosion has not currently adversely impacted the concrete manhole stack, but progressive erosion will lead to further exposure of the stack and an increased potential for damage to the stack.

Abandoned storm drain manhole. Filled with sand and dirt to within 6-8 ft. of the top. Inlet/Outlet not visible.

At the time of the field reconnaissance, the manhole stack and connected sewer conduit had not been impacted by the degraded channel reach and do not appear to require any structural rehabilitation. It was later determined that this is an abandoned storm drain manhole that is filled with sand and dirt. Therefore it is proposed that the manhole be removed during associated storm drain and stream construction activities.

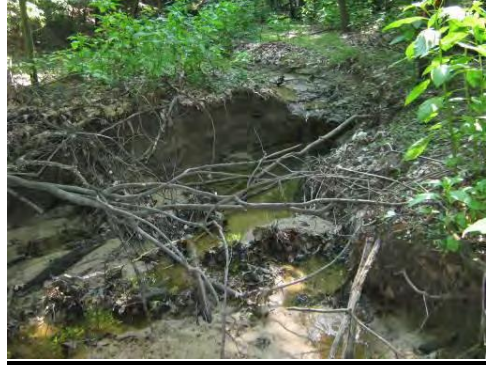
4D-910-166ER

This reach of stream is experiencing severe erosion and widening with erosion attacking both banks. There is an outfall and an exposed pipe in the stream. The pipe could possibly be a historic road crossing, a failed storm water management facility, or some other type of drainage structure which is now abandoned. The inlet of this pipe appears to be buried under the current streambed. The stream banks along the exposed pipe are severely eroded. Current erosion has affected 200 linear feet reach of stream with banks in excess of 5-feet in height.

Average of 5-foot high erosion observed along a 200-foot reach length on the left and right bank.

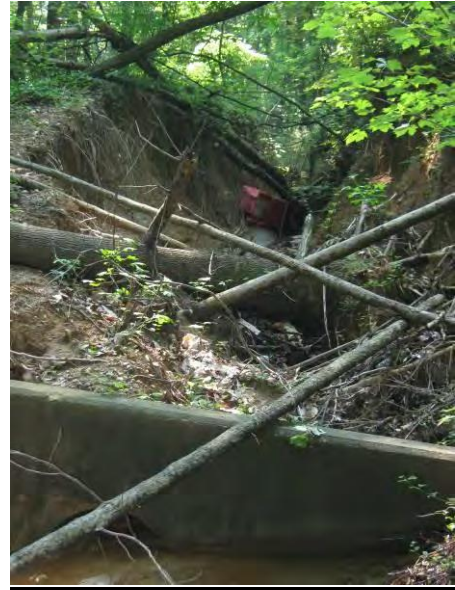
Pipe endwall with failed foundation. Unknown source of pipe. Possibly a failed storm water pond, a historic road crossing, or some other type of drainage structure.

The outfall located at 4D-910-165OT in the main channel will not be stabilized under the proposed concept but rather shall be removed. Prior to further investigations into the project concept, county should confirm that the outfall is part of a failed drainage system that is eligible for removal over repair. The proposed design involves removal of the abandoned outfall and exposed pipe from the stream and creation of a stream channel through stream restoration and natural channel design techniques.

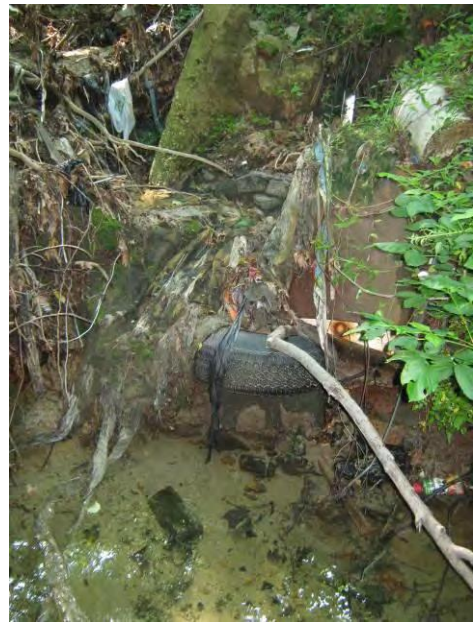
4D-910-167TR

Significant quantities of trash and debris observed along the project reach. Observed trash is residential and commercial in nature, including floatables, tires, plastic, appliances, construction, and scrap metal. Total volume of trash is estimated to be less than 12 truck loads.

Source of trash is possibly illegal dumping and flooding. Plastic waste, tires, appliances, construction waste and metals found in the stream and on the riparian area.

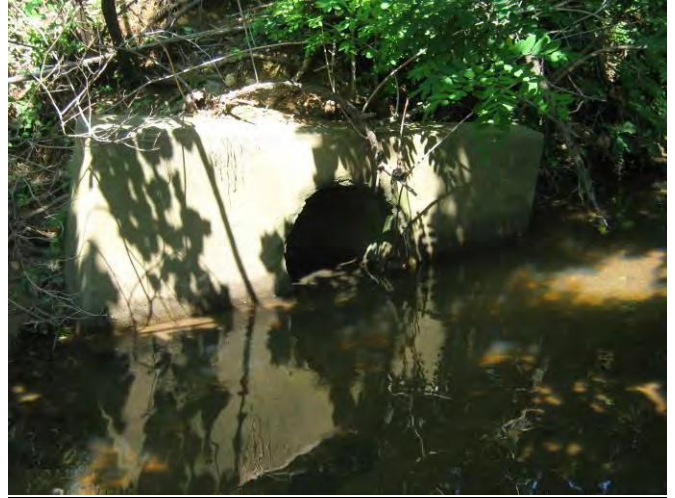
4D-910-160OT

Storm drain outfall foundation is completely undermined and is slumping into the channel bed. The joint between pipe and endwall is also broken. There is also erosion around and behind the endwall. Continued undermining of endwall foundation will result in complete failure of the endwall structure adversely impacting the stream. The endwall is located on the left streambank approximately 40 feet downstream of the Route 1 culver crossing of Marumsko Creek.

Infrastructure Maintenance – The storm drain outfall is currently undermined and in need of maintenance to prevent failure. Failure of the endwall can potentially lead to a chain reaction destabilization of the storm drain pipe system with pipes breaking, joints separating and sinkholes forming.

Outfall foundation completely undermined, slumping and failing. Joint broken inside. Bank erosion around the outfall and behind the outfall.

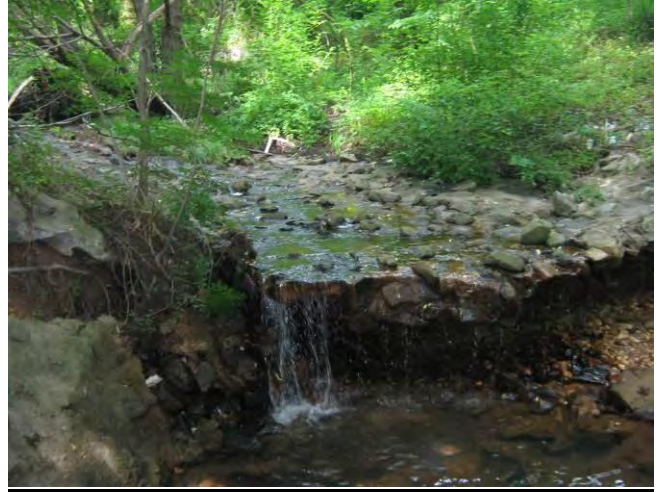
5C-915-01CM

Stream section immediately downstream of the Jefferson Davis Highway culvert crossing outfall is channelized using grouted riprap. There is significant undermining of the grouted riprap apron which provides a barrier to fish passage and is also a cause of erosion of natural channel bed downstream. The reach downstream of the grouted riprap apron is also experiencing widening and bank failure with erosion attacking both banks. Current erosion has affected a 310 linear foot reach of right streambank and 185 linear foot reach of the left streambank with bank heights in excess of 7-feet.

Grouted riprap channel bed that is undermined and slowly breaking apart. The riprap apron starts at the Jefferson Davis Highway culvert outfall and is approximately 50-feet long.

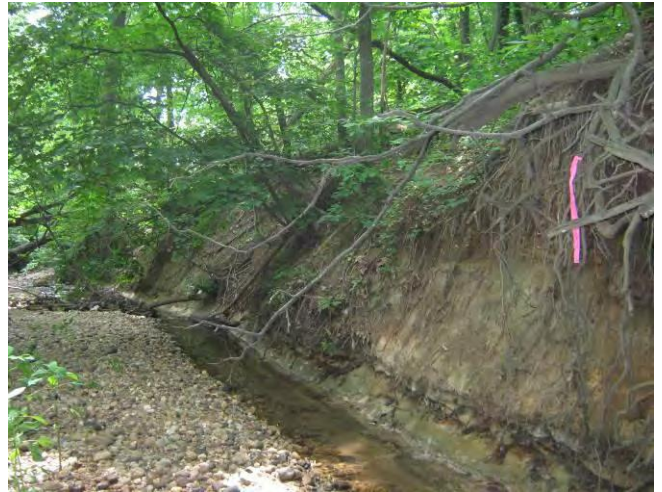
5C-915-02ER

Widening and bank failure. 7-foot high erosion on left and right banks for total reach length of 185 ft on left bank and 310 ft on right bank.

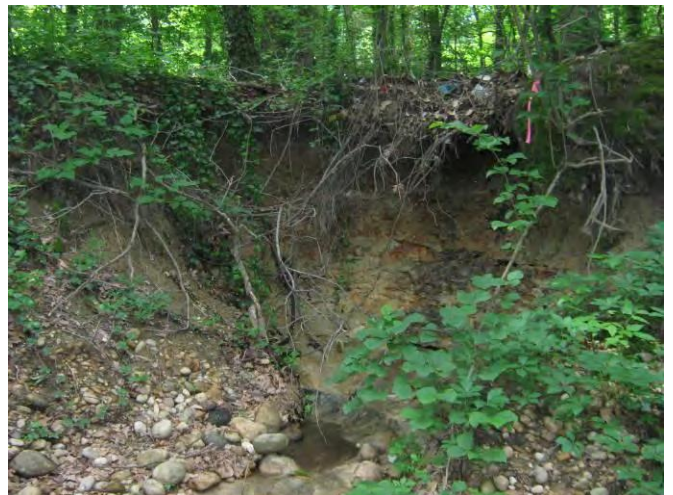
5C-915-04ER

8-foot high bank erosion along the right streambank. Erosion is occurring due to headcutting at the confluence of a shallow drainage swale with tributary 1.

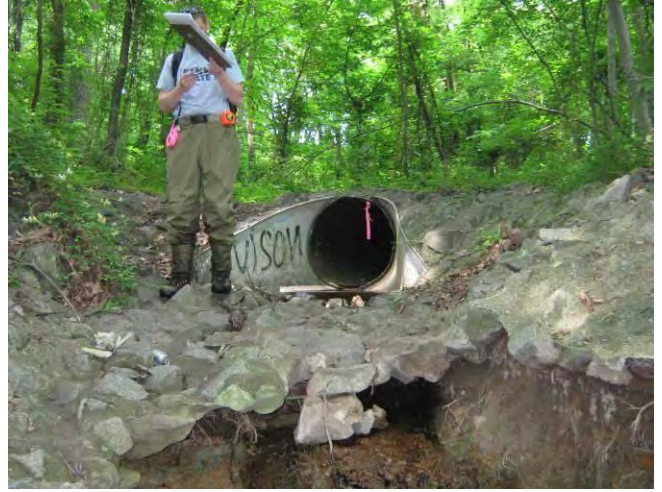
5C-915-03OT

Stormwater management BMP (FAC Id 5197) outfall at the right bank of the degraded reach of stream is corroded. Erosion / headcutting is encroaching and undermining the grouted riprap outfall protection. The outfall currently is perched approximately 6 feet above the channel bed. Continued erosion will cause the endwall to fail.

Infrastructure Maintenance – The storm water management BMP outfall is currently undermined and in need of maintenance to prevent failure. Failure of the endwall can potentially lead to a chain reaction destabilization of the storm drain pipe system with pipes breaking, joints separating and sinkholes forming.

Corrosion observed. Grouted riprap apron failing with a headcut downstream.

Stabilization of the storm drain outfall will be incorporated into the stream stabilization design with the in-stream structures for grade stabilization being utilized to protect the endwall from undermining. At the time of the field reconnaissance the storm drain endwall was undermined and perched above the streambed, but appears to be salvageable. However, replacement of the outfall may be required, if progressive erosion causes the endwall to fail before a stabilization project can be effectively implemented.

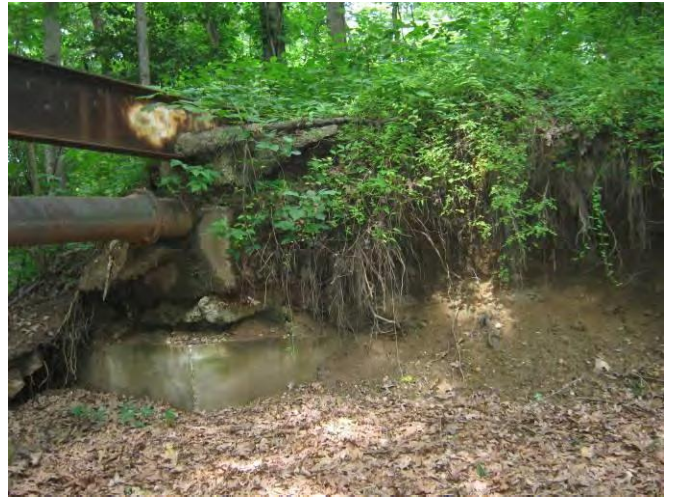
5C-915-05UT

Sewer line is suspended on steel I-beam above channel bed. The foundations on both sides of the stream on which the steel I-beam rests are undermined and is failing. There is also erosion of the left streambank around the foundation. Continued erosion will lead to progressive deterioration of the foundation and eventual failure.

Infrastructure Protection – Erosion around the foundations of the steel I-beam has the potential to eventually undermine the foundations completely and lead to its failure.

Sanitary line suspended on I-beam. Foundation undermined and failing. Progressive deterioration.

Stabilization of the suspended sewer line will be incorporated into the stream stabilization design with reinforcement of the foundations on both sides of the stream. Associated channel bank grading will decrease the erosional stresses around the foundations.

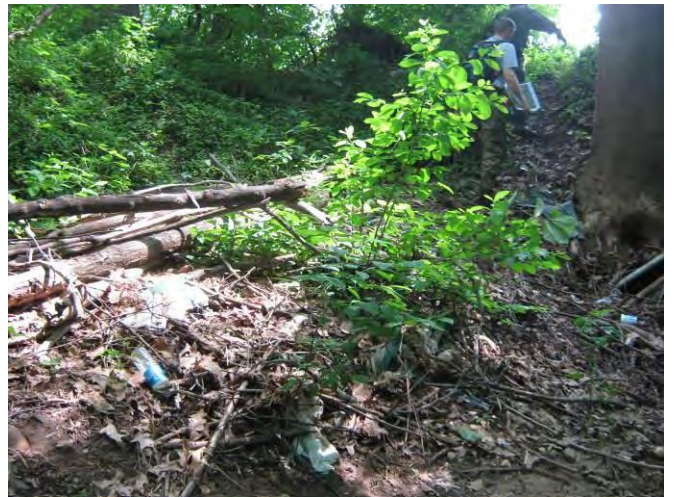
5C-915-08TR

Moderate quantities of trash and debris observed along the lower portion of the project reach. Observed trash is mostly residential in nature, including floatables, plastic and yard waste. Total volume of trash is estimated to be less than 1 truck load.

Plastic and yard waste accumulated on the left bank possibly because of flooding.
