Appendix E

Dawkins Branch (262) Subwatershed Project Conceptual Design Narratives

Project: Dawkins Branch 262-13 Major Repair

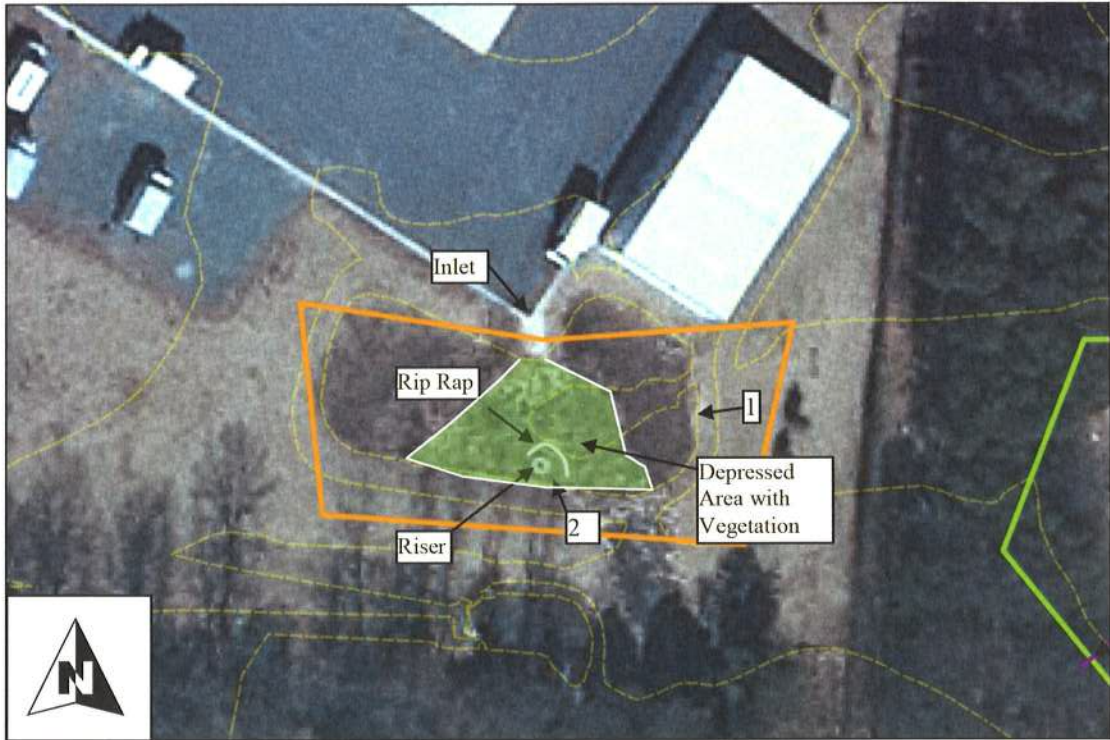
Problem Description: This facility's function has degraded over time due to a lack of proper maintenance. The low flow orifice is damaged, and a ring of riprap has been installed around the riser. Dense woody vegetation has been allowed to grow in the center of the facility, making inspection and maintenance of the riser difficult. The higher elevations of the basin are routinely mowed, as are the surrounding side slopes and berm. Sediment has accumulated at the inlet. The riser is a small drop inlet only about 1 foot above the basin bottom.

Existing Condition: Facility has broken low flow orifice and is in need of maintenance.

Project Description: This facility requires repairs to address the broken low flow orifice as well as maintenance to remove the sediment and vegetation. The riprap berm around the riser should also be removed. The site design could be improved by adding a forebay to control sediment inputs. The facility needs to be added to the County inventory, and receive routine inspections.

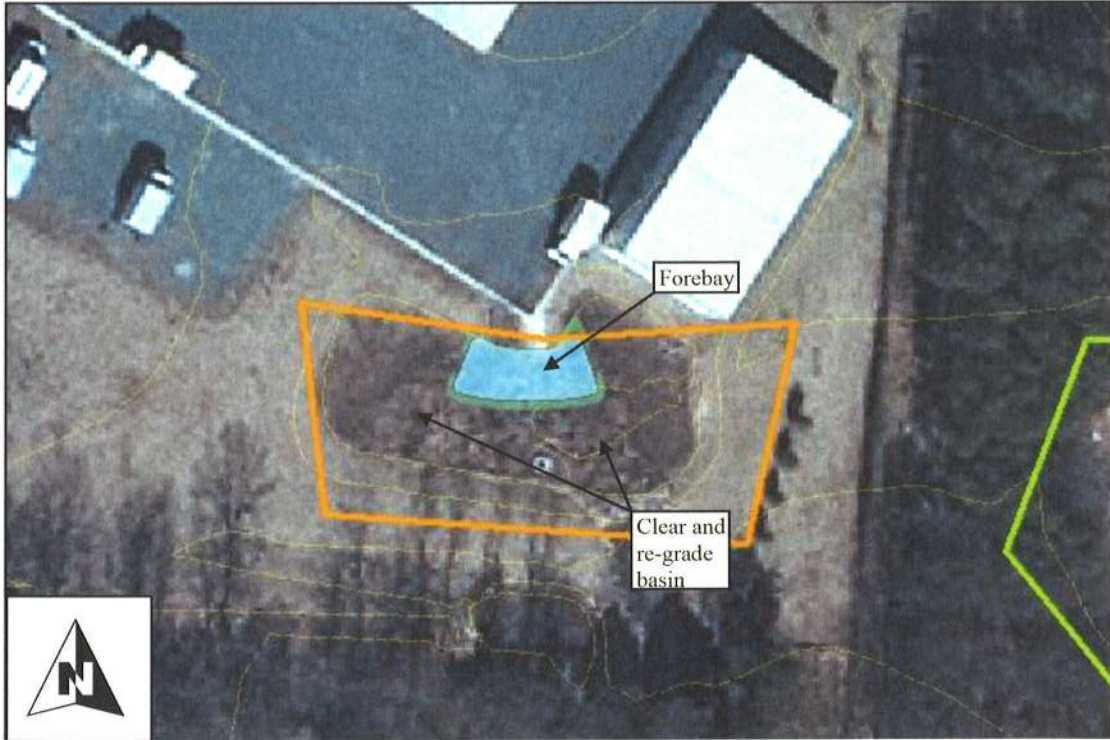
Conceptual Plan: Repairs to riser and addition of forebay

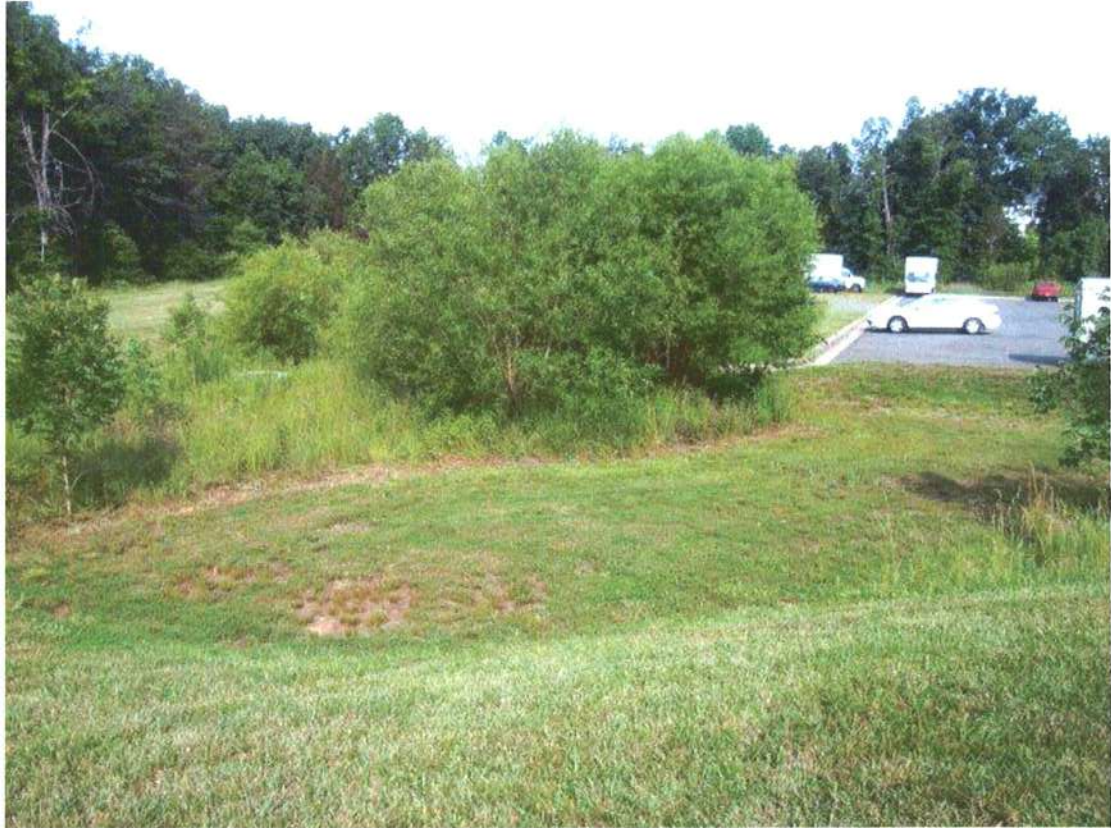
Photo 1: The center of the basin is significantly lower and lacks maintenance.

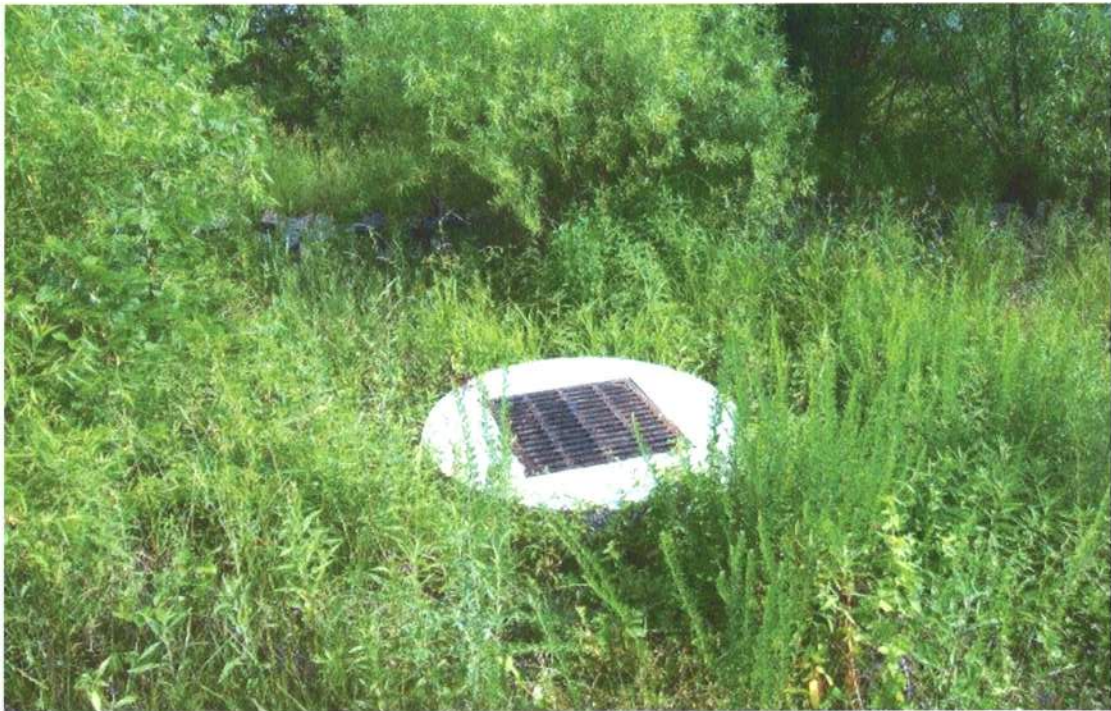
Photo 2: Riser is relatively small and the PVC low flow outlet is broken

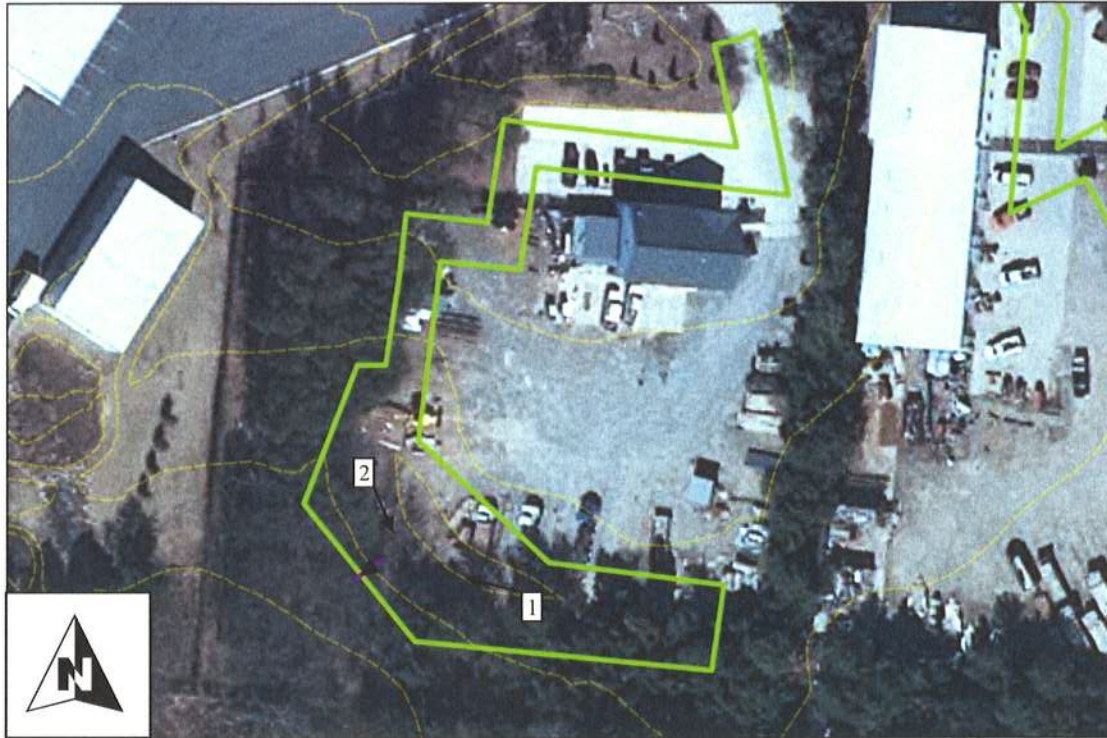
Problem Description: This dry basin BMP was added to the County database in 2000, and includes a note that the County is responsible for maintenance. The database indicates that this facility does not have a riser, and none was found during the site visit. However, the GIS indicates that there should be a 15 inch culvert outlet. Based on the SWM easement in the GIS, the site appears to have been partially filled by expansion of the adjacent gravel parking area. The facility has also been encroached upon by storage of materials. There is no evidence of recent maintenance of this facility. However, there is a depressed area that has cattails and receives runoff.

Existing Condition: SWMP/BMP has been impacted by expansion of parking area

Project Description: It is recommended that the entire facility be reconstructed to current standards for size, storage, inlet controls and outlet design. Based on the drainage area (1.3 ac.) and impervious surface area (0.9 ac.), if the facility were reconstructed as a Level 1 bioretention facility, a basin of 2,100 sq.ft. designed for 6" of ponding would accommodate the treatment volume with additional capacity available for channel protection volume.

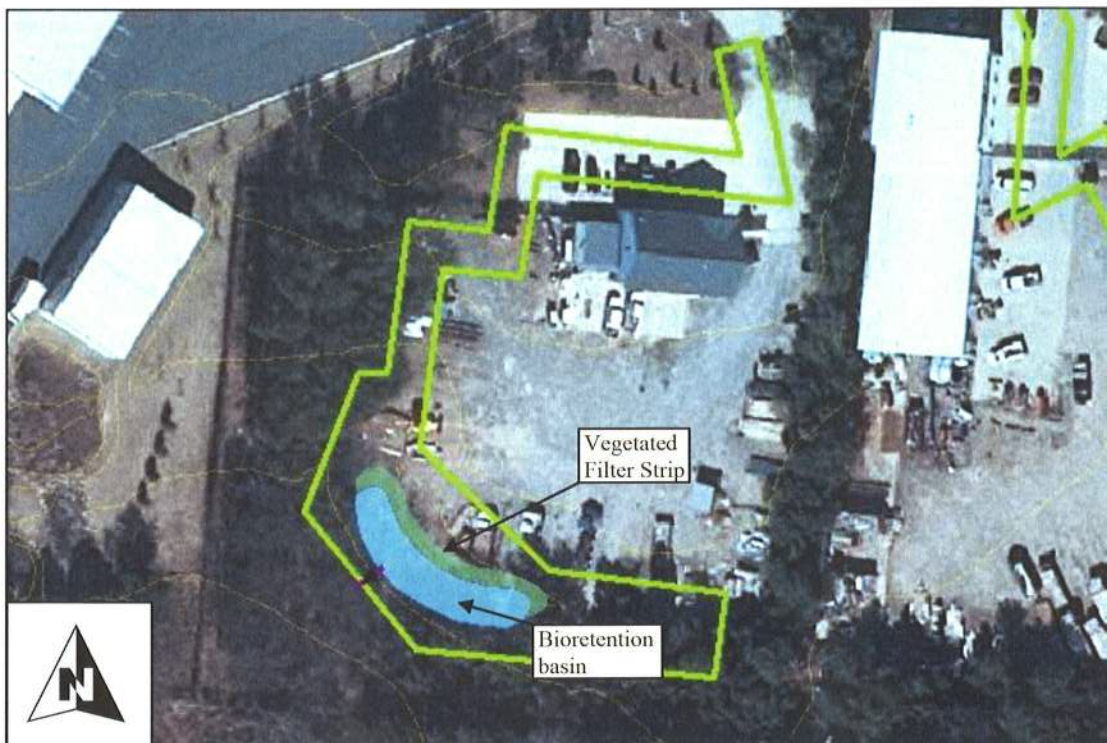
Conceptual Plan: Reconstruct facility to current standards with bioretention

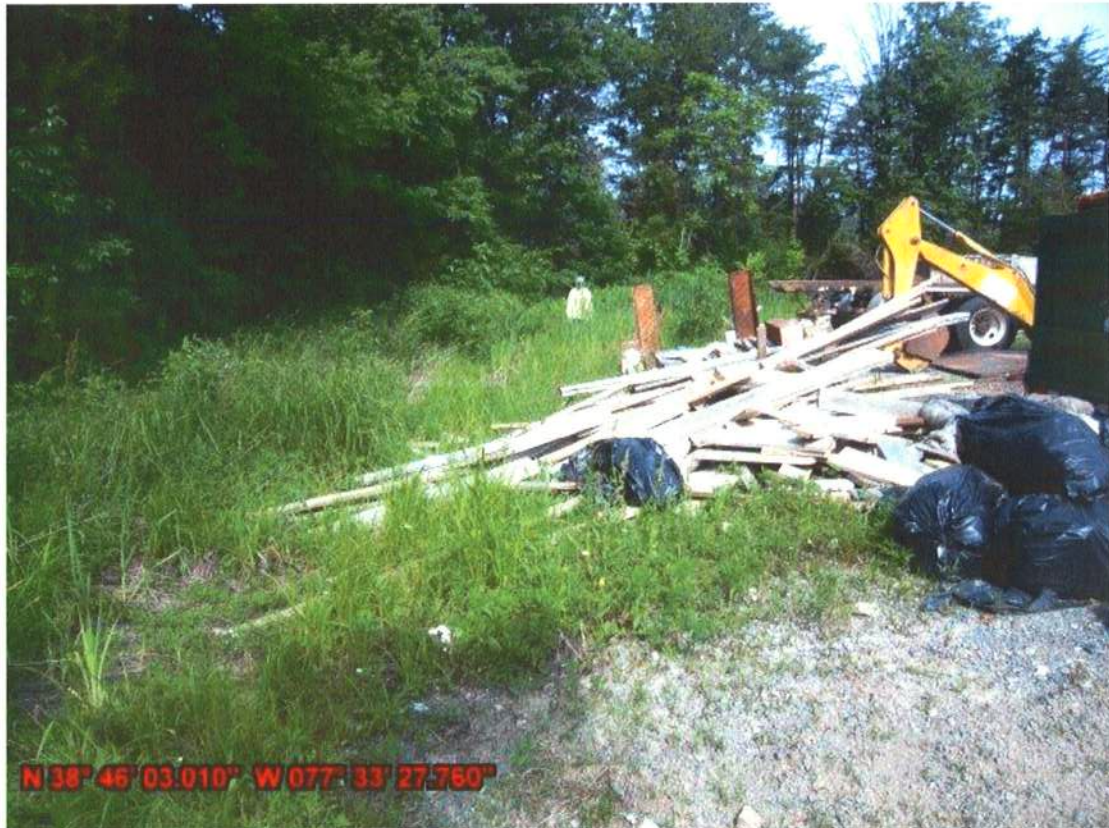
Photo 1: BMP facility appears to be partially filled by gravel parking and storage

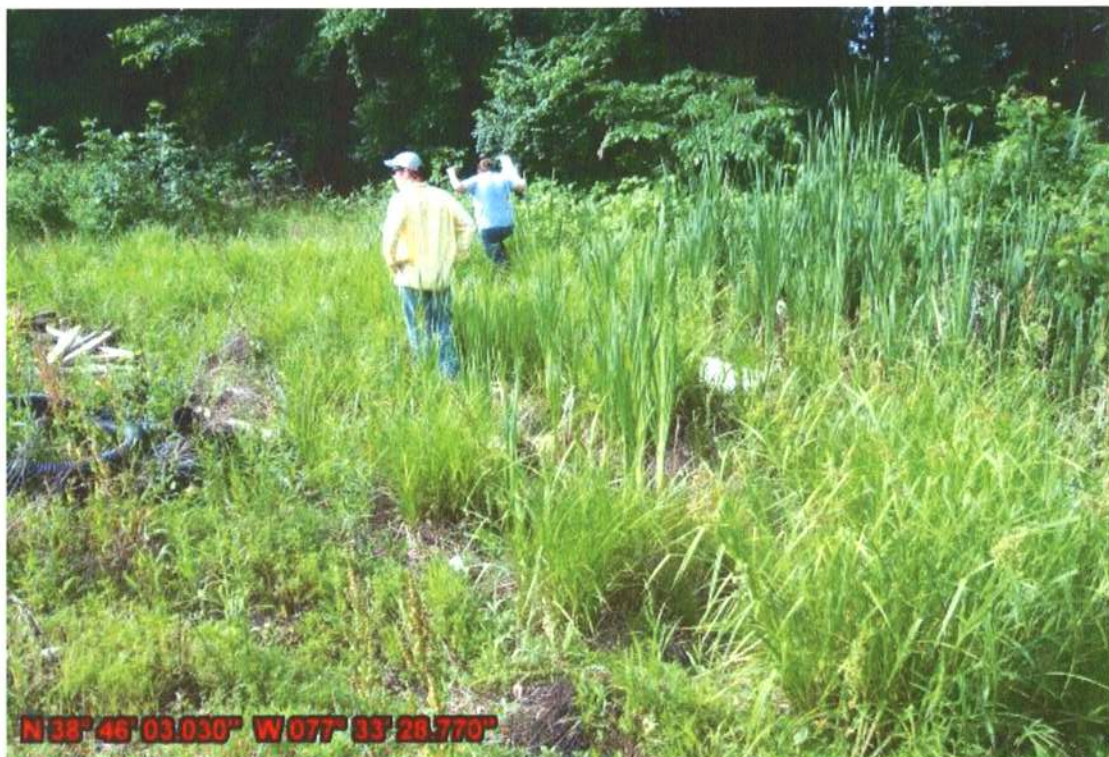
Photo 2: Site shows lack of routine maintenance in area that does collect water

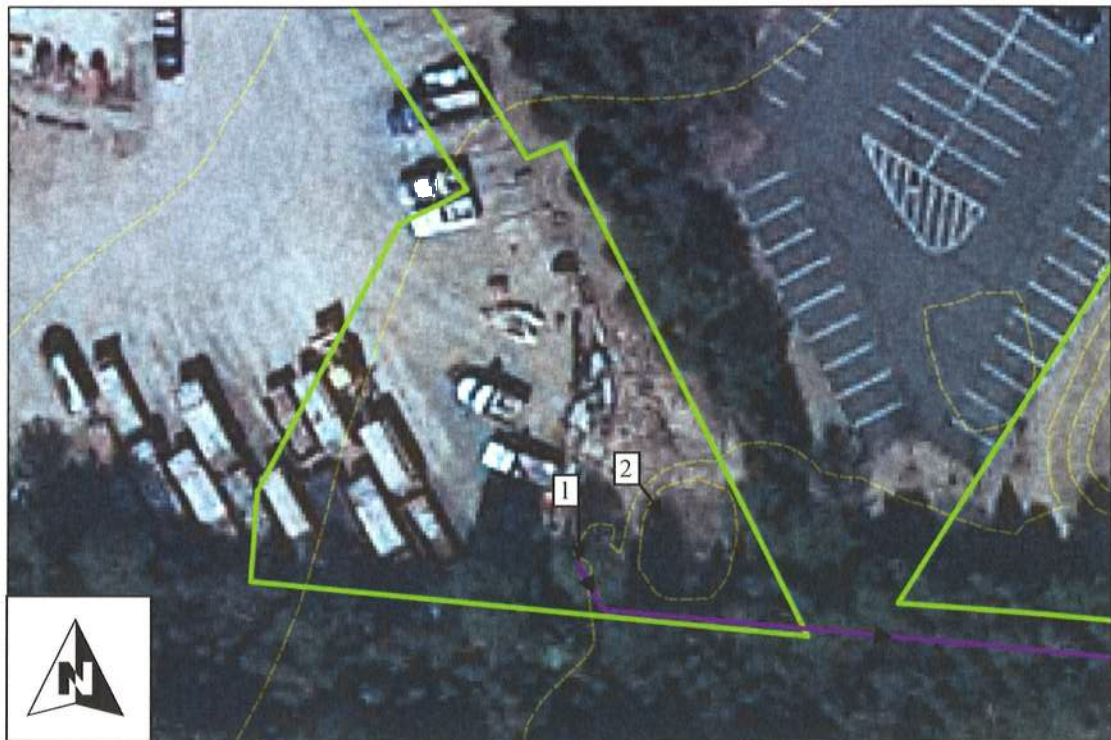
Problem Description: This facility was added to the County database in 2003 and indicates it has a 48 inch riser. GIS database indicates a 15 inch outlet pipe. Based on the stormwater easement shown in the County's GIS data, the facility may have been significantly larger when designed than its current size. The adjacent gravel parking area appears to have been expanded into the facility's original footprint. The riser is relatively intact but has a broken PVC inlet. The basin bottom is covered with heavy vegetation growth and requires maintenance. The riser is less than 2 feet above the basin bottom, so the facility has very shallow detention. Inflow appears to be sheet flow from the parking lot. The facility is significantly degraded in its present state.

Existing Condition: BMP is not maintained, and parking has encroached into easement

Project Description: This facility requires a full reconstruction to regain its original size. The riser could probably be re-used if modified. If reconstructed, the facility should meet current standards, including a forebay or other pretreatment.

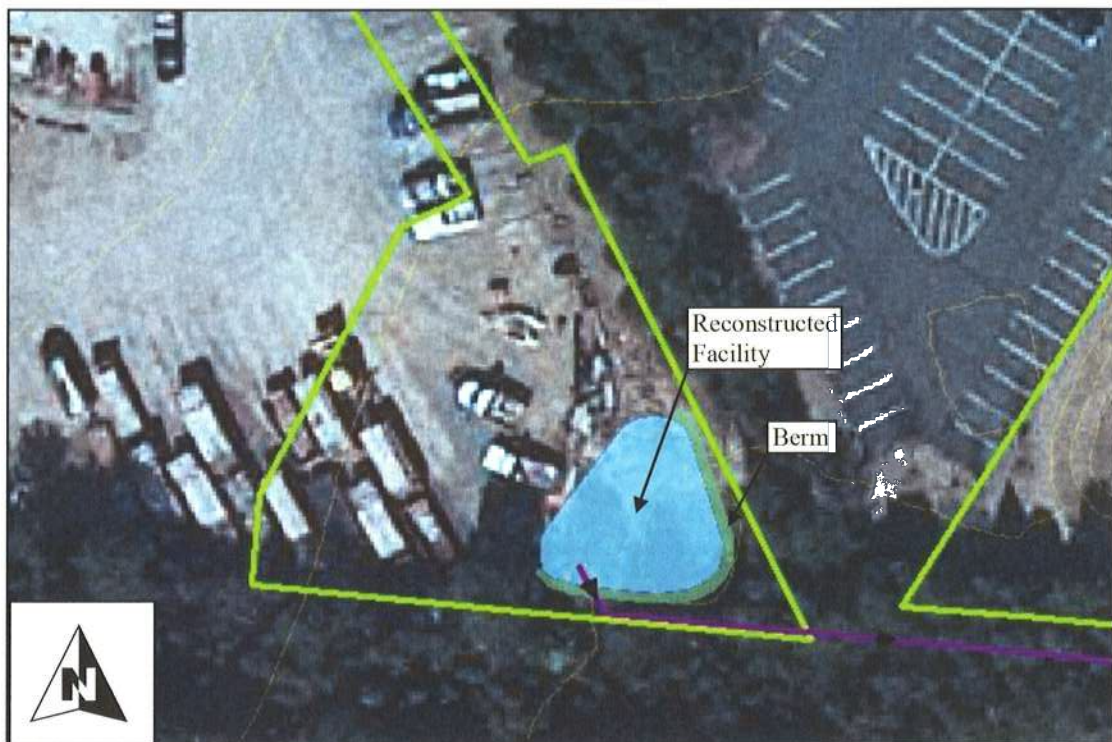
Conceptual Plan: Reconstructed detention facility with minimum footprint.

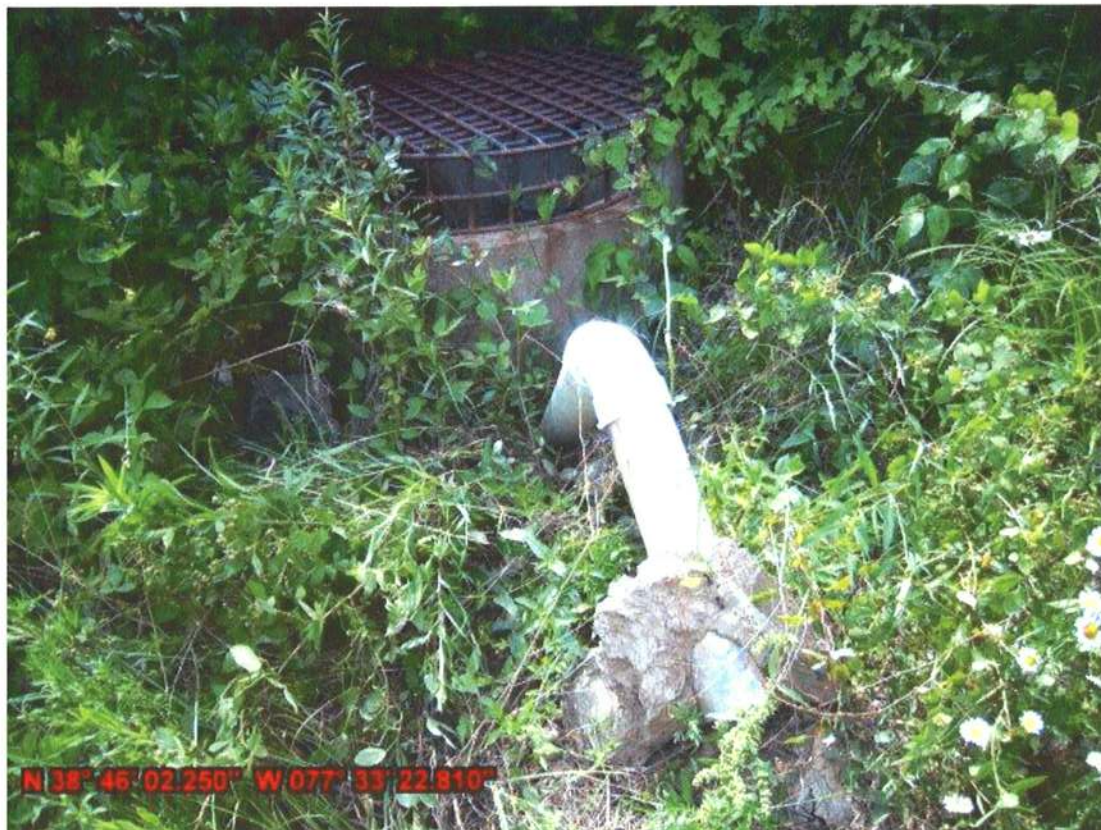
Photo 1: Riser with broken low flow inlet

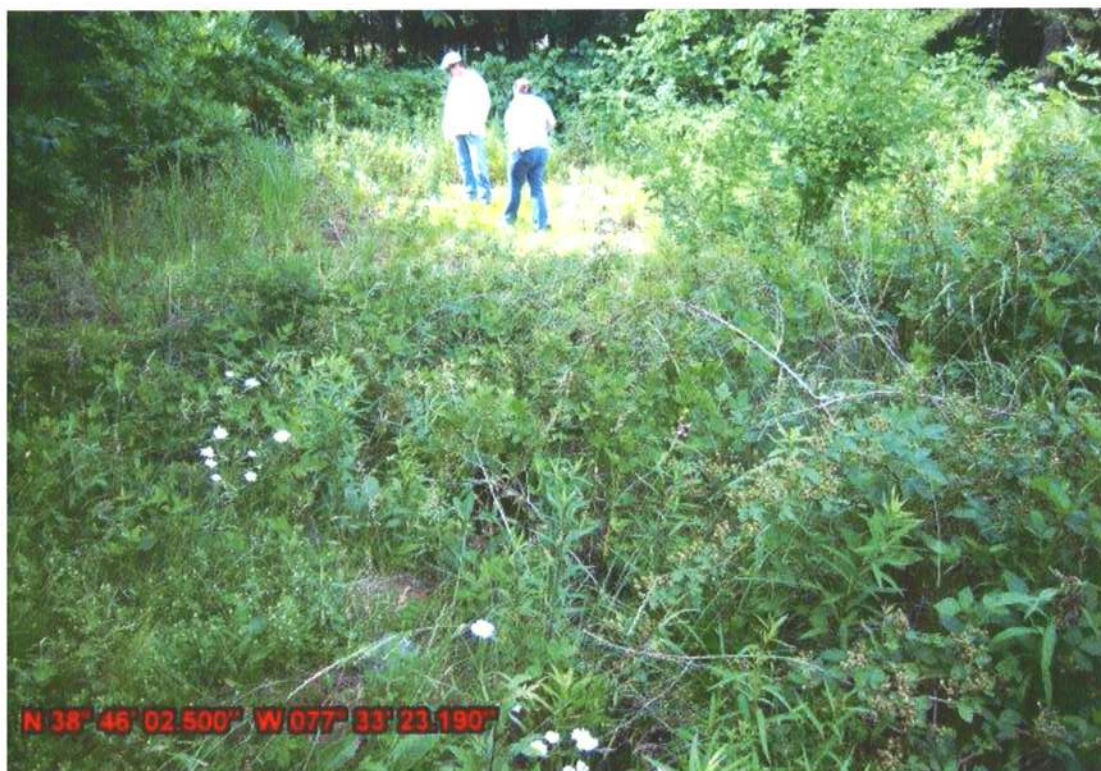
Photo 2: Basin not maintained and possibly filled

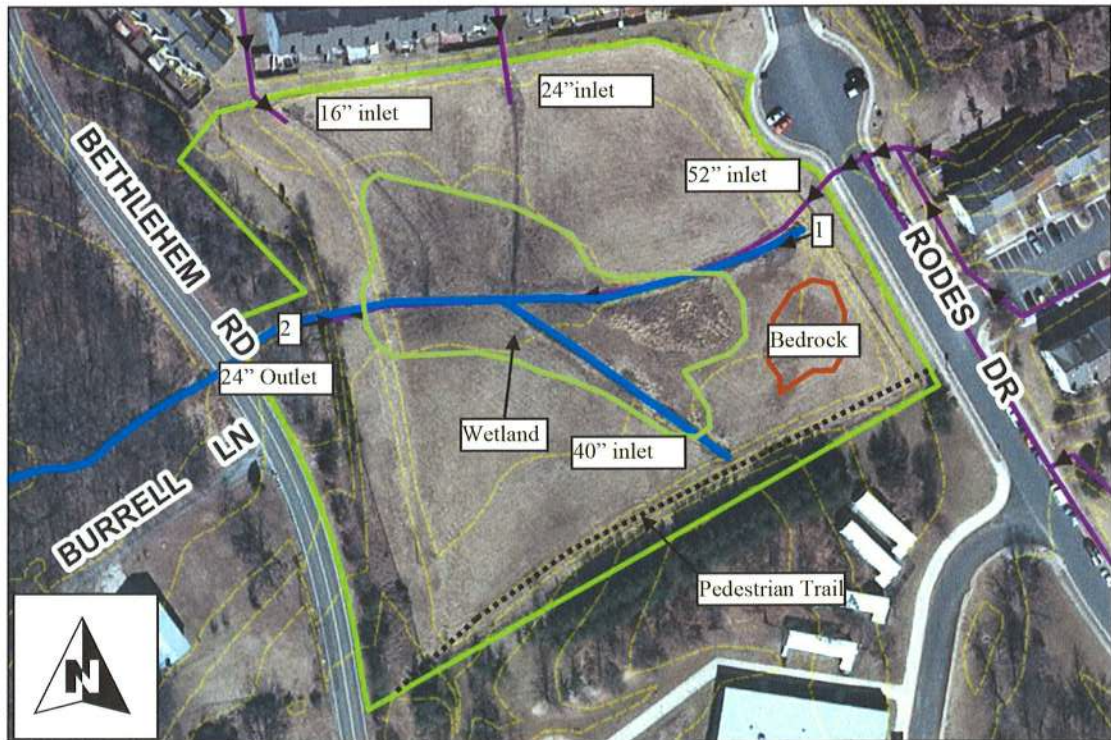
Problem Description: This stormwater facility is listed in the County database as a SWMP without a riser, but in the comment section it is referred to as the “Paradise SWM/BMP”. In the field, the basin has a 54 inch square riser with a 24 inch outlet pipe. There is a low flow orifice in the riser, but the orifice is buried by 1 to 2 feet of sediment. The basin is ponded with up to 2 feet of water and extensive wetlands have formed in the basin. An informal pedestrian trail was identified through the basin along the southern boundary adjacent to a school. This dry basin is approximately 3.4 acres in size, and is draining approximately 47 acres consisting mostly of multifamily housing.

Existing Condition: A large dry basin BMP supporting extensive wetlands

Project Description: The existing ponding and wetlands are a function of complete clogging of the low flow orifice by sediment. Given the large size of this facility and its demonstrated ability to hold water and support wetlands, it is recommended that the facility be retrofitted into a constructed wetland facility. A retrofit would include disrupting the channelized flow directly from the inlets to the riser, increasing the flow path with berms, and creating a permanent micropool at the riser. The riser would be modified with a subsurface intake to minimize clogging. Forebays would be constructed at the two primary inlets to contain sediment inputs. Any work on this facility should include a HOA education and maintenance plan so that its functioning is not impaired by future maintenance.

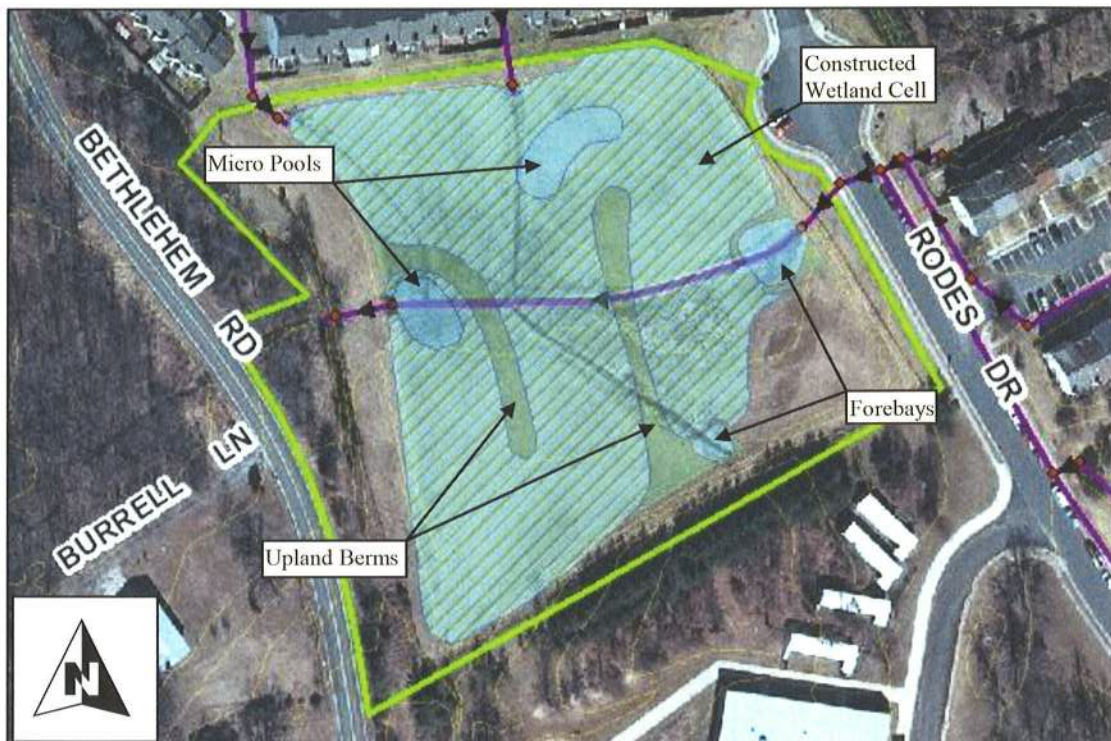
Conceptual Plan: Constructed stormwater wetland with forebays for pre-treatment and upland berms to increase flow lengths and residence time

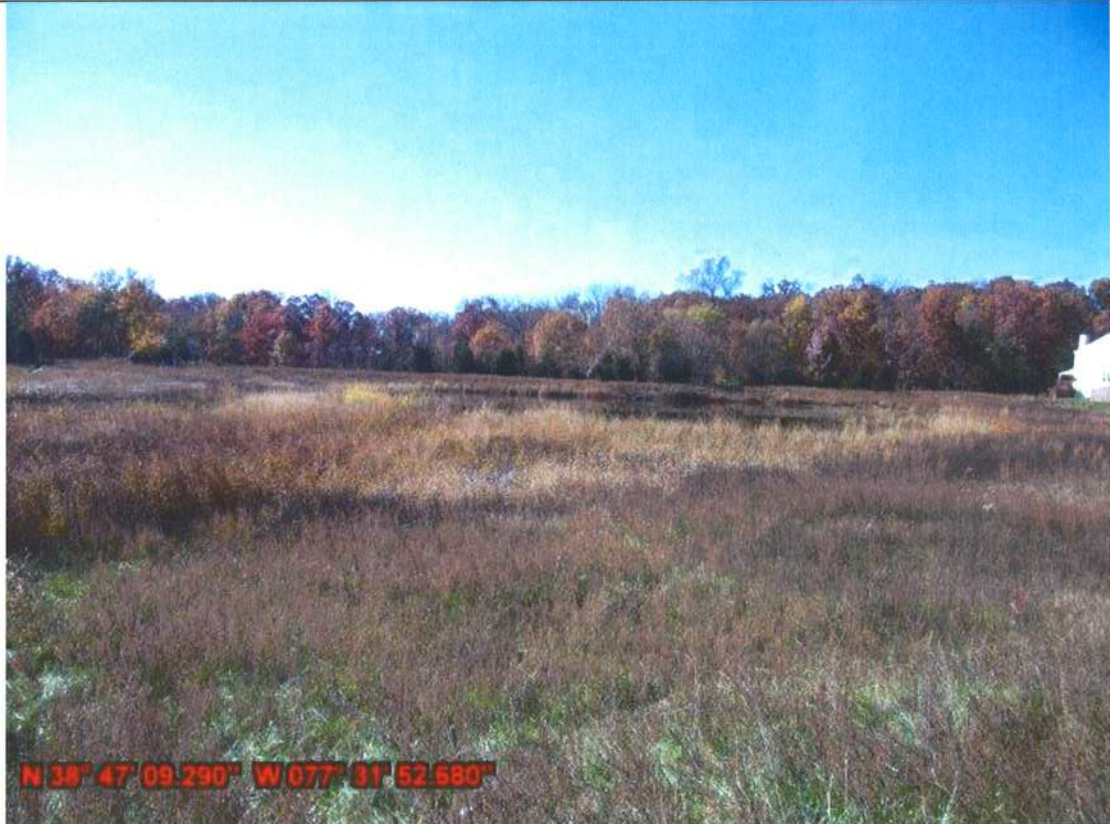
Photo 1: Dry basin (SWMP) with large wetland and ponded to 2' deep

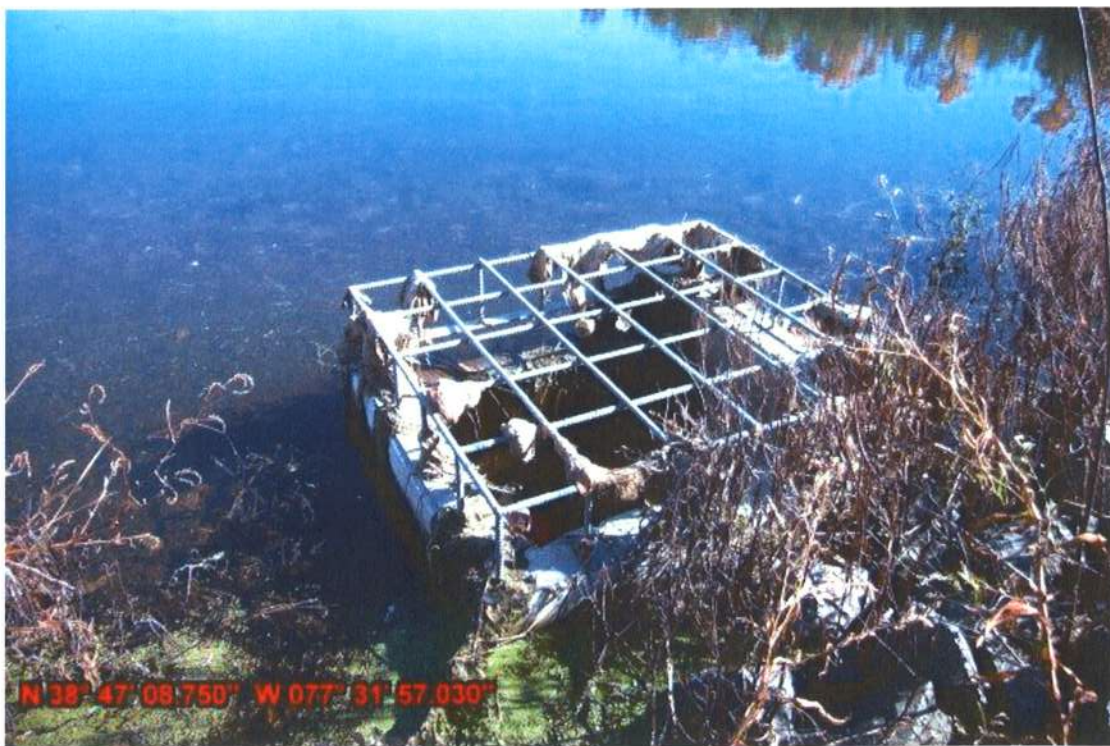
Photo 2: Low flow orifice clogged below 1'-2' of sediment

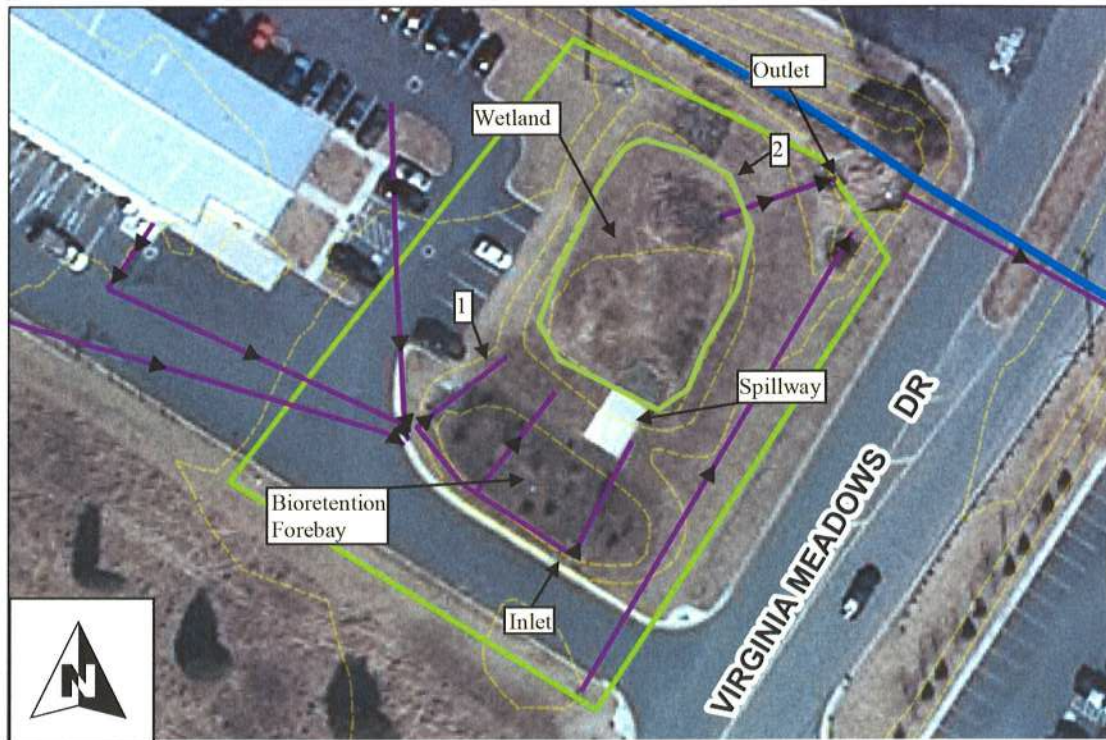
Problem Description: This facility, constructed prior to 2005, has a large bioretention “forebay” (3,600 sf) which drains to a large dry basin (6,000 sf). The dry basin provides quantity storage while the bioretention area provides the quality function. The principle outlet for the dry basin is a culvert through the embankment without a riser. The dry basin floor is covered with wetland vegetation supported by groundwater and seepage from the bioretention facility. The bioretention “forebay” has three stormwater inlet pipes (15-18 inches) and one paved flume from the roadway. The forebay has three 4 inch underdrains which were located in the field and appear to be discharging groundwater to the dry basin. The use of bioretention in a forebay is not a standard practice. The primary function of a forebay is to trap sediments. Bioretention facilities tend to clog if subjected to a sediment load. Combining the function of a forebay and a bioretention facility is a conflict of goals. Vegetation in the bioretention basin is sparse and some shrubs are dead. The current facility, although unconventional, is still probably very functional for water quality and quantity control. However, the forebay will deteriorate over time as sediment clogs the infiltration capability of the basin.

Existing Condition: Site with bioretention forebay and dry basin without riser

Project Description: To renovate the bioretention basin/forebay it is recommended that a forebay be installed at the location of the three stormwater inlet pipes to protect the function of the bioretention basin. The remainder of the bioretention facility would be renovated, including new soils, plants and mulch. The functioning of the under drain system should be checked as a part of the renovation. Based on the size of the drainage area (2.4 acres), the bioretention area is not large enough to provide full water quality treatment. With ponding of 6 inches, the basin treats approximately 80% of the WQ volume. Additional water quality storage should be designed into the dry basin, with micropools, wetlands, and other features. A weir wall outlet structure could be added to maintain the water level and provide additional quality and quantity control within the dry basin.

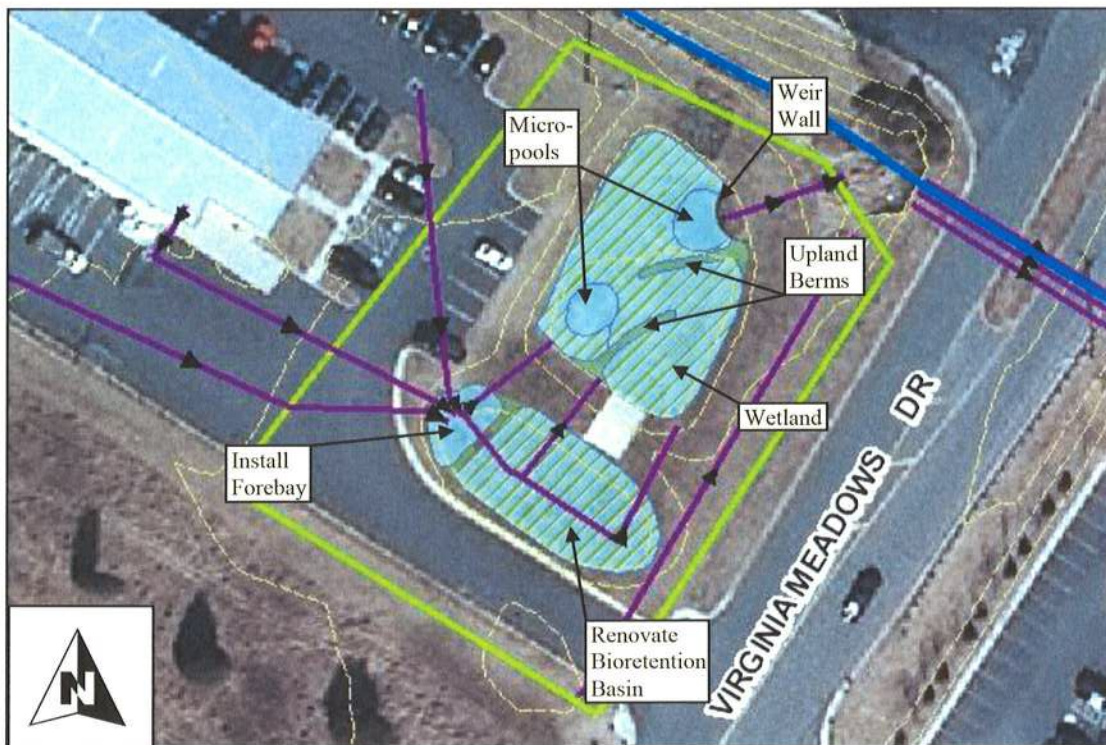
Conceptual Plan: Renovate bioretention basin and install forebay to capture sediment. Improvements to dry basin including micro-pools, wetlands, berms and weir wall outlet structure

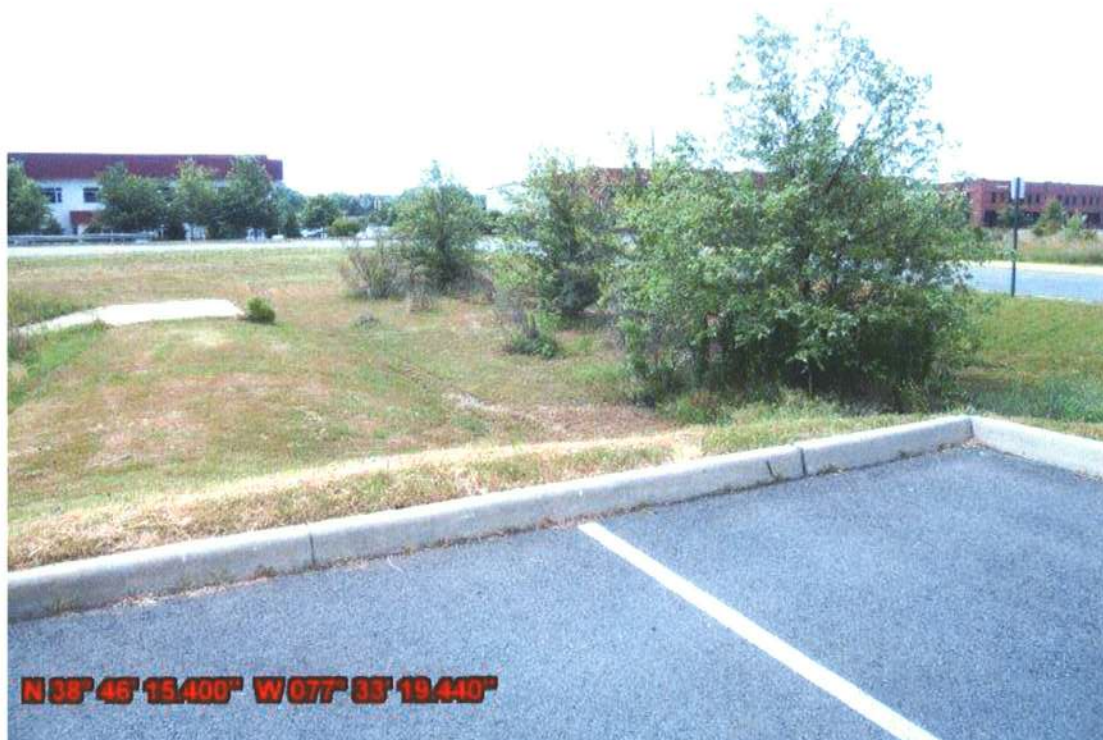
Photo 1: Bioretention forebay with under drains which discharge to dry basin

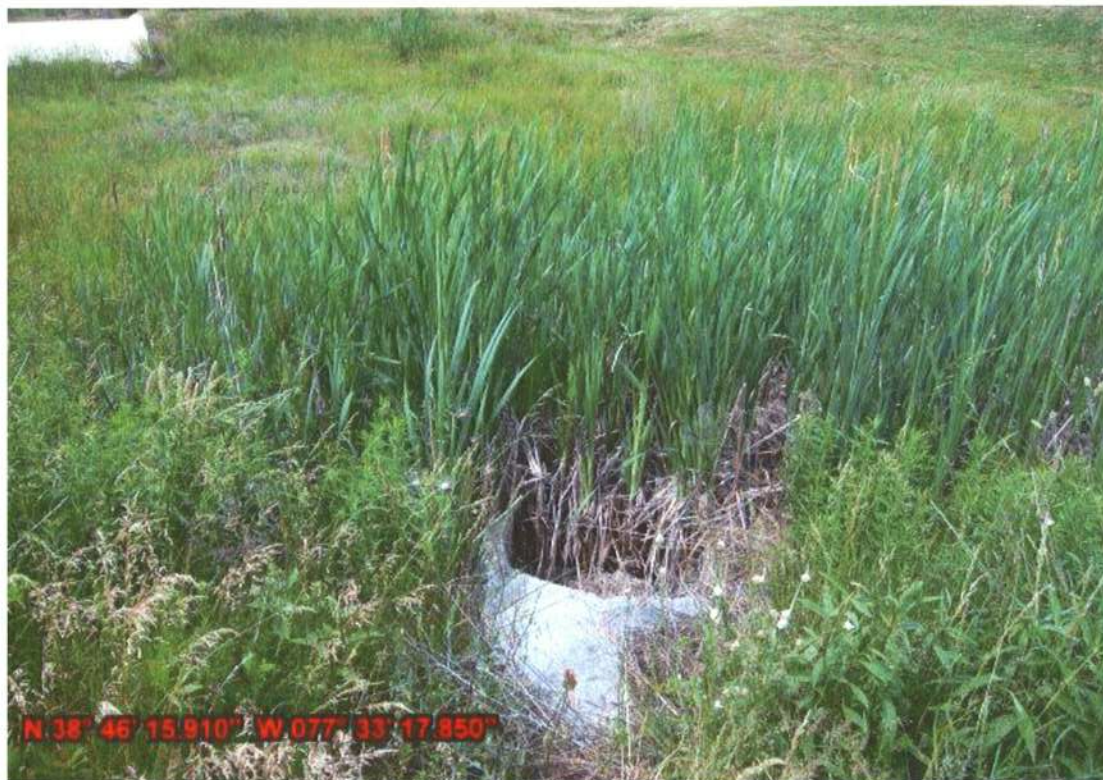
Photo 2: Dry basin outlet pipe without riser, basin supports large wetland

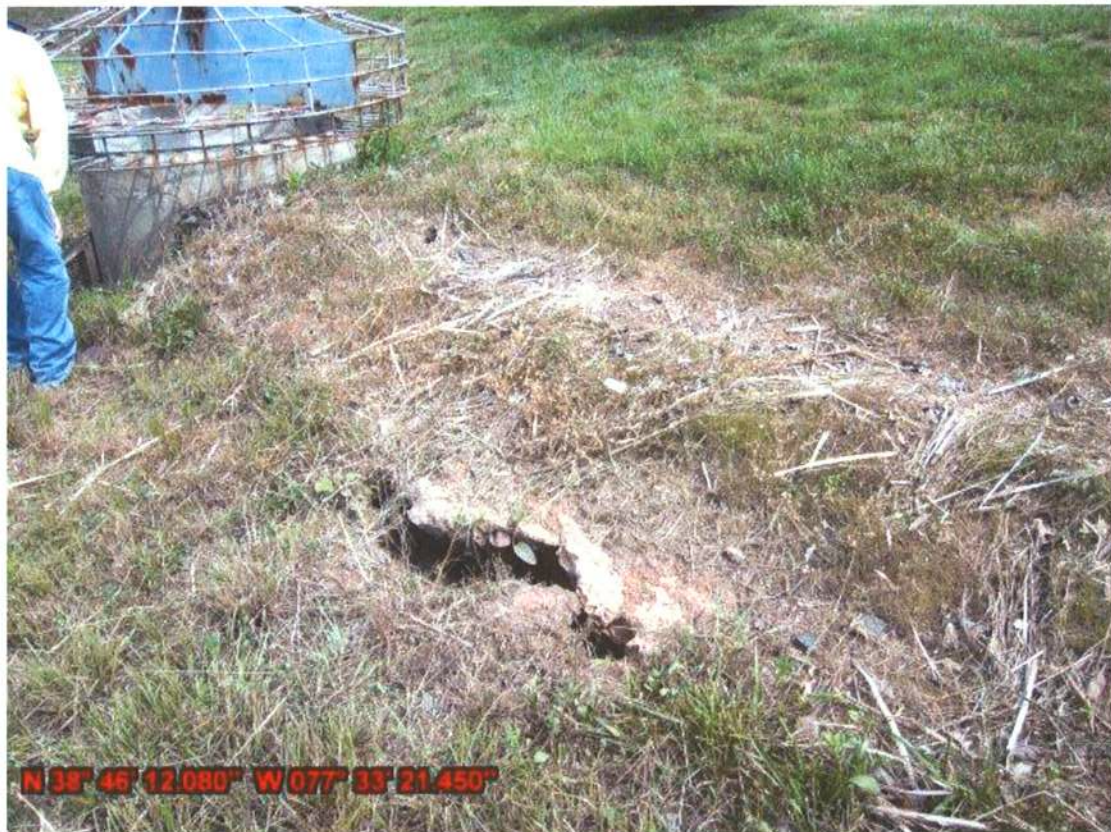
Problem Description: This dry basin is located in commercial property and is maintained by the County. It was built prior to 2003 and has a 48 riser with a RCP outlet pipe, and no spillway. Initially the CSWMP/BMP appears well maintained, but closer inspection indicates that soil is piping through the embankment and into the outlet pipe (see photo). There is grout around the soil piping hole from past repair attempts. This type of piping would require significant head pressure. A more detailed inspection of the riser indicated that the constrictor plate installed in the low flow orifice is solid – it lacks a low flow orifice. This pond appears to pond deeply between storms, and the primary outlet for the ponded water is through the outlet pipe instead of the riser. Significant rust on the trash rack also supports the possibility of long ponding durations. One small PVC pipe discharges to the BMP which may not be stormwater. The BMP does not have a forebay and there is minor sediment accumulation at one end of the facility.

Photo 1: Soil piping into outlet pipe and rust on riser may indicate prolonged ponding

Project Description: A detailed inspection of the riser and outlet pipe should be conducted, and repairs completed to eliminate the causes for the soil piping into the outlet pipe. Due to the angle of the outlet pipe through the embankment, there is very shallow fill over the pipe, which should be addressed in any repairs.

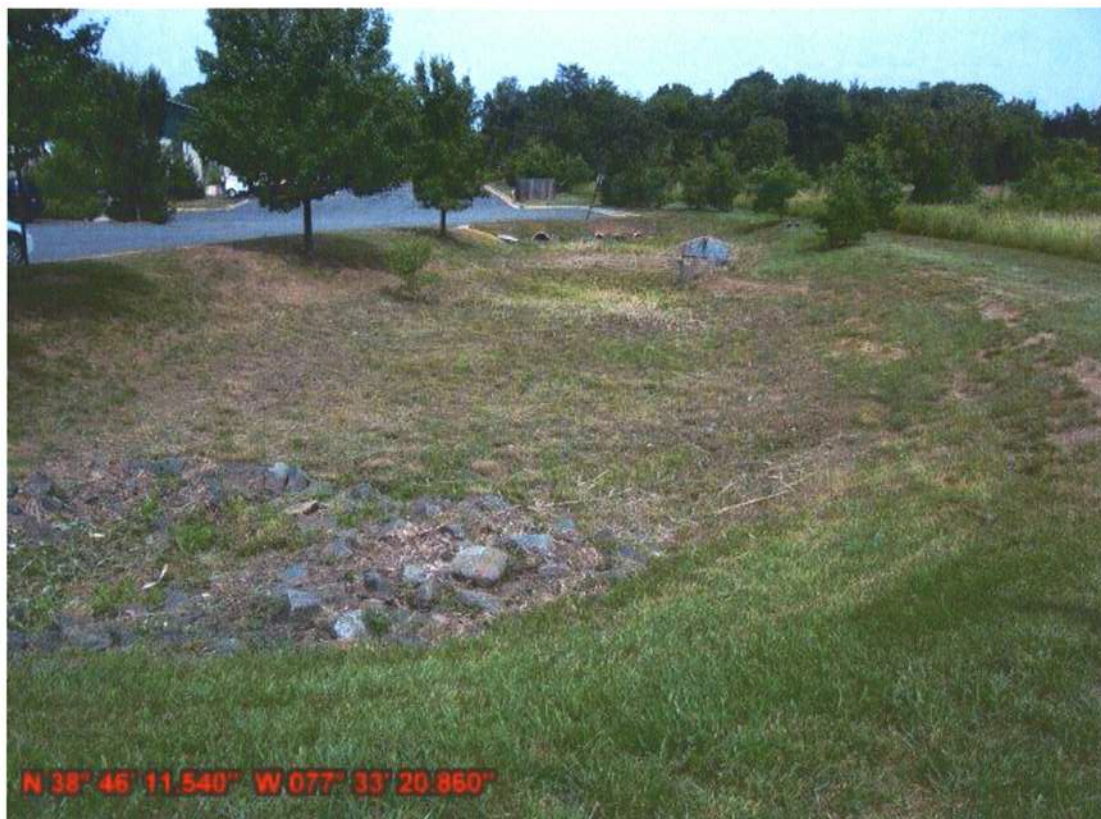
Photo 2: Basin is well maintained, but sediment is accumulating at far end.
