Appendix D Index

SWM/BMP Facility Site Photographs

Appendix D
SWM/BMP Facility Site Photographs
Occoquan Watershed – Study of Four Subsheds
WSSI #25156.01

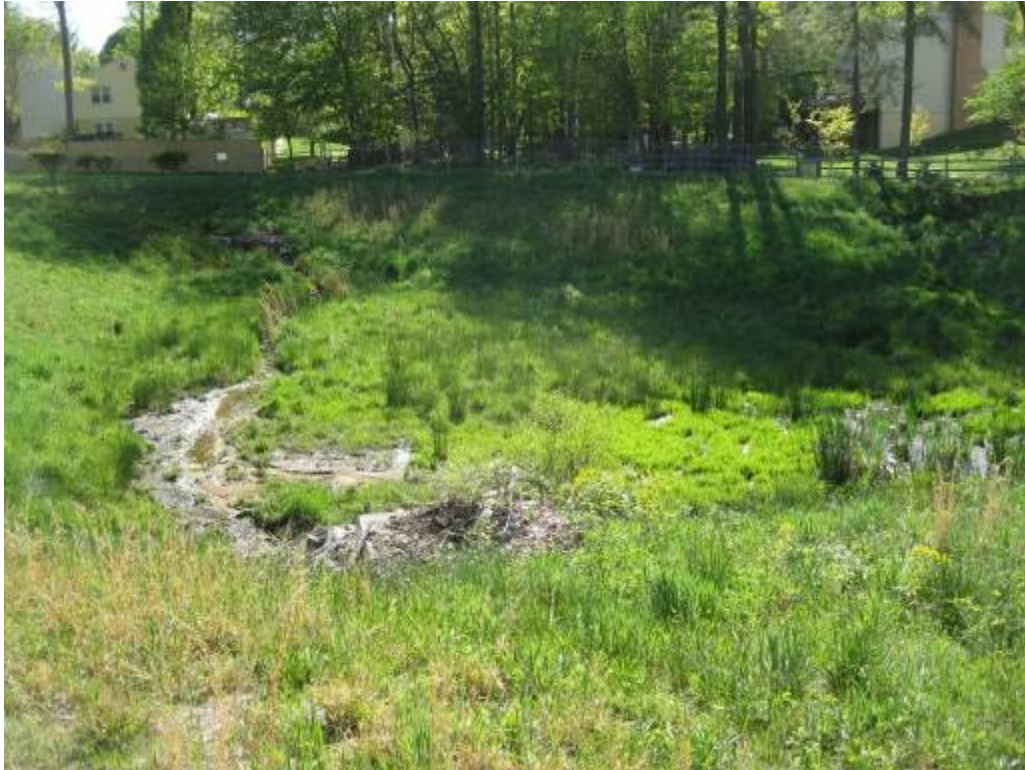
1. Facility 19. Looking upstream at stream and ponding area in facility.

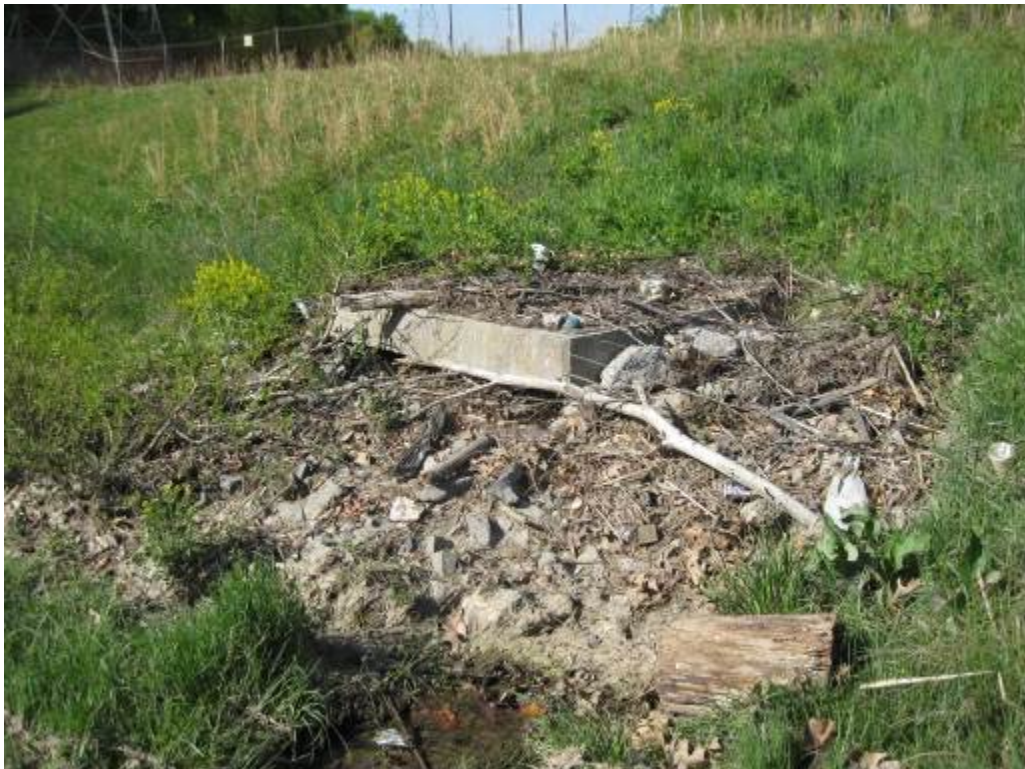
2. Facility 19. Existing riser is clogged with sediment and debris.

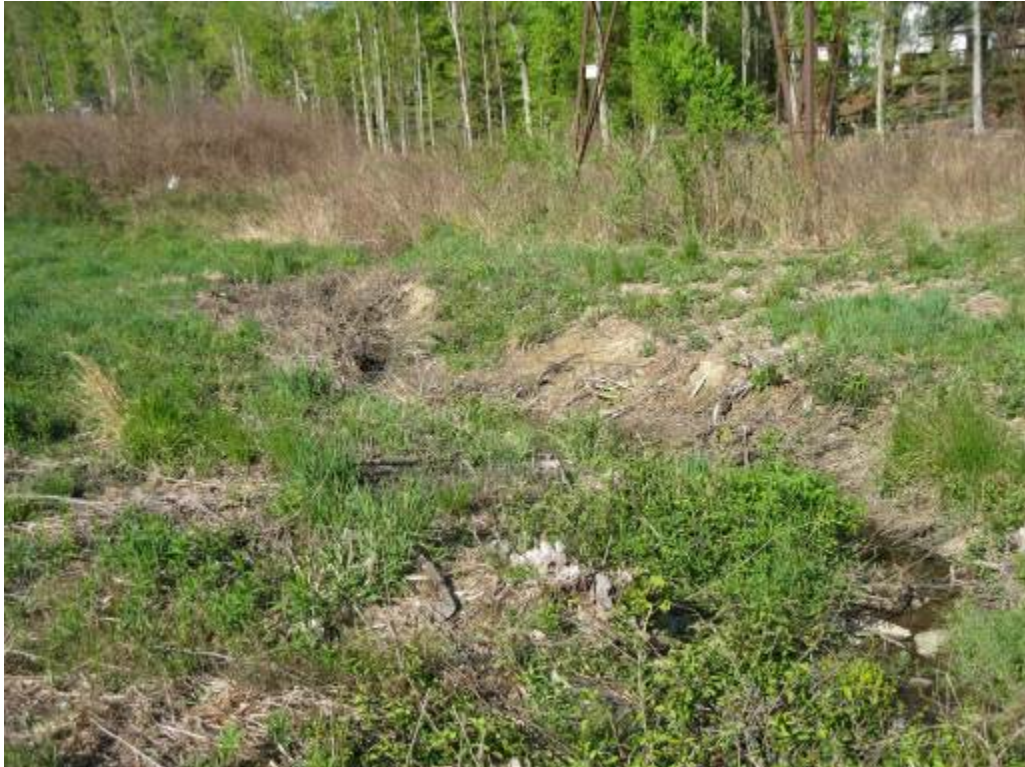
3. **Facility 19. Looking downstream of facility at the receiving channel that runs through the existing utility easement. Spot erosion is evident, but overall the channel is stable.**

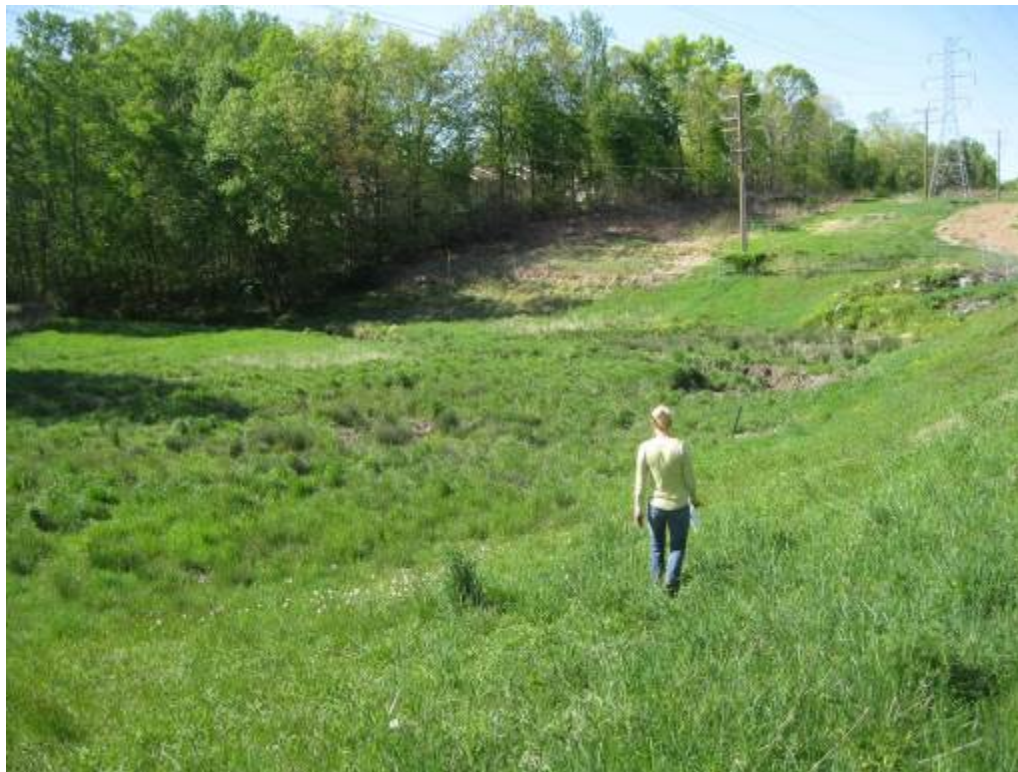
4. **Facility 489. Looking north at the facility located within in the existing utility easement.**

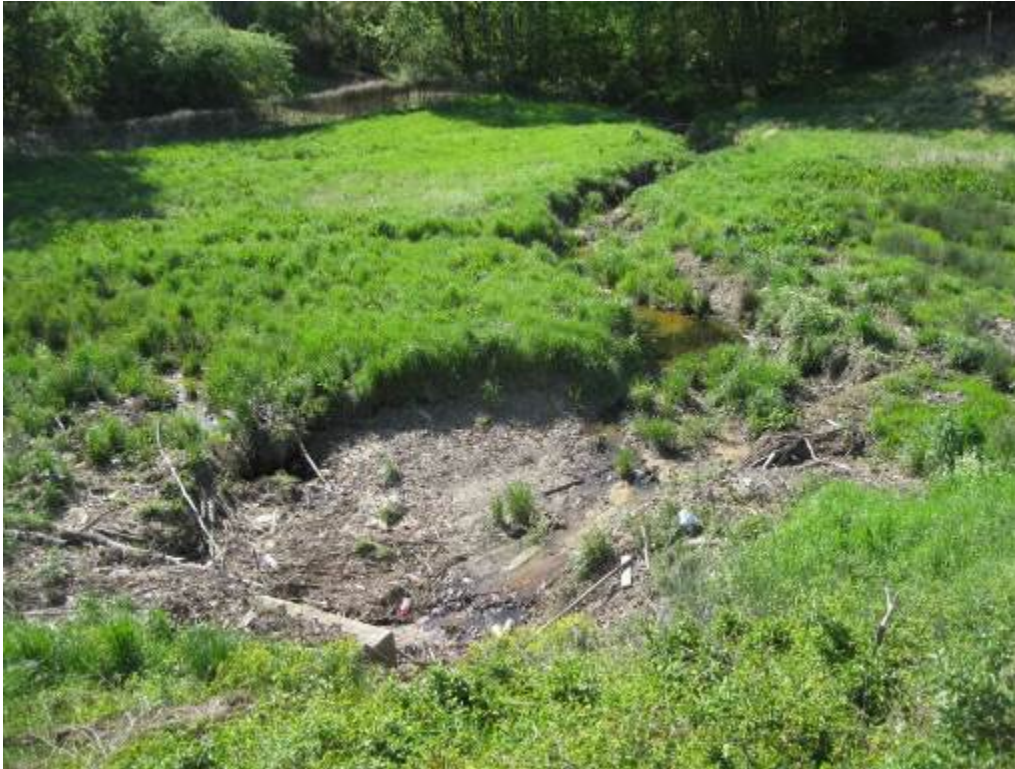
5. **Facility 489. Looking upstream at channel and backwater area within facility (headwall for culvert in foreground). Some indications of ponding in overbank area, but entire facility is not being utilized.**

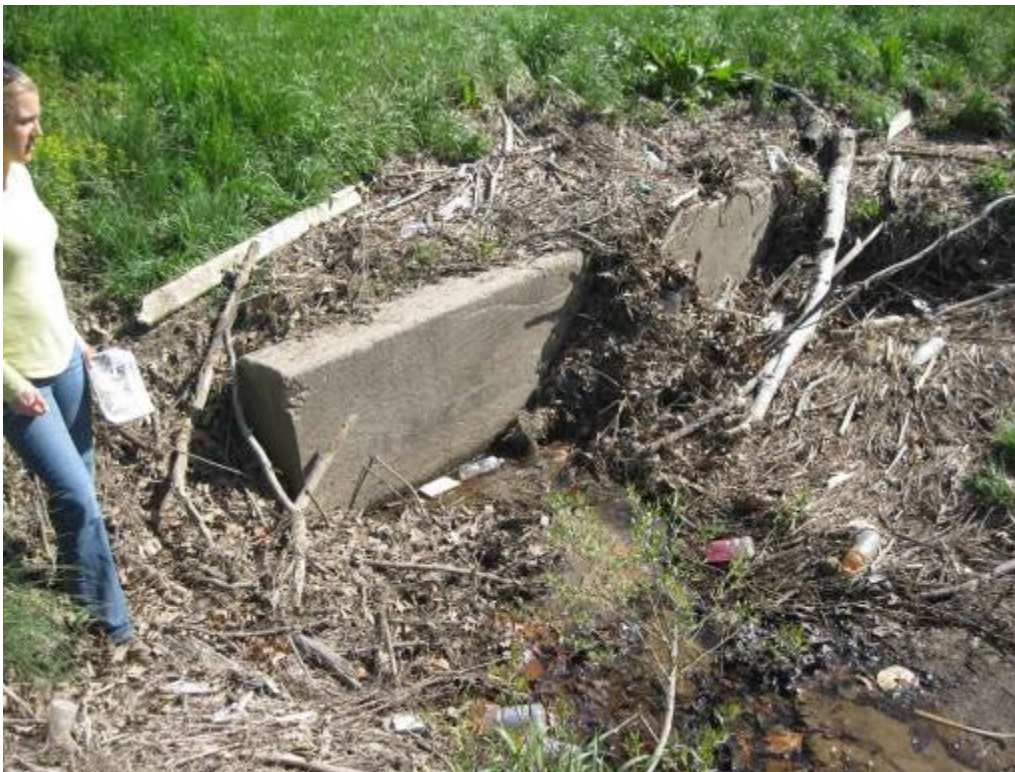
6. **Facility 489. Facility outlet is a culvert with headwall. The culvert is clogged with sediment and debris.**

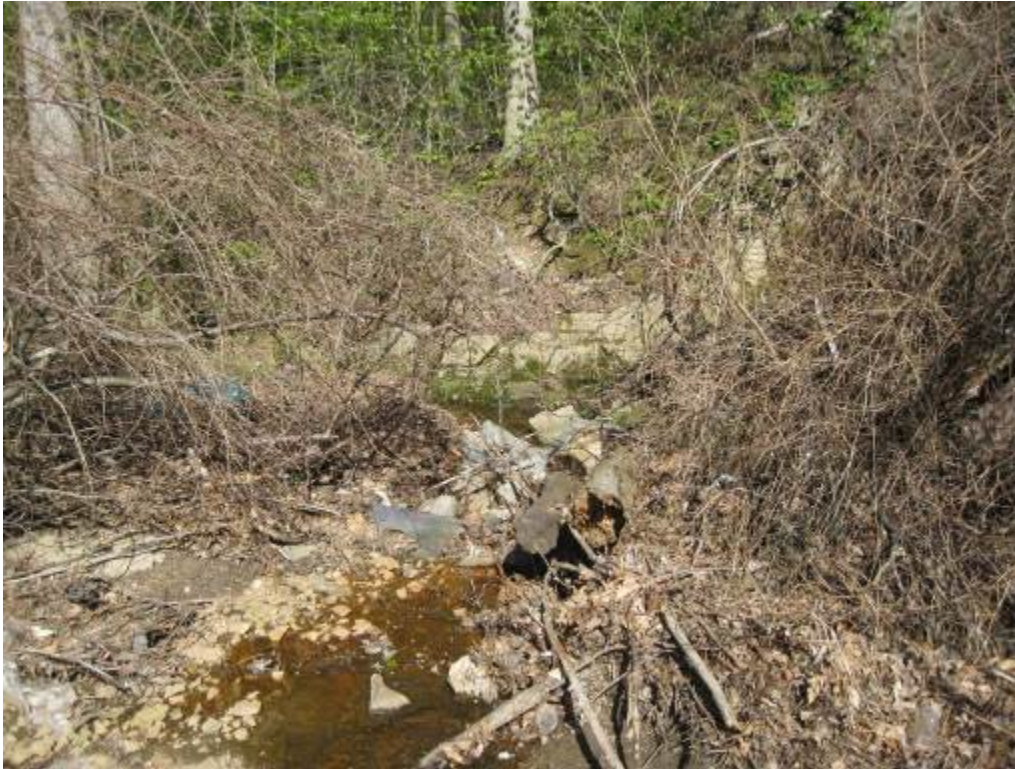
7. **Facility 489. Looking immediately downstream of facility at receiving channel which is stable, but full of debris and litter.**

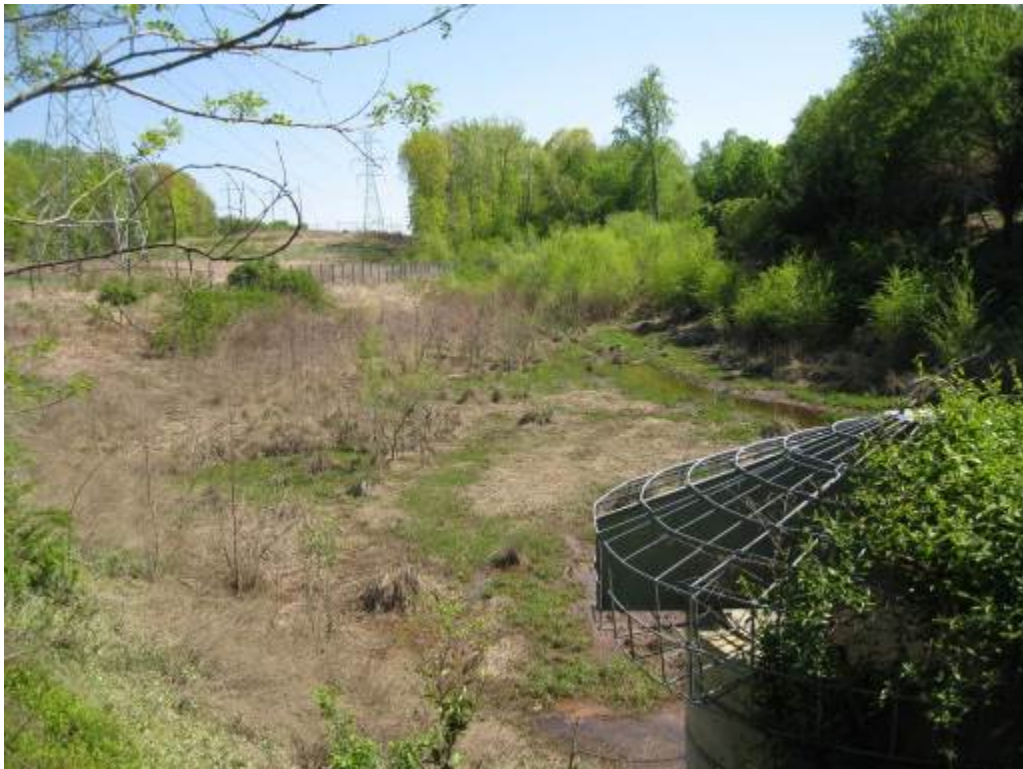
8. **Facility 63. Looking upstream from riser with anti-vortex plate at channel and ponding area within existing power utility easement. Ponding area was wet with signs of recent inundation.**

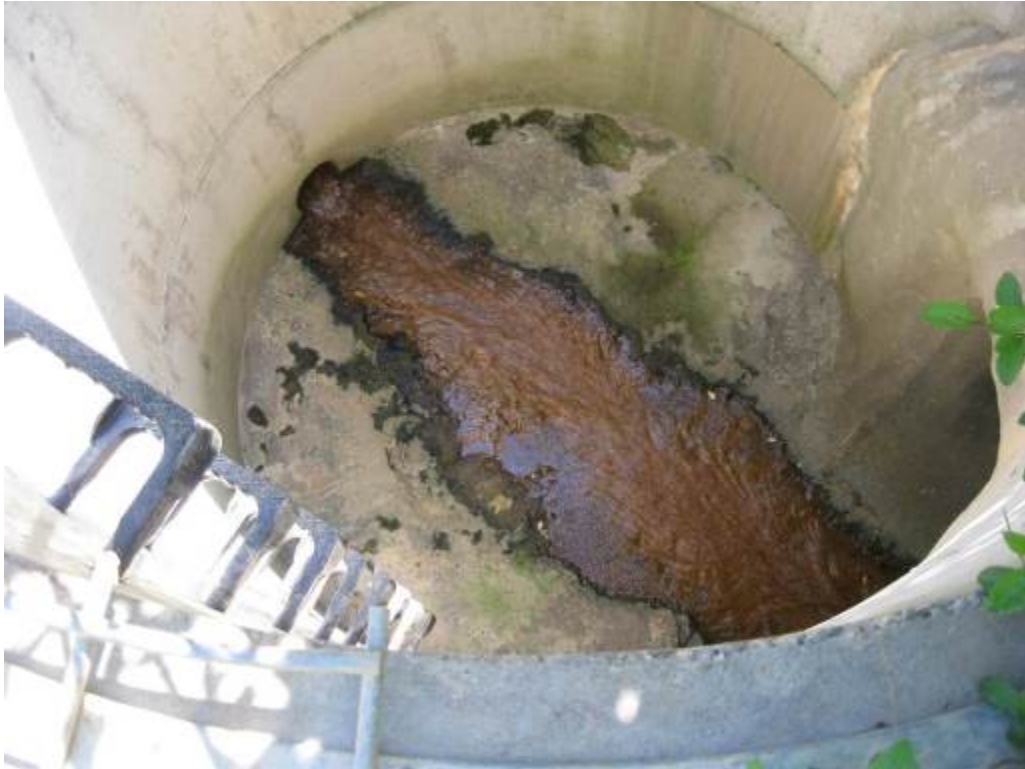
9. Facility 63. Trash rack covering low flow orifice at base of riser was covered with sediment and debris, but orifice was still draining as shown.

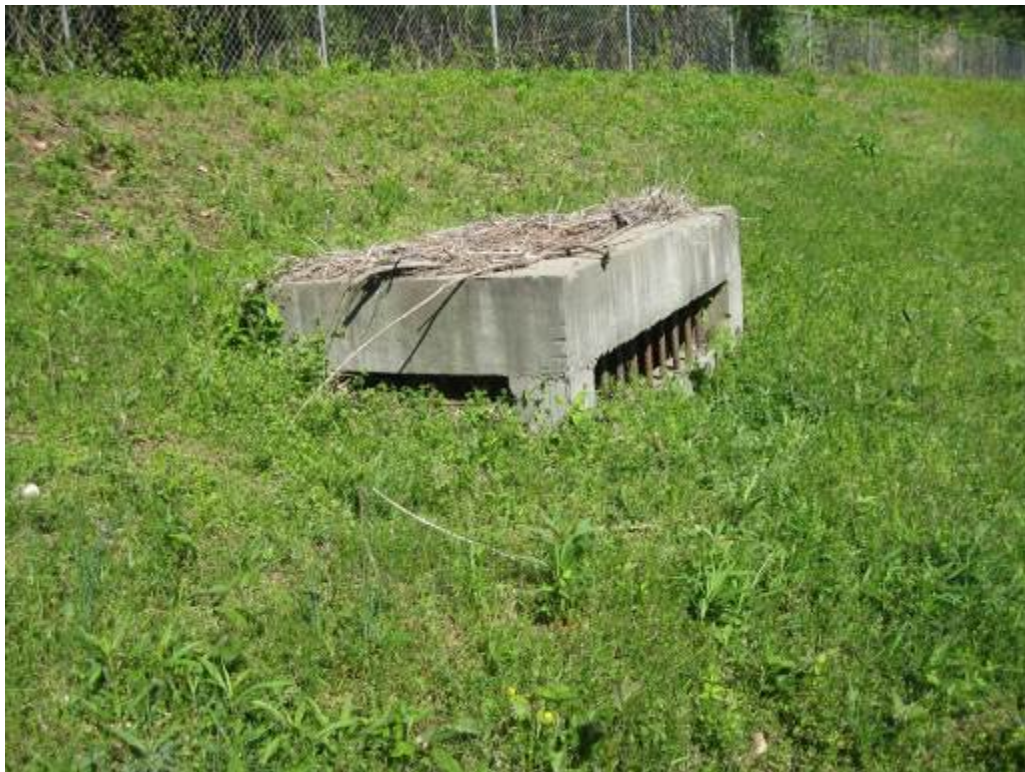
10. Facility 632. Looking at riser with debris on top of flat grated trash rack.

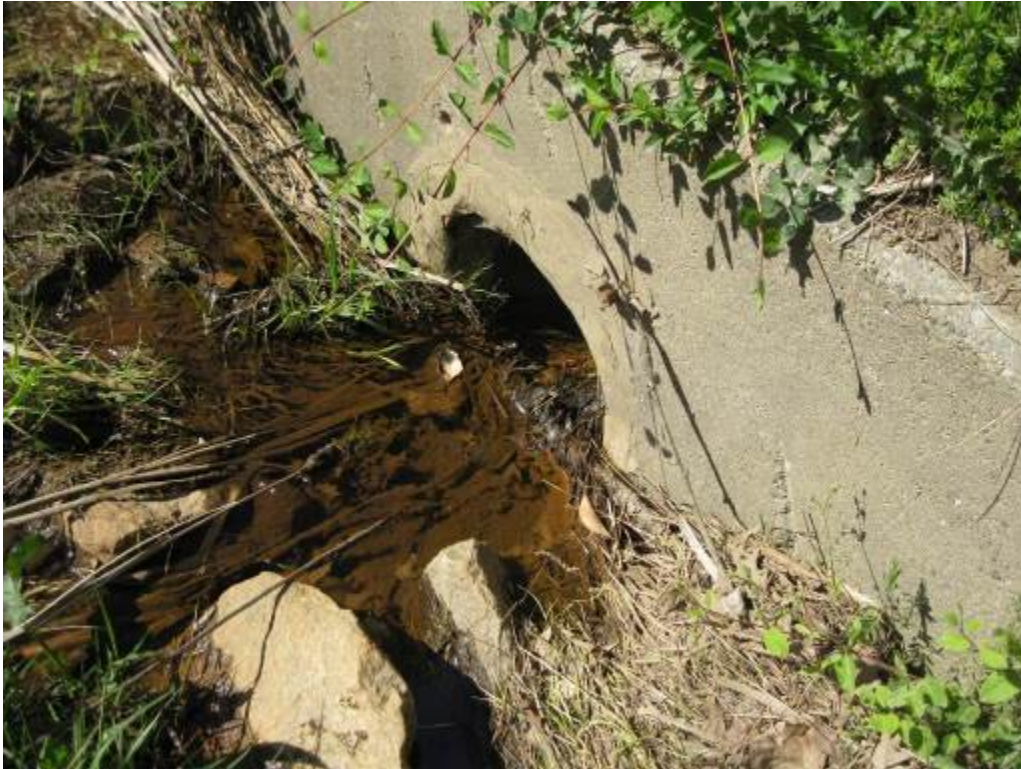
11. Facility 632. Looking at low flow orifice. Holes in headwall indicate a BMP plate or other protective plate was likely removed.

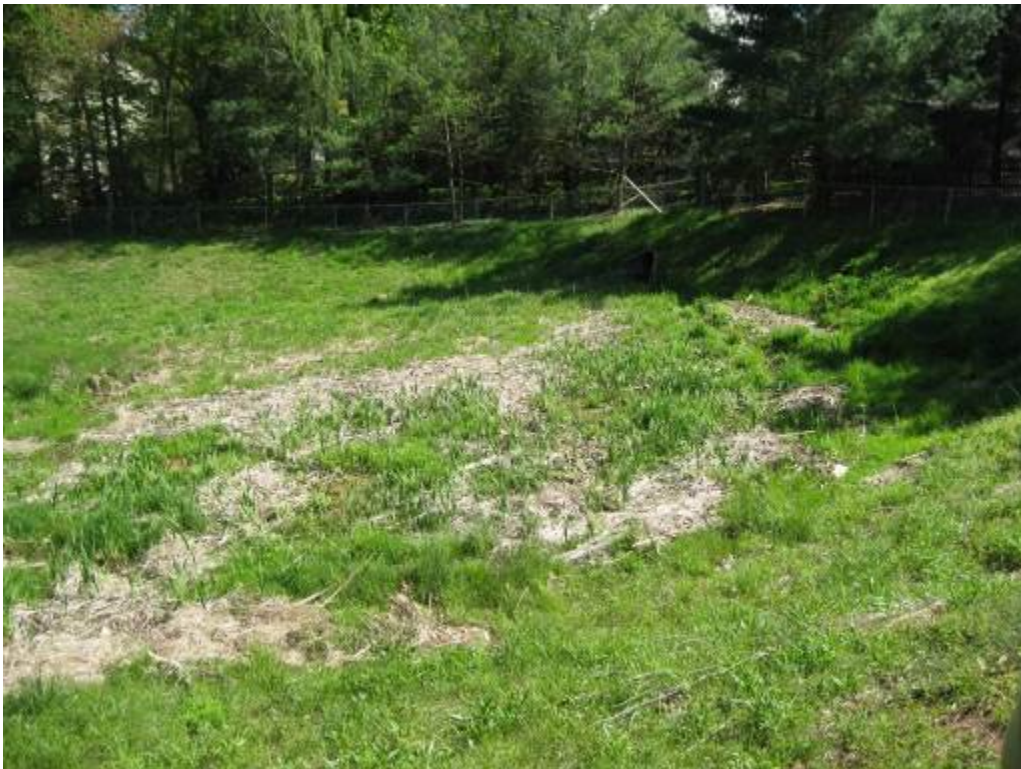
12. Facility. 632. The ponding area was wet.

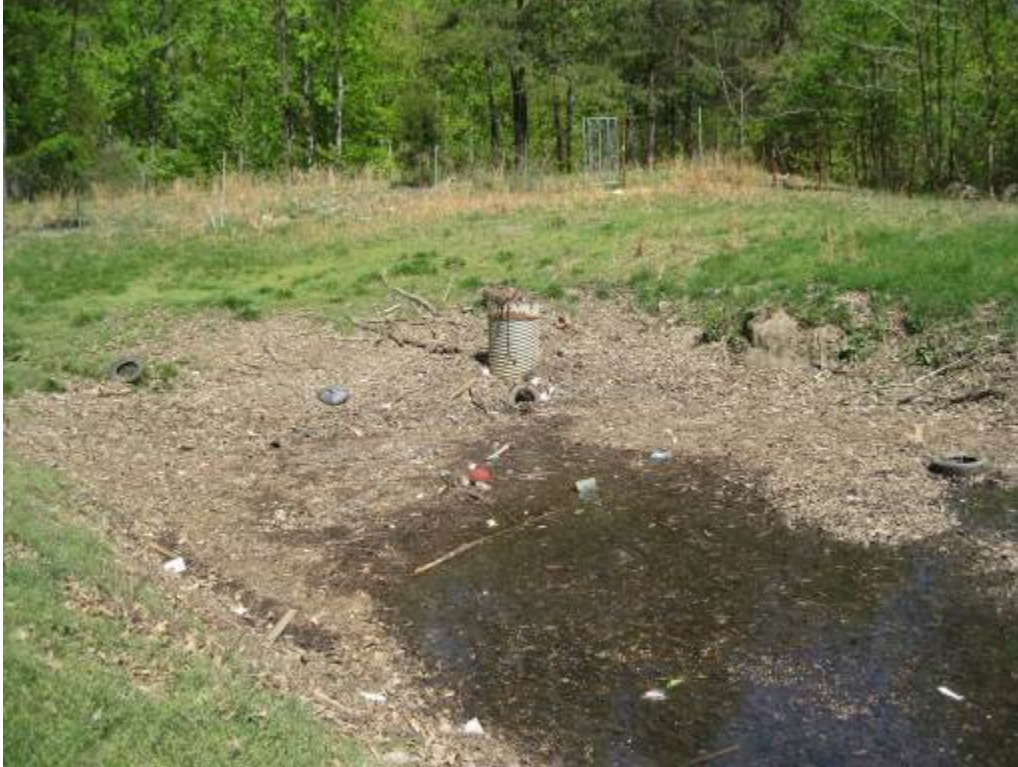
13. Facility 28. Perforated corrugated metal riser was clogged with trash, leaf litter, and other organic material. A foul odor was coming from the riser structure. The emergency spillway and dam are shown in the background.

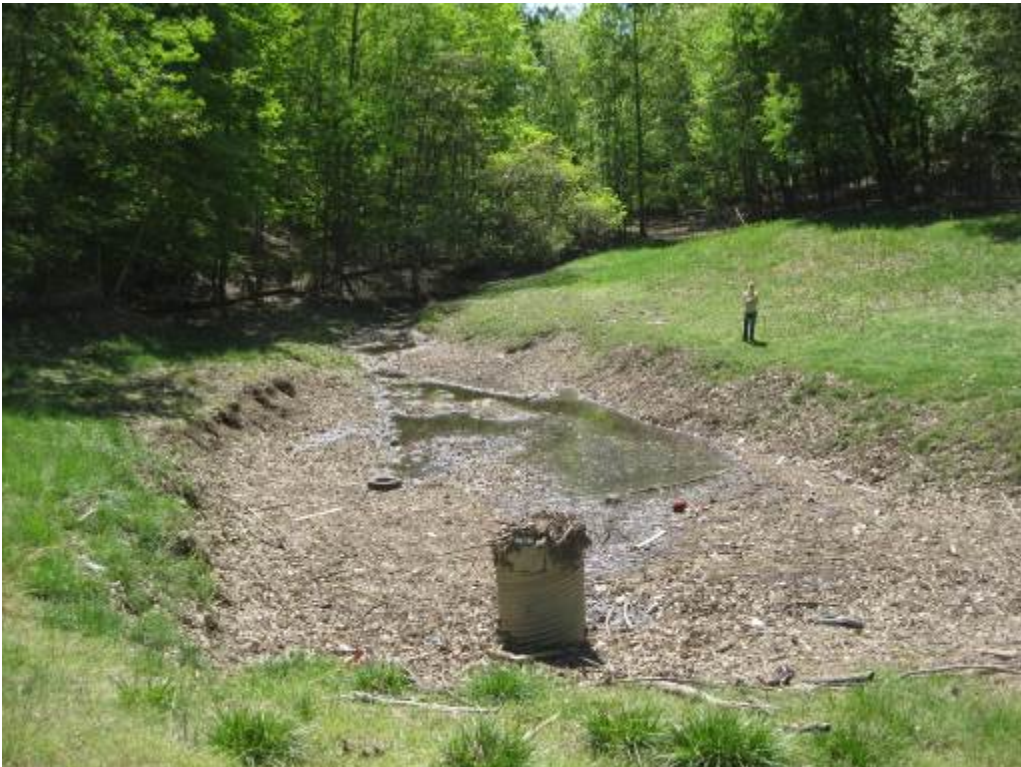
14. Facility 28. Looking at channel and limited ponding area within facility. Bedrock was evident through the facility. There is room for a sediment forebay, but bedrock may restrict excavation.

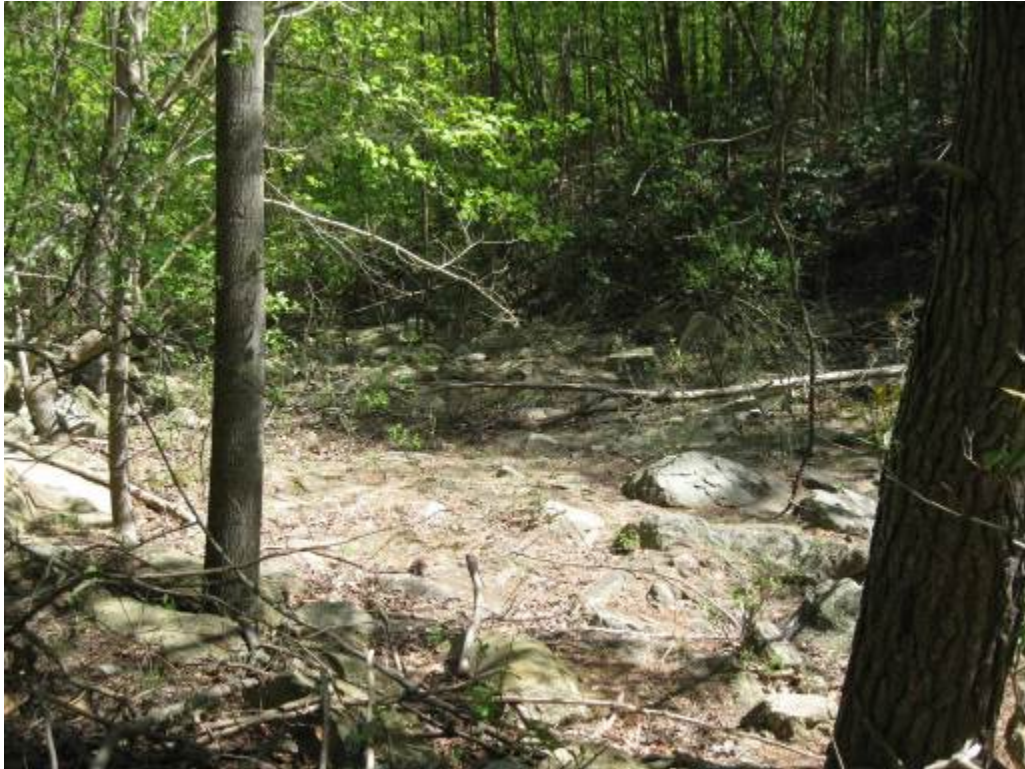
15. Facility 28. Looking at grouted natural boulder in emergency spillway.

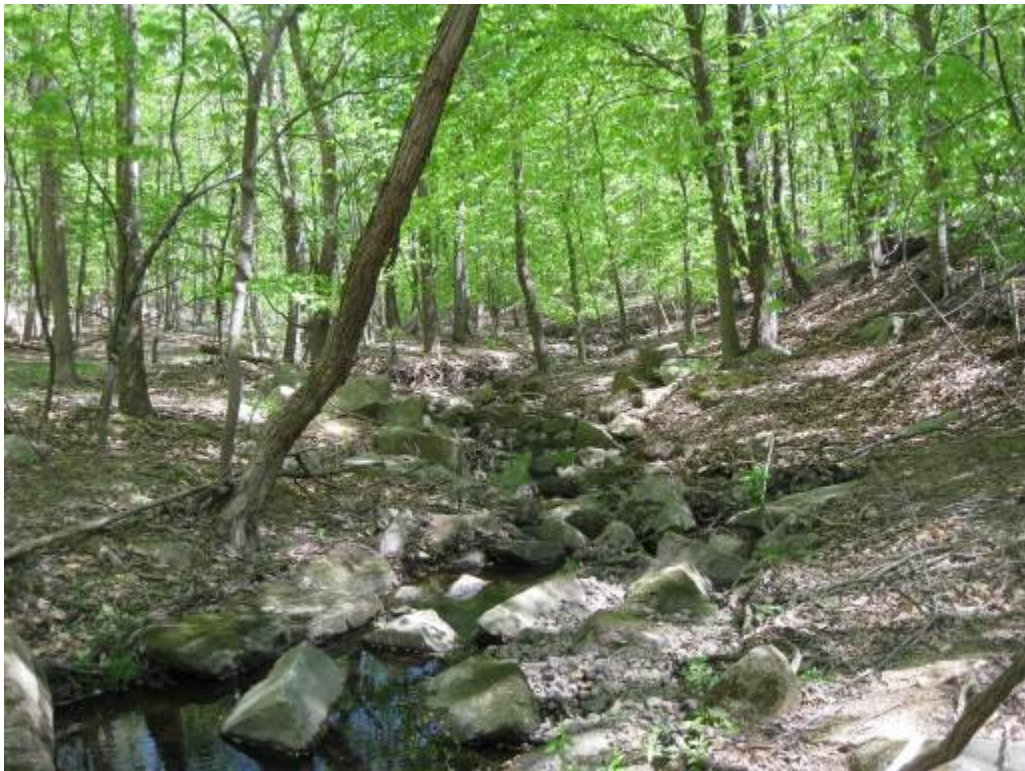
16. Facility 28. Looking at stable receiving channel where facility and emergency spillway drain.

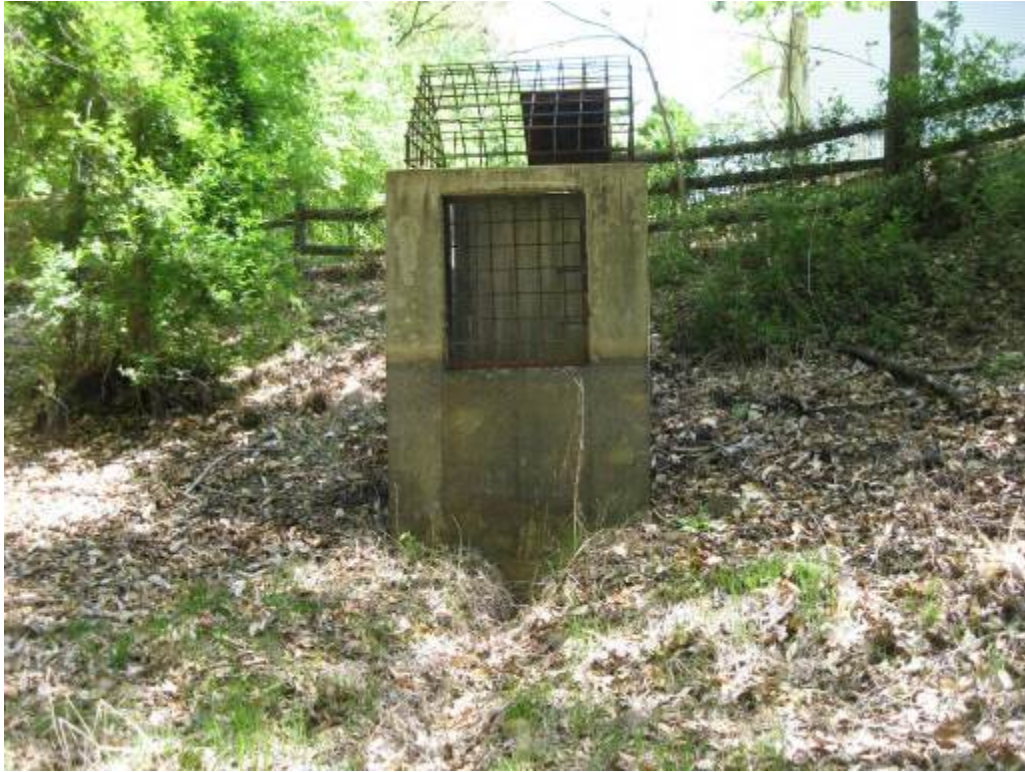
17. Facility 481. Looking at square concrete riser with angled trash rack. Wood perimeter fence is shown background.

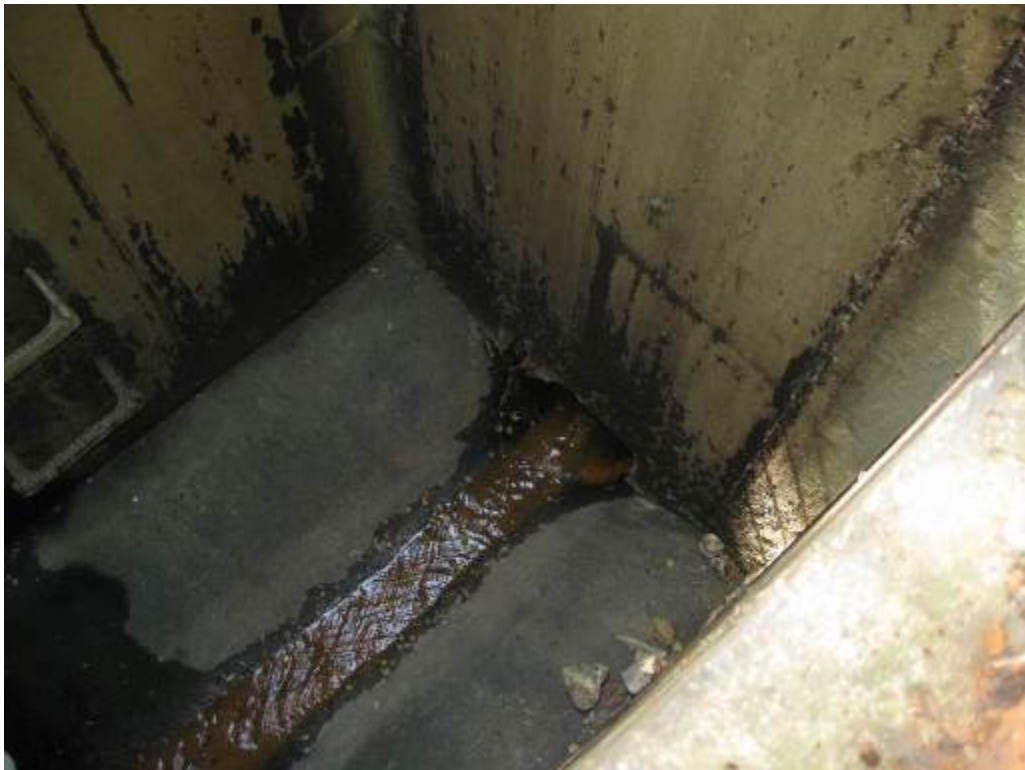
18. Facility 481. Looking in riser at low flow orifice.

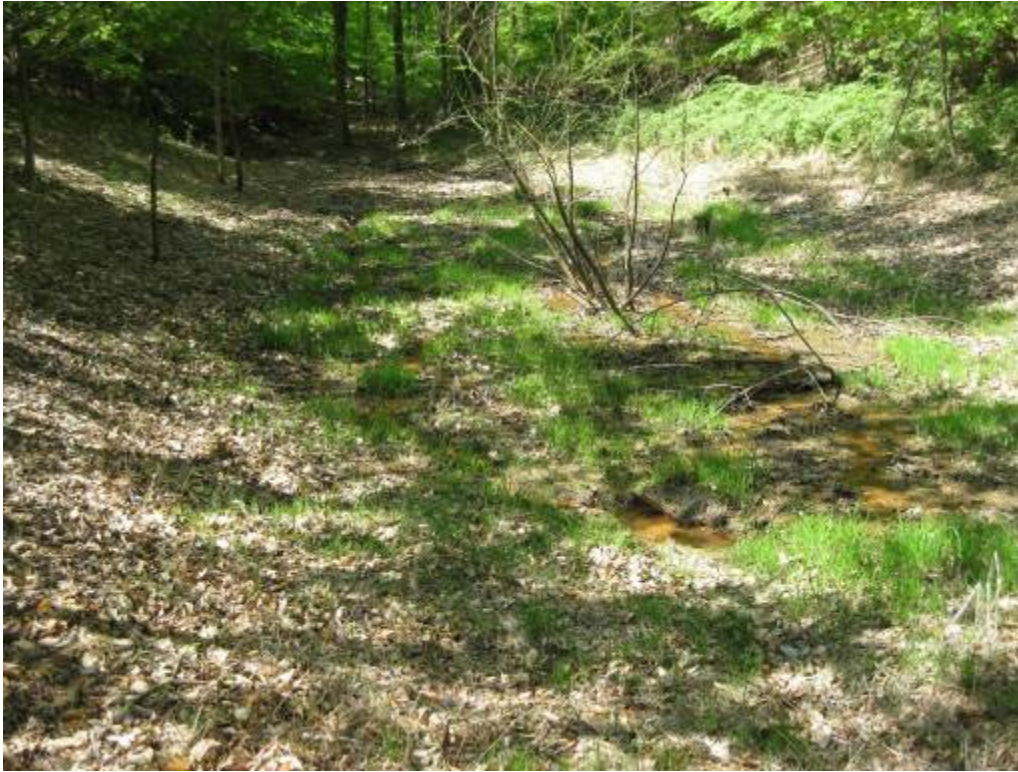
19. **Facility 481. Looking upstream at channel flowing through ponding area. Drain tile flush with ground is in foreground (See next photo)**

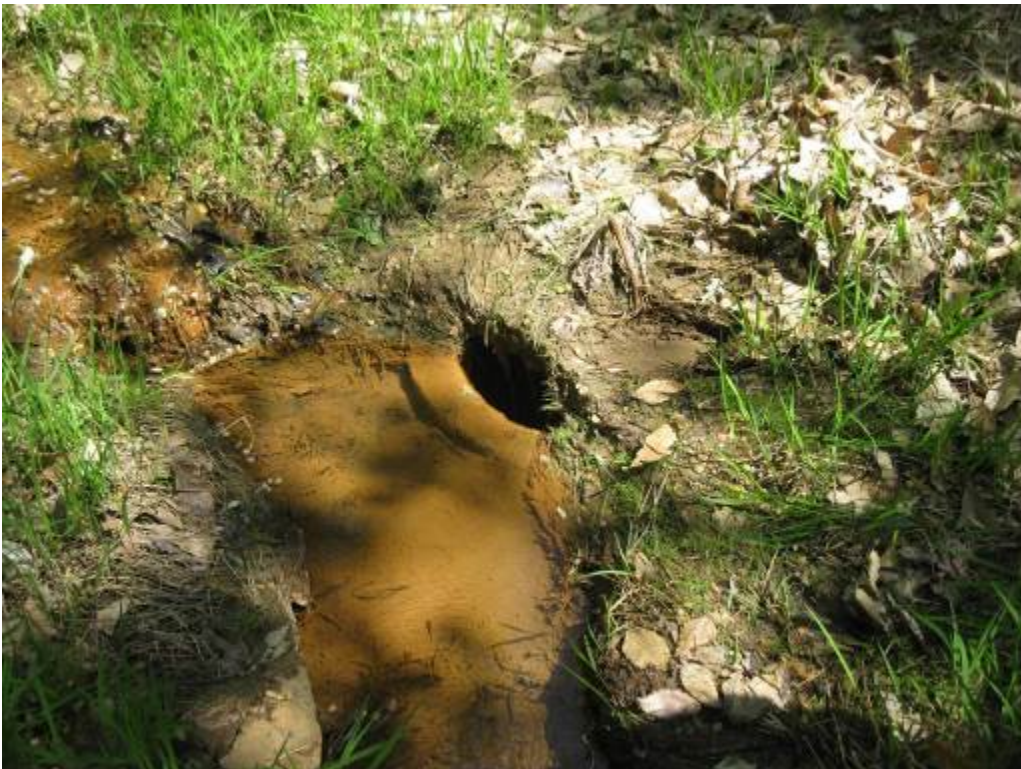
20. **Facility 481. Looking at drain tile, which is partially blocked with sediment and debris.**

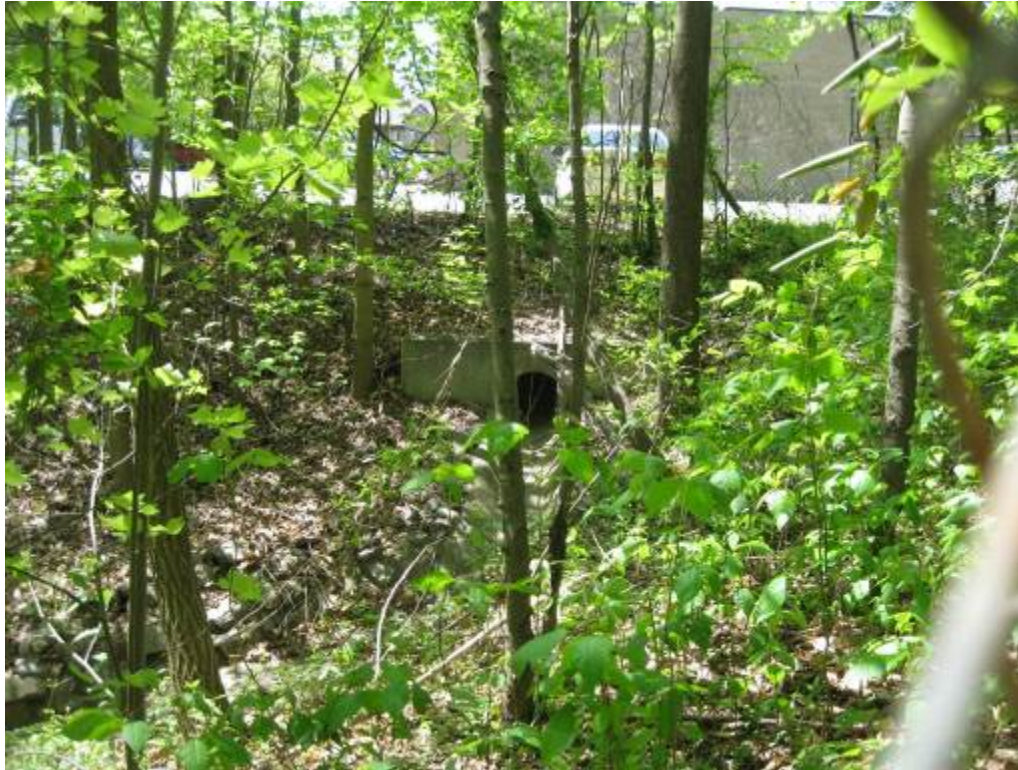
21. Facility 5147. Looking at pipe that drains parking lot runoff into facility.

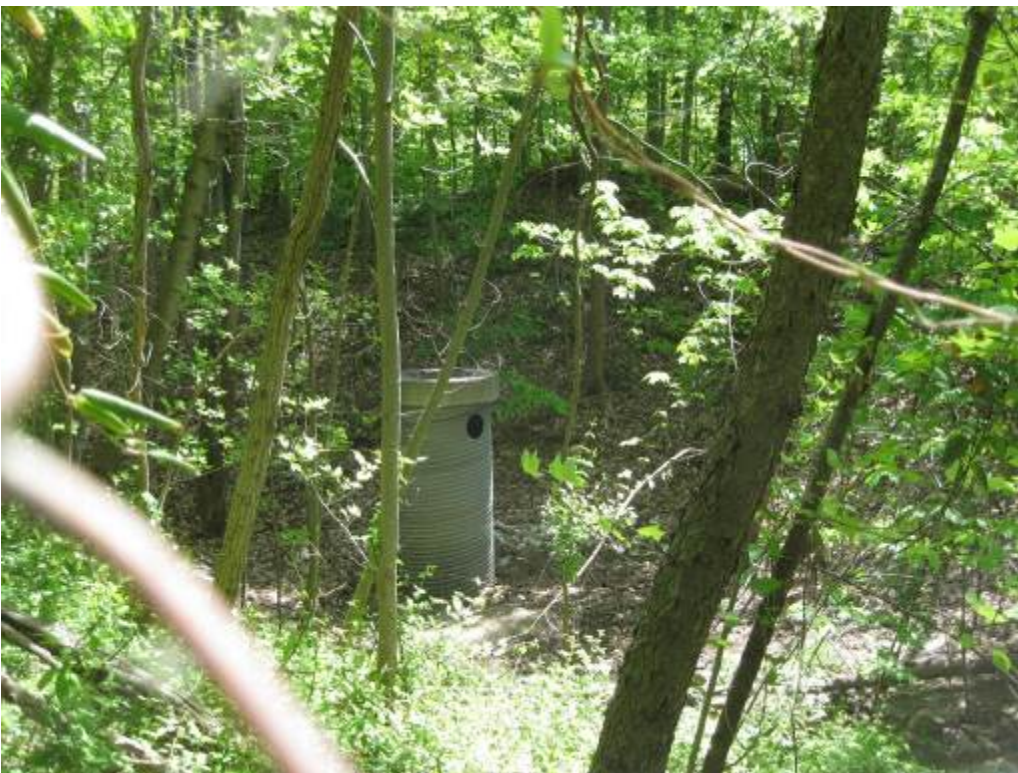
22. Facility 5147. Looking at perforated corrugated metal pipe with flat grate trash rack on top. Concrete trickle ditch runs through bottom of facility and drains into yard inlet at base of riser.

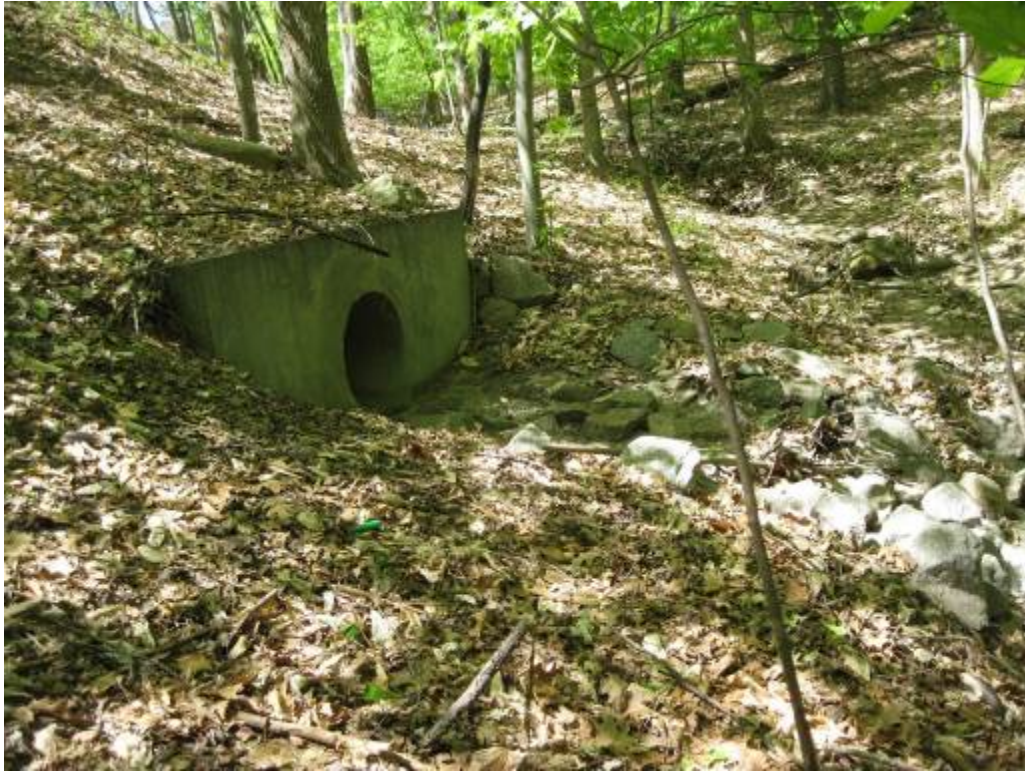
23. Facility 5147. Looking immediately downstream of facility outlet as it drains into receiving channel which is stable.

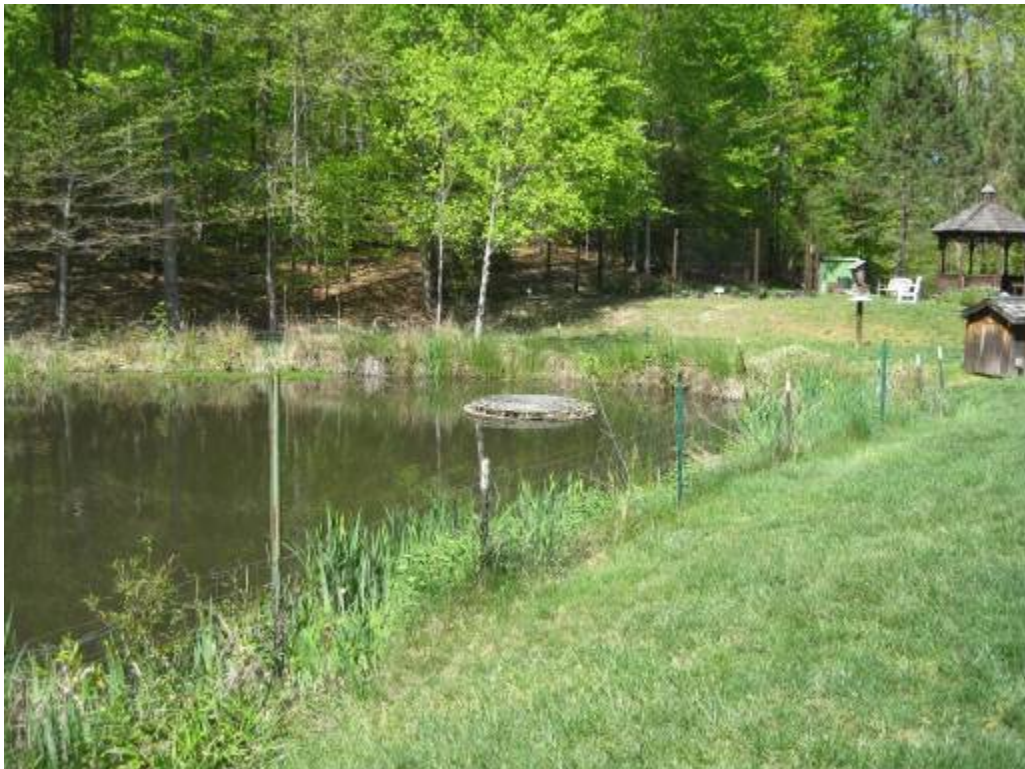
24. Facility 5255. Looking at riser and perimeter fence.

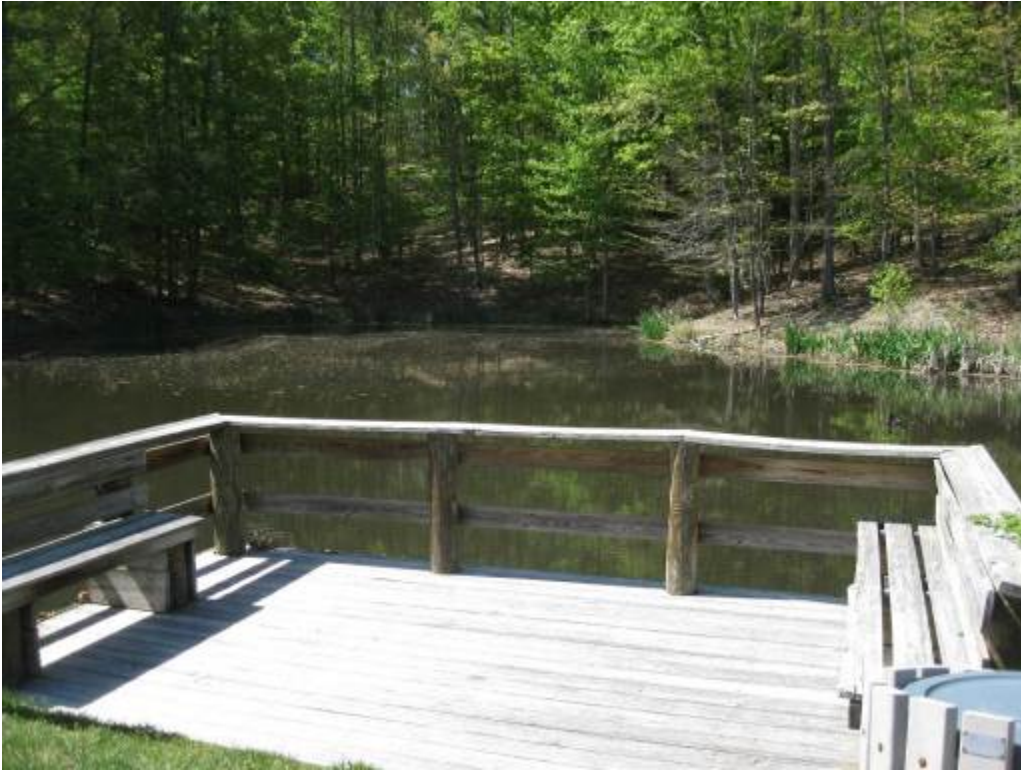
25. Facility 5255. Looking at naturalized ponding area.

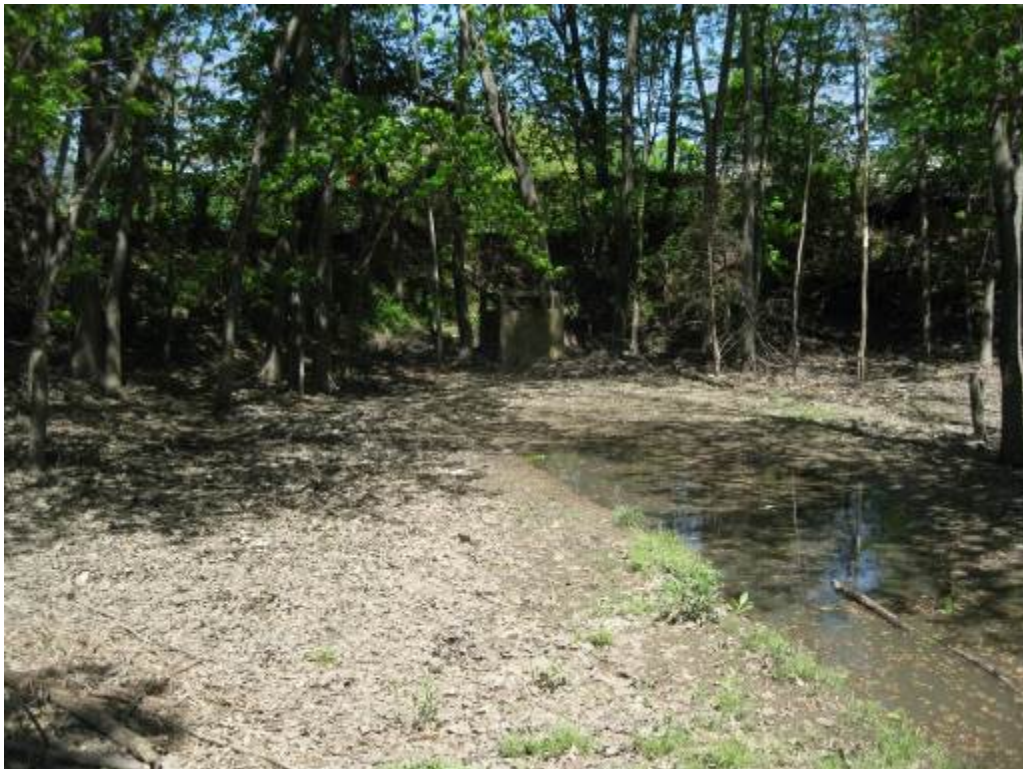
26. Facility 9026. Looking at riser in background with stagnant water in upstream channel and ponding area.

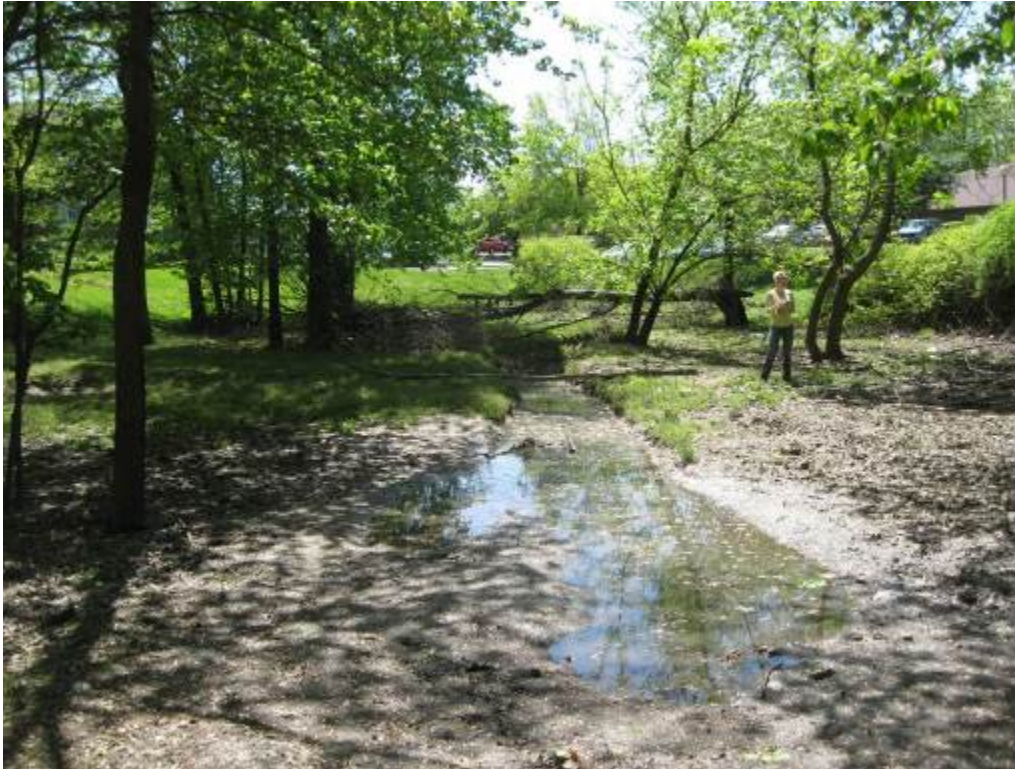
27. Facility 9026. Looking upstream from riser. Water in channel is stagnant with signs of recent inundation in overbank areas. There is no perimeter fence, and there are large trees within the facility.

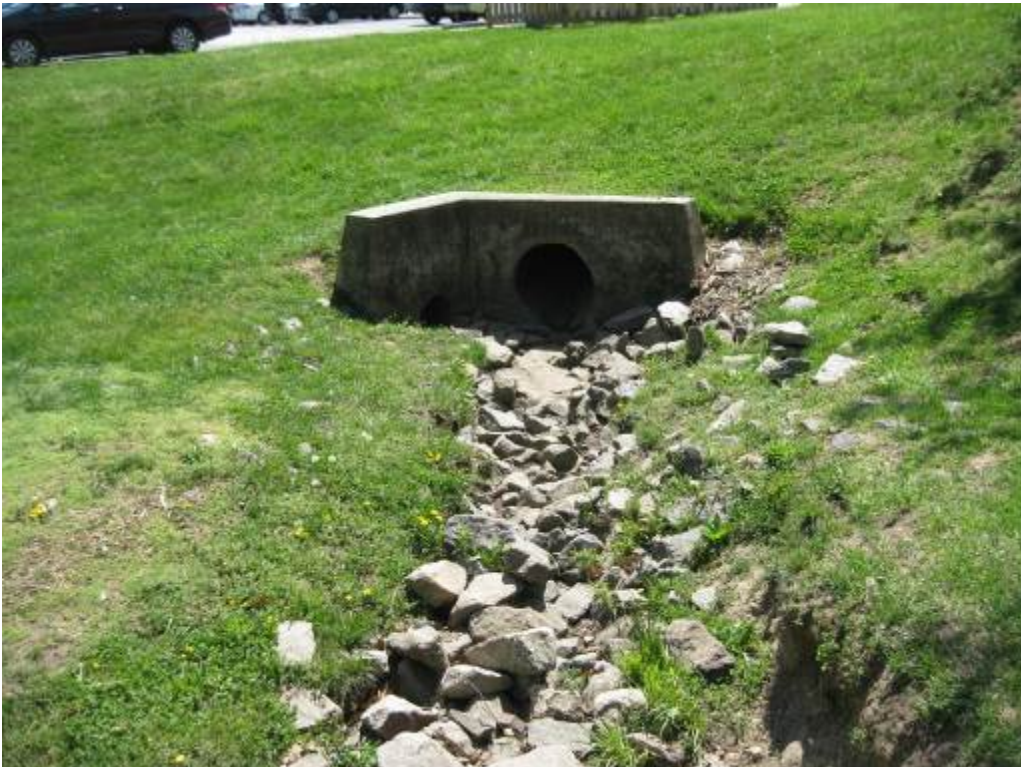
28. Facility 9026. Looking at inlet that drains parking lot runoff into facility.
