Appendix D Index

SWM/BMP Facility Site Photographs

Appendix D
SWM/BMP Facility Site Photographs
Occoquan Watershed – Study of Four Subsheds
WSSI #25156.01

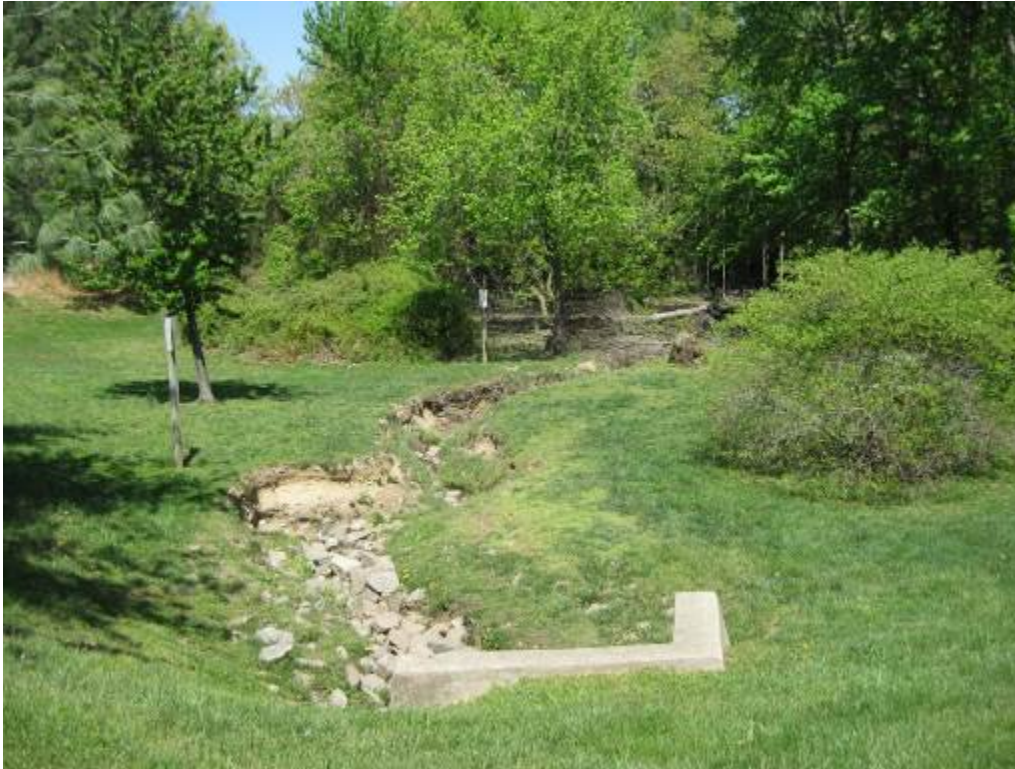
29. Facility 9026. Looking downstream at eroding channel that drains into the facility.

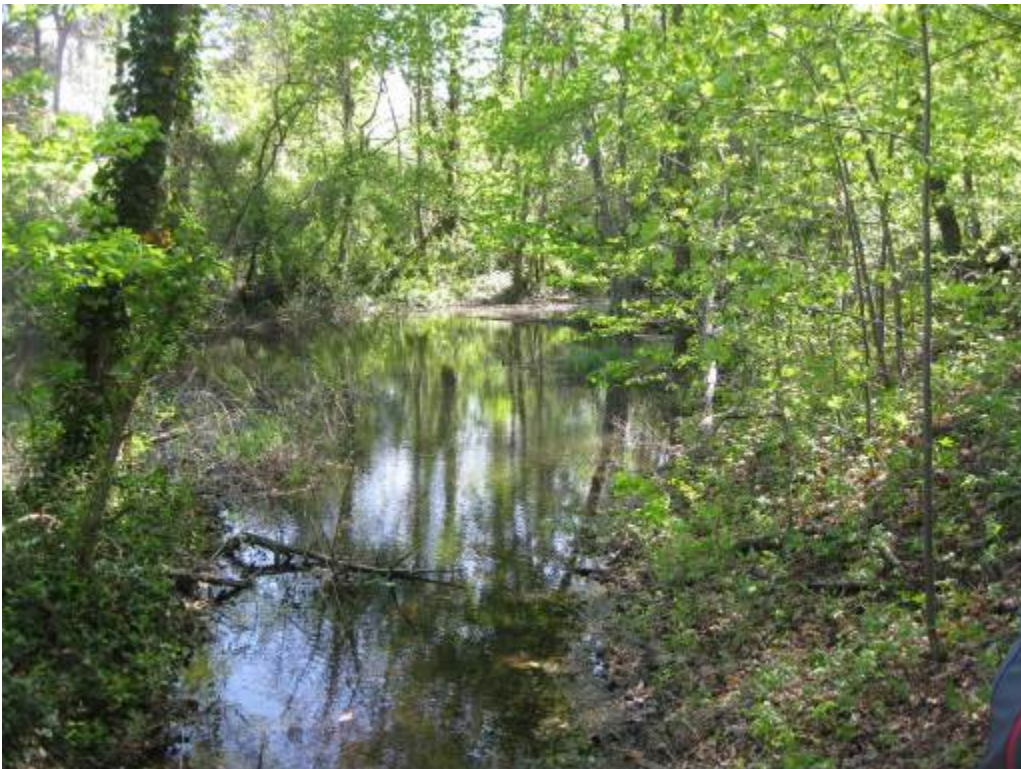
30. Facility 92. Looking at facility from channel inlet.

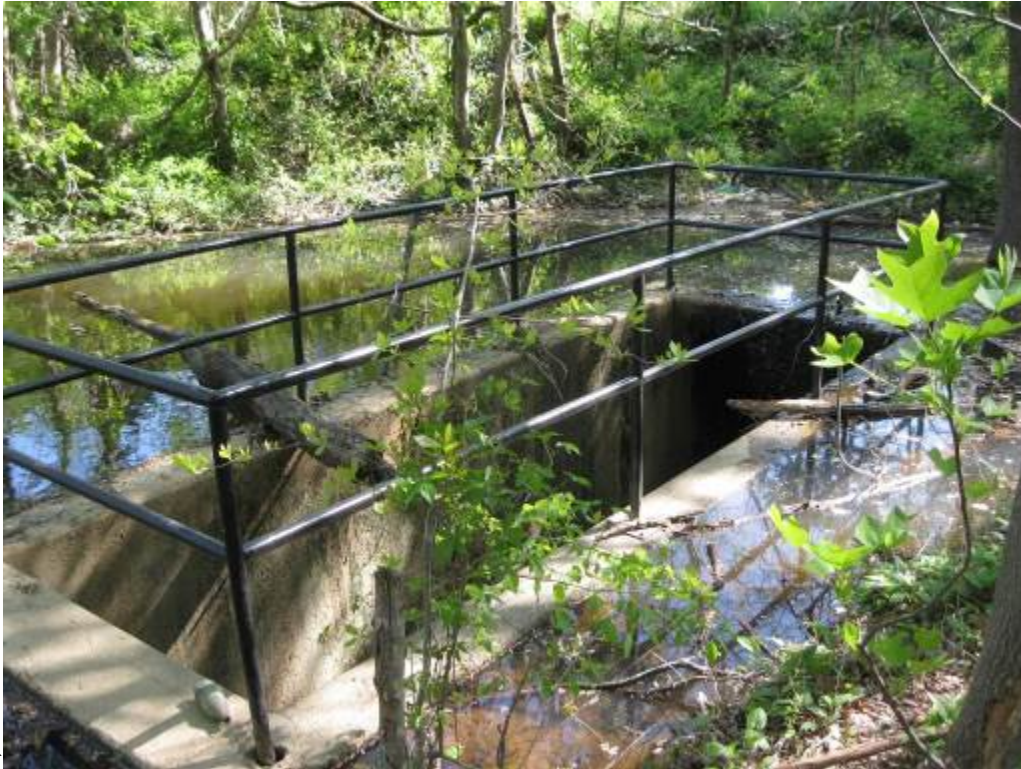
31. Facility 92. Looking at weir outlet structure. Water was overtopping weir.

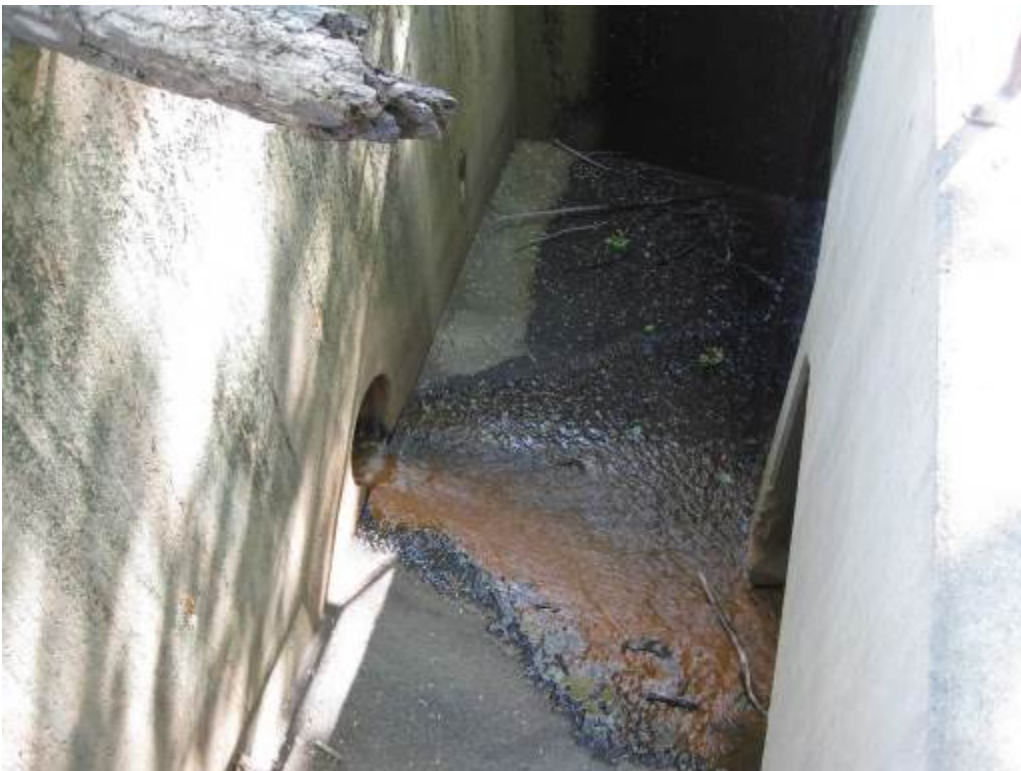
32. Facility 92. Looking at outlet which is draining to double box culvert under Interstate I-95.

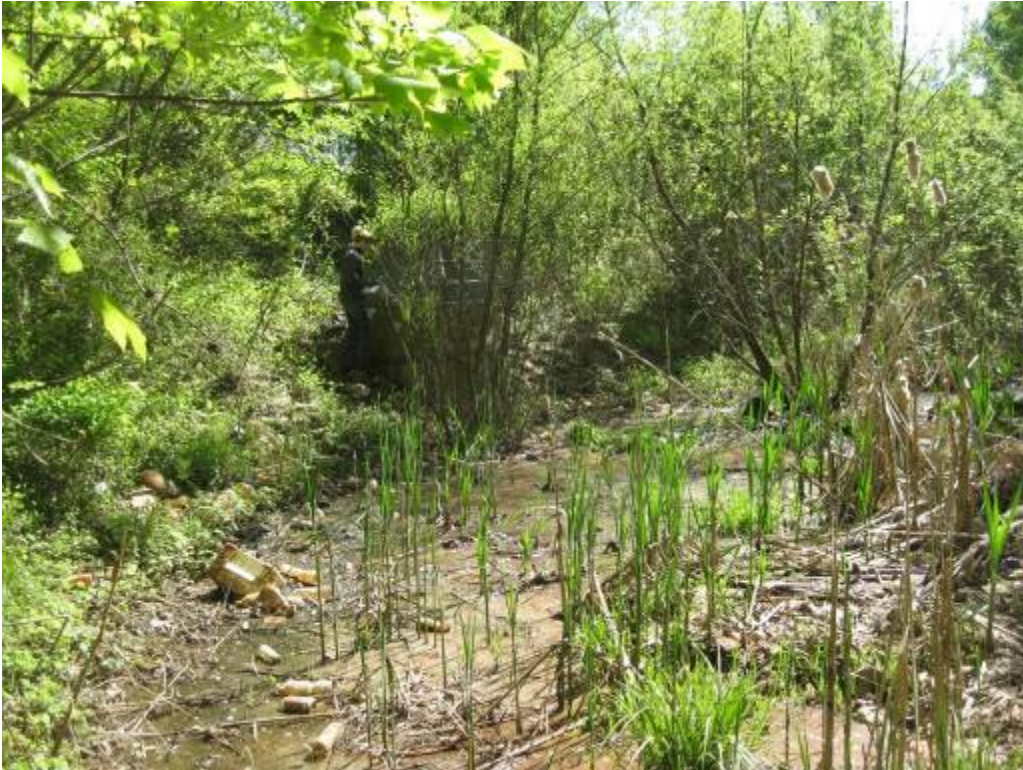
33. Facility 163. Looking at riser and ponding area. Ponding area is full of litter and fine sediment.

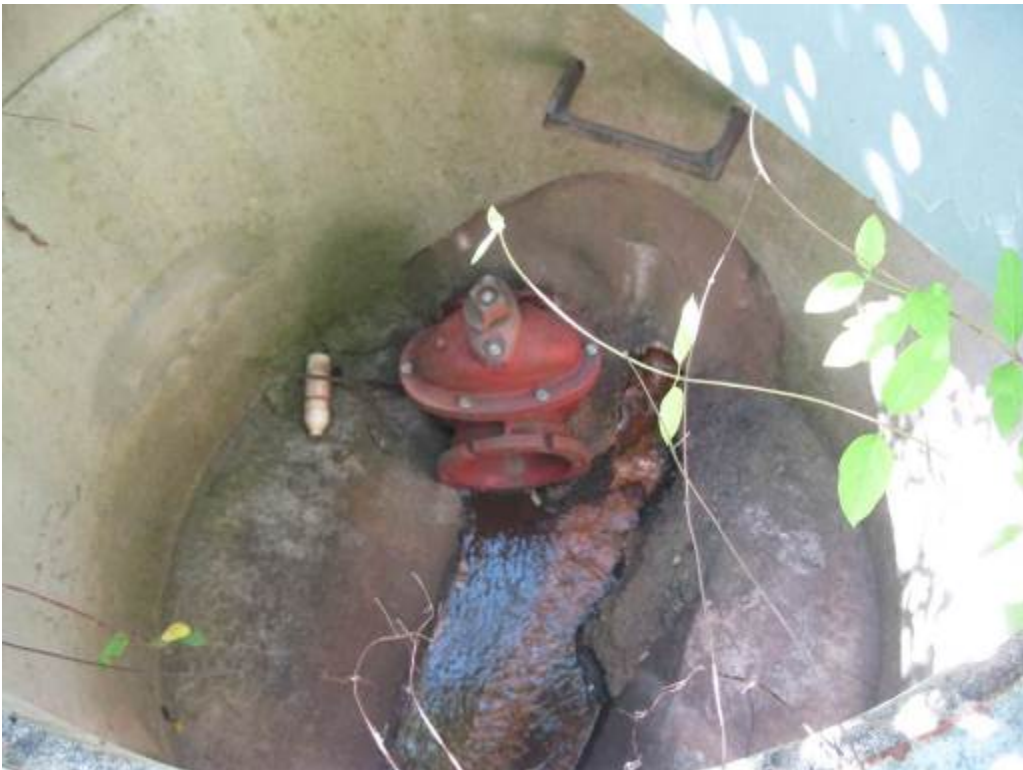
34. Facility 163. Looking in riser at maintenance valve and low flow orifice.

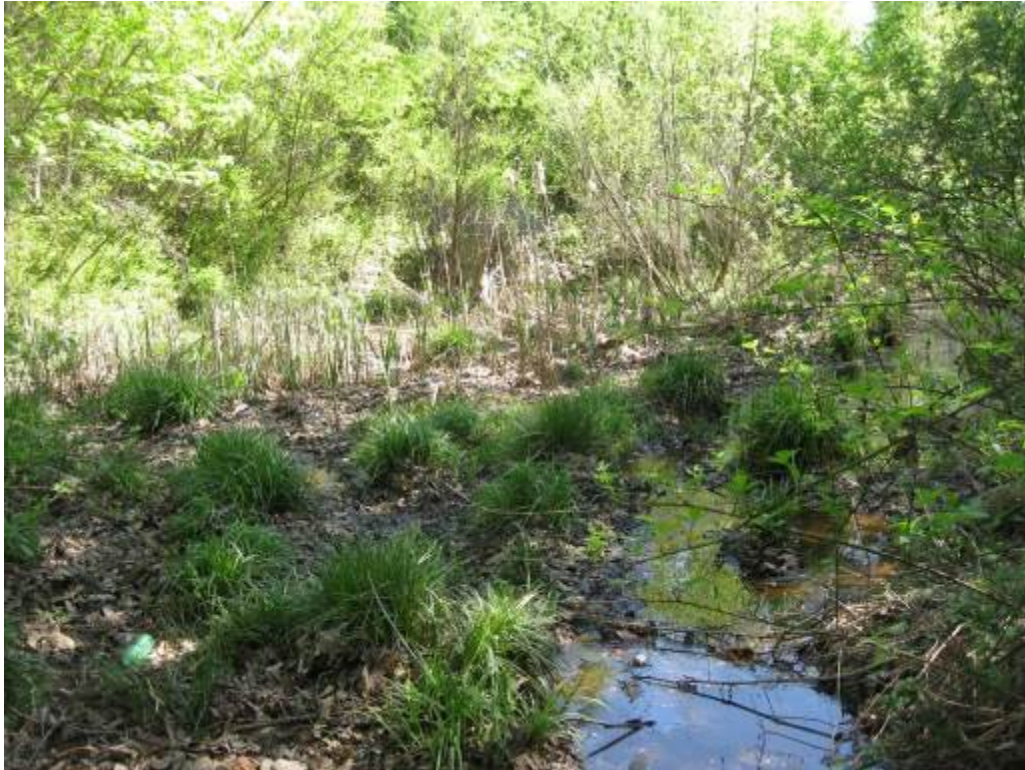
35. Facility 163. Looking at ponding area from riser.

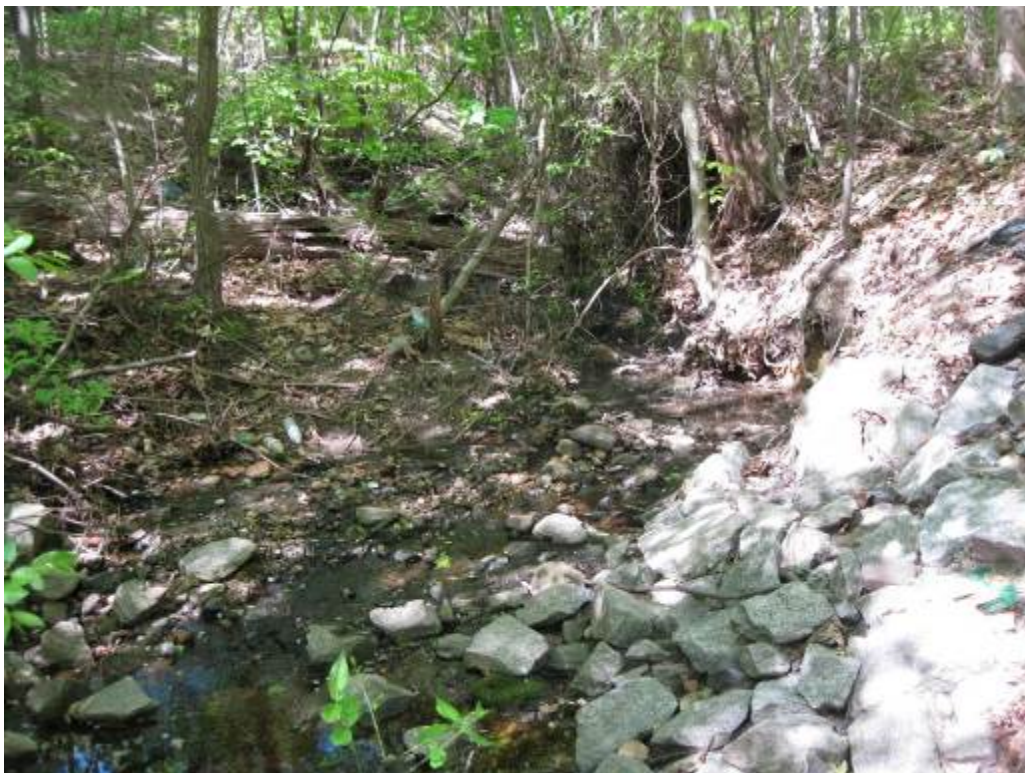
36. Facility 163. Looking at upstream channel. The channel shows some incision and bank instability.

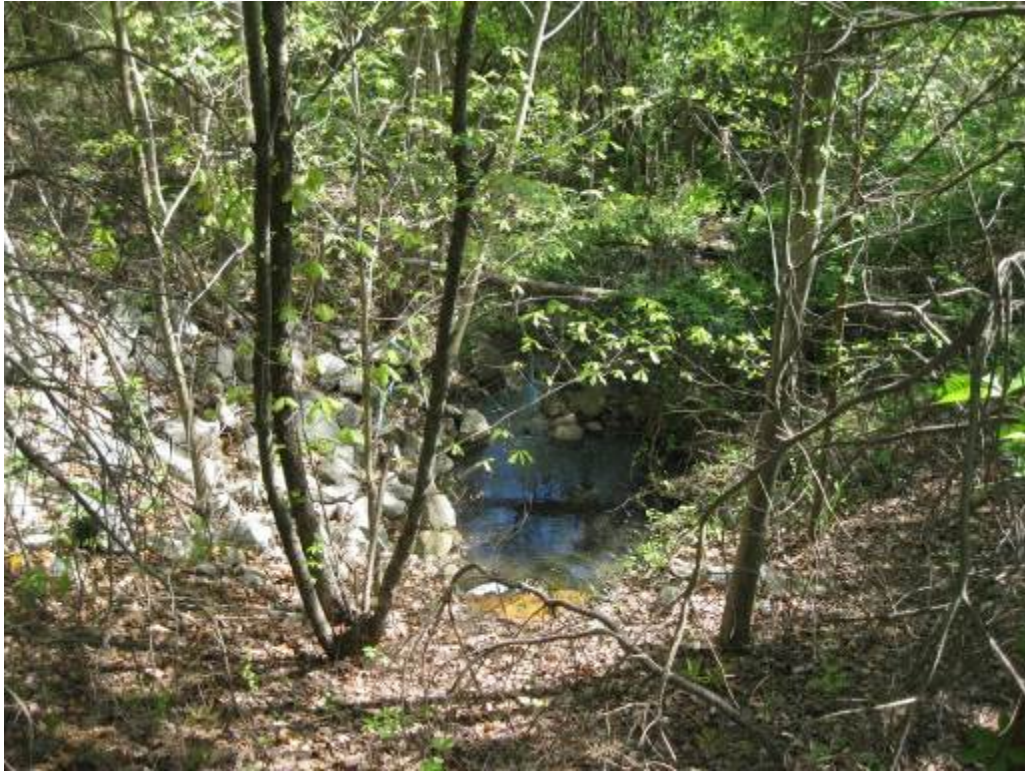
37. Facility 163. Looking at stable receiving channel immediately downstream of facility.

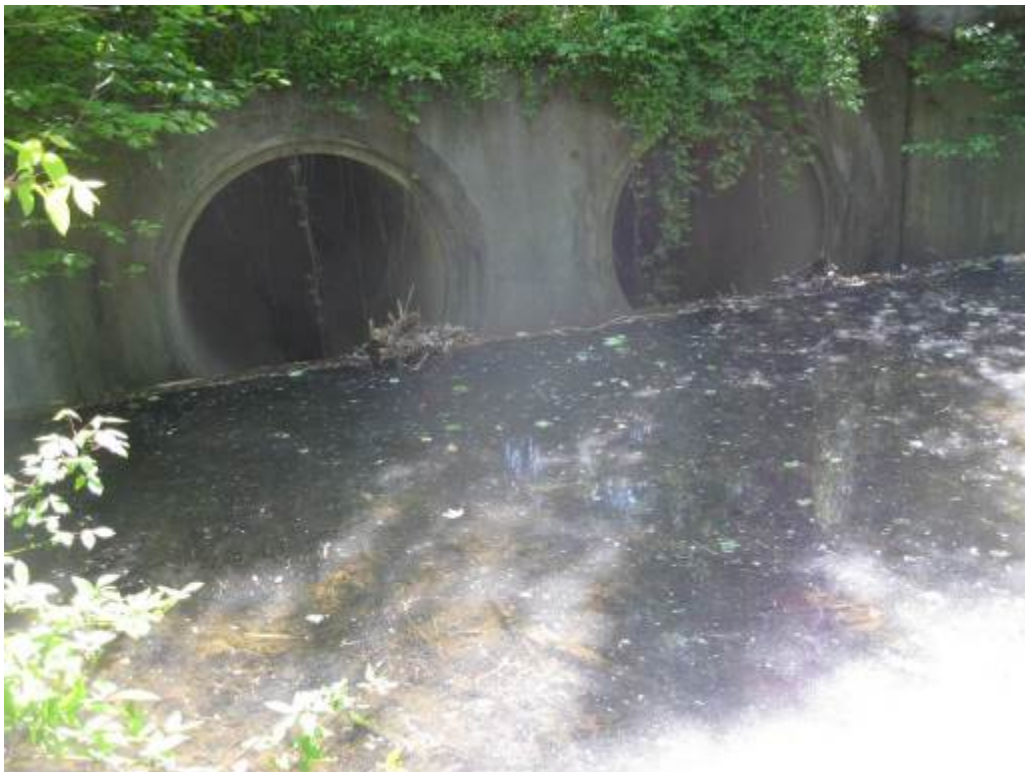
38. Facility 201. Weir wall upstream of two large concrete pipes under Abner Avenue. Sediment accumulation is evident upstream of facility.

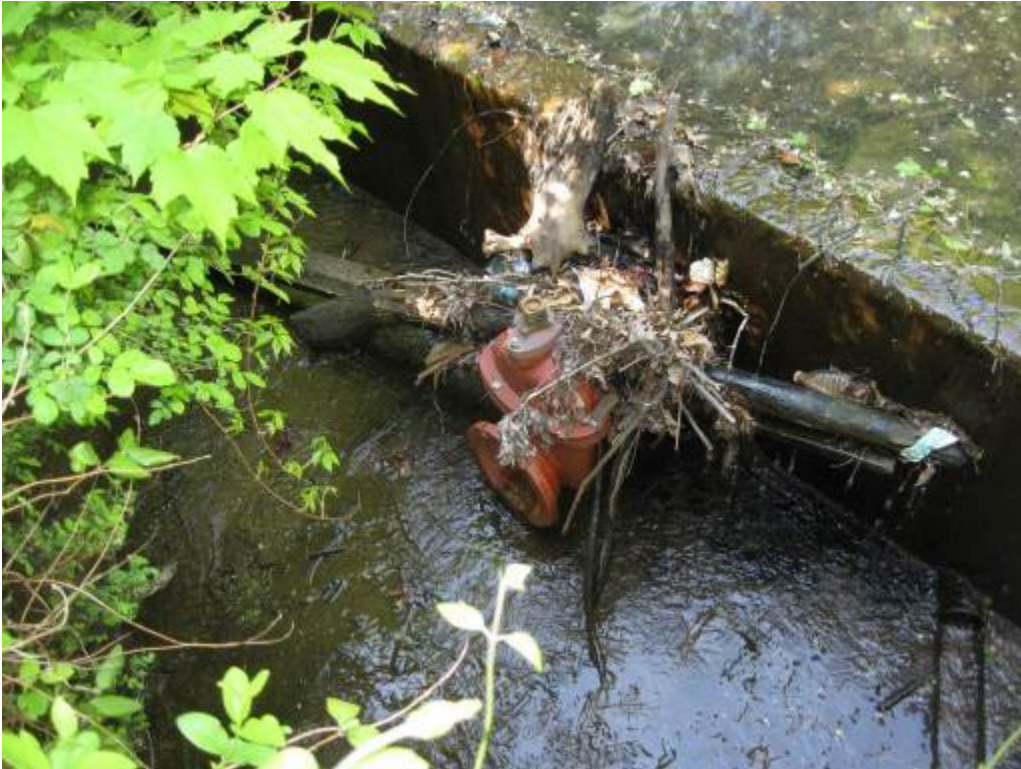
39. Facility 201. Looking at maintenance valve in weir wall currently covered in debris. The low flow orifice is an approximate 2" diameter pipe with the cut in concrete at the bottom corner. Water was draining through the low flow orifice and overtopping weir wall.

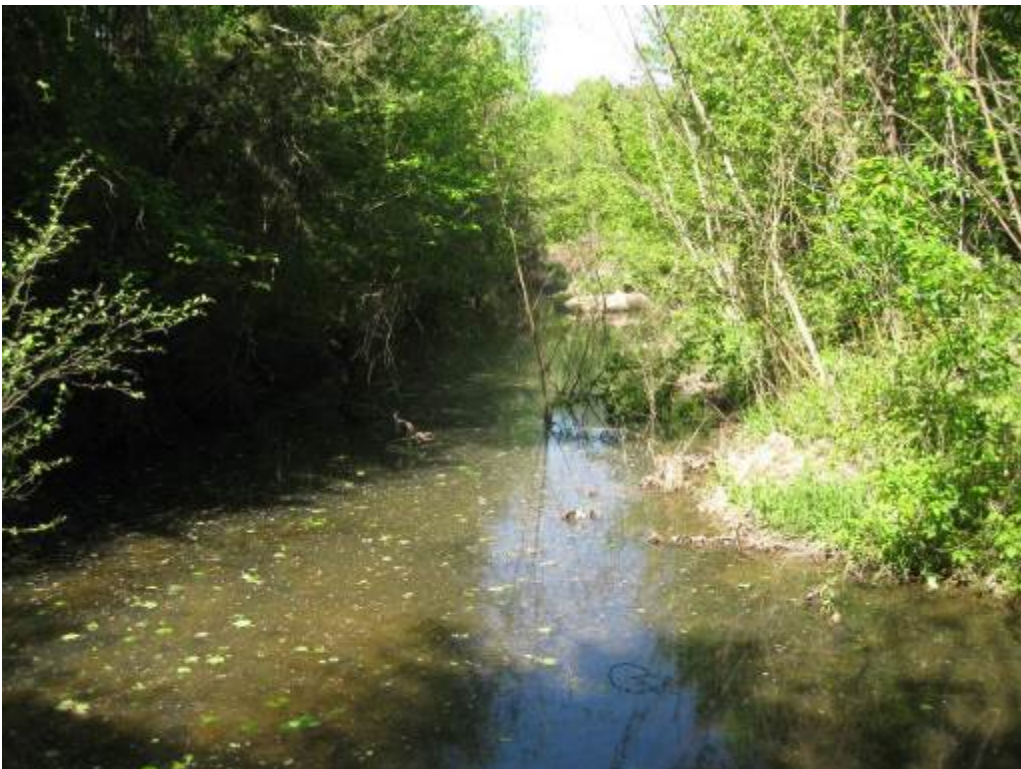
40. Facility 201. Looking upstream at backwater area in existing channel within facility. There were no signs of recent inundation in the overbank areas.

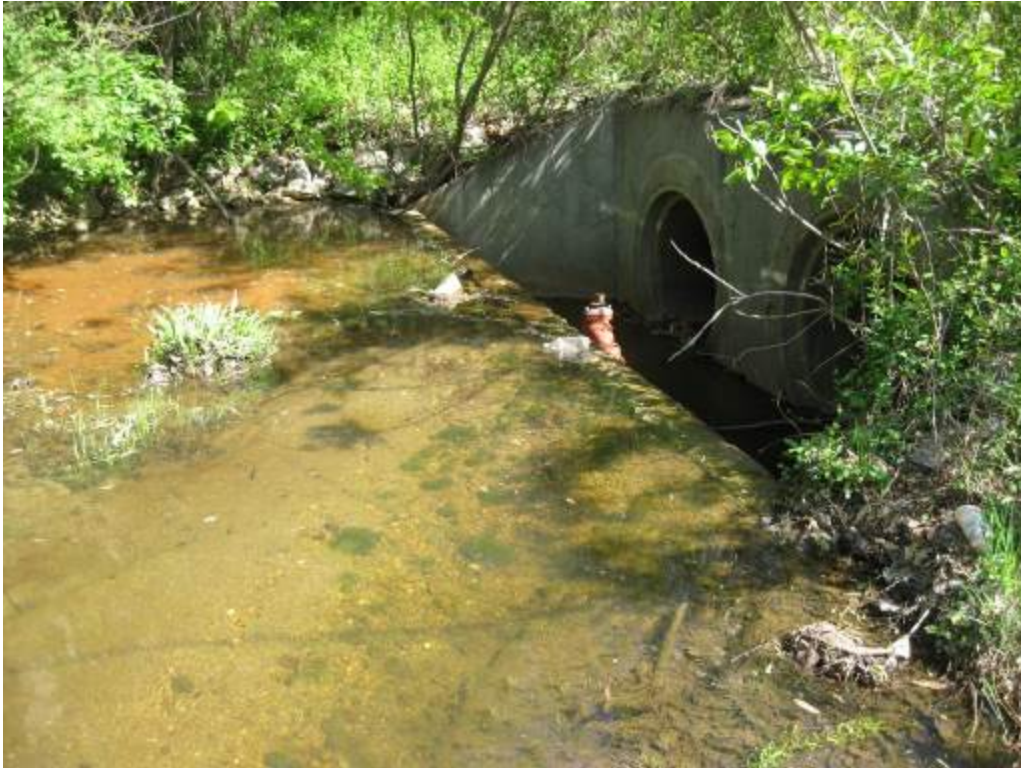
41. Facility 200. Looking downstream at weir wall and double round culverts. Sediment accumulation is evident upstream of facility.

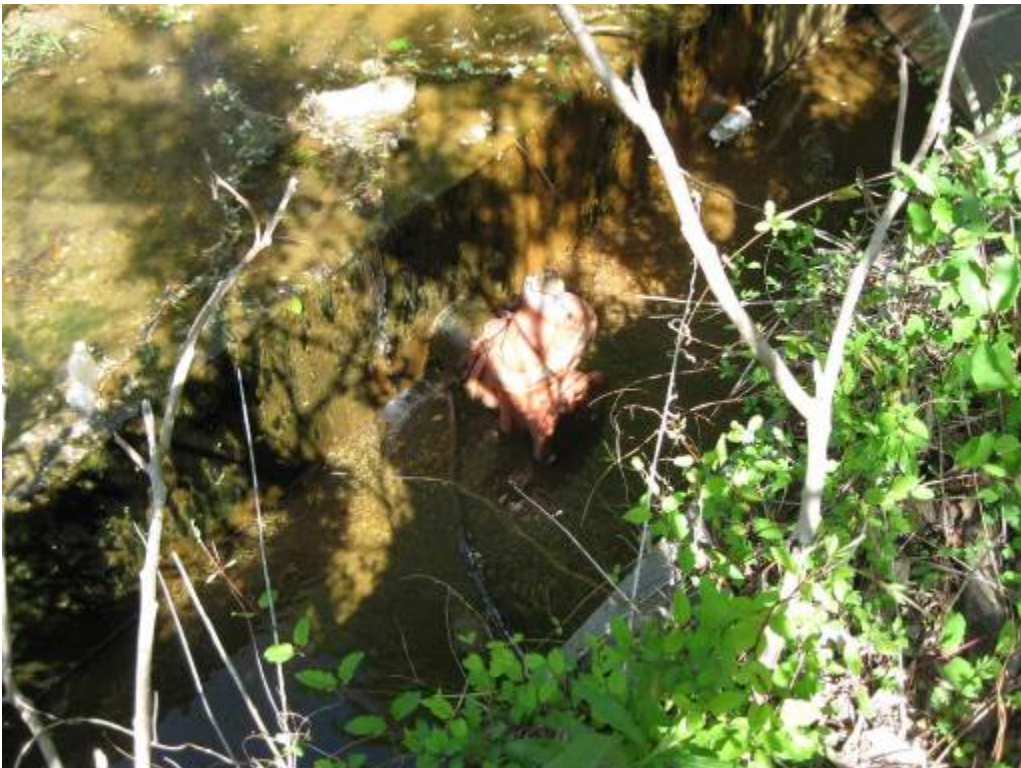
42. Facility 200. Looking at maintenance valve in weir wall. Water was draining over weir wall and through low flow orifice (approx. 2" diameter pipe through wall).

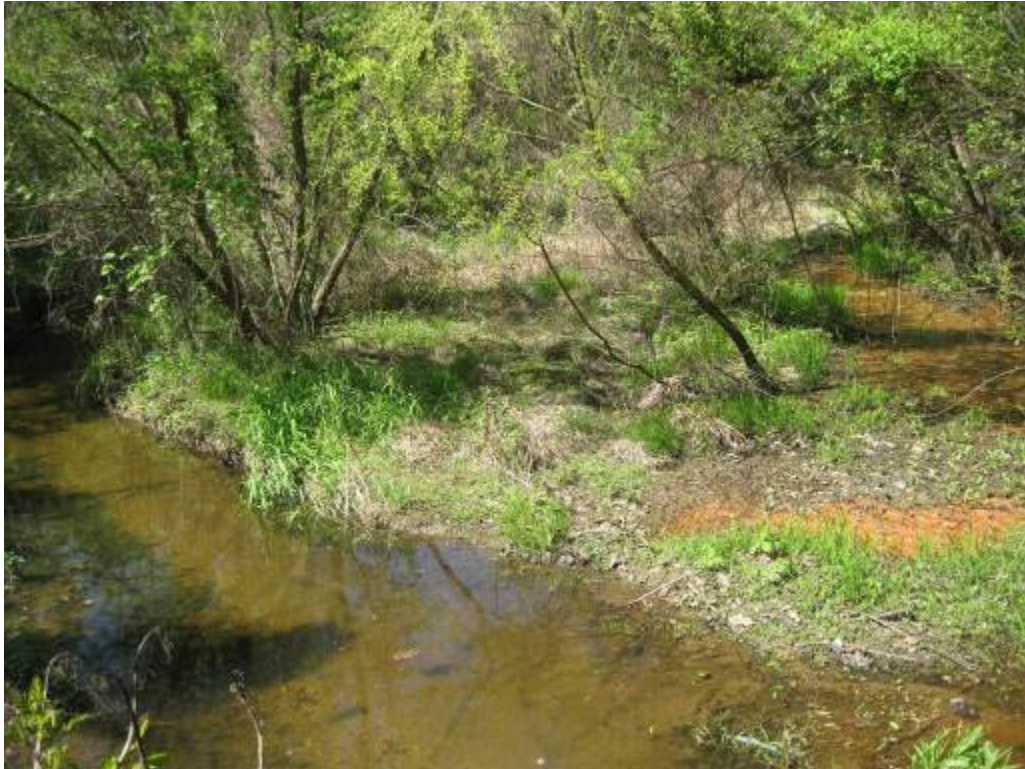
43. Facility 200. Looking at both channels that flow through facility. Sediment has accumulated in overbank areas creating delta shown in photo. The overbank areas which show little sign of recent inundation.

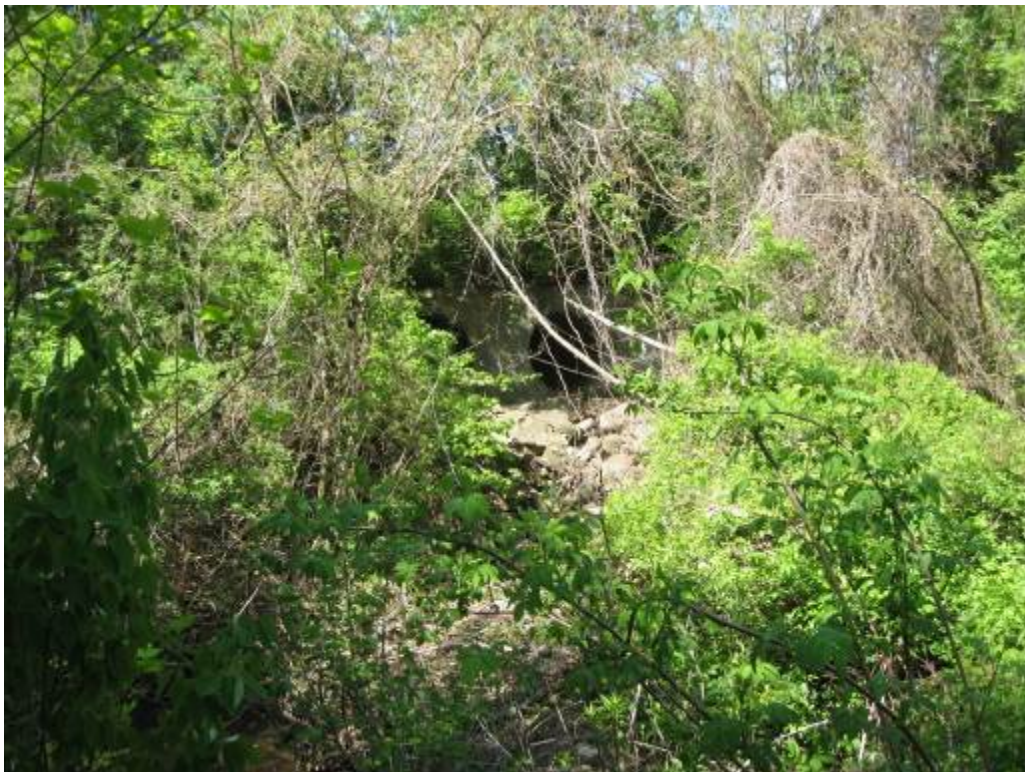
44. Facility 200. Double culverts under Abner Avenue that drain directly from Facility 201.

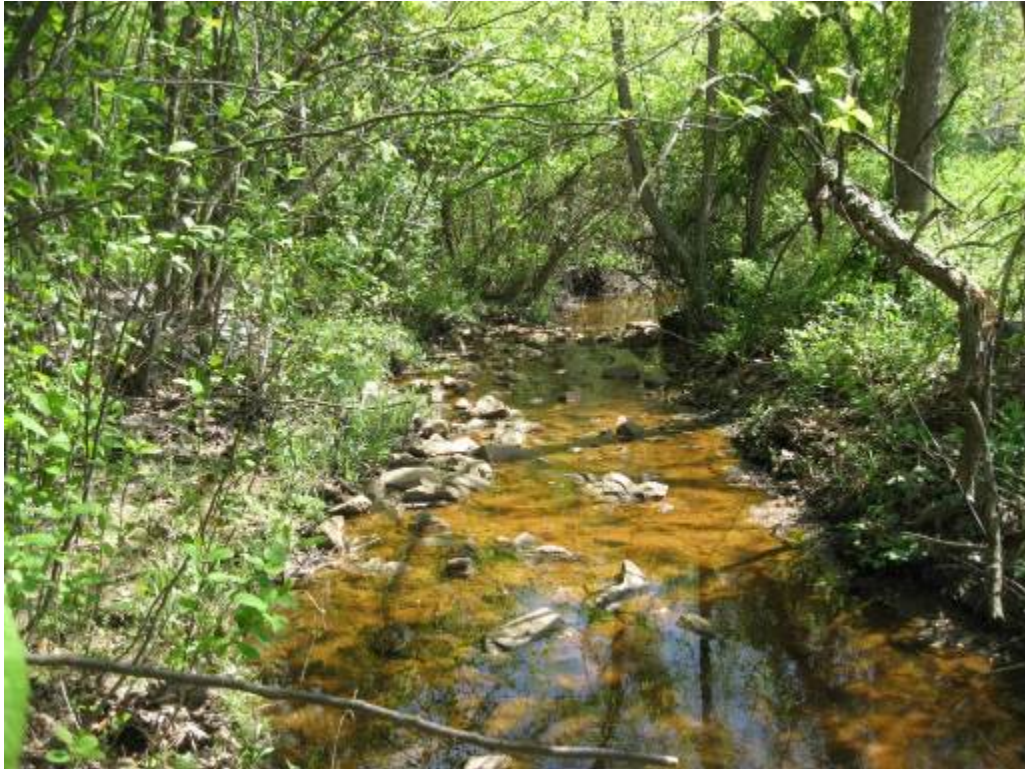
45. Facility 200. Looking immediately downstream of facility at stable receiving channel.

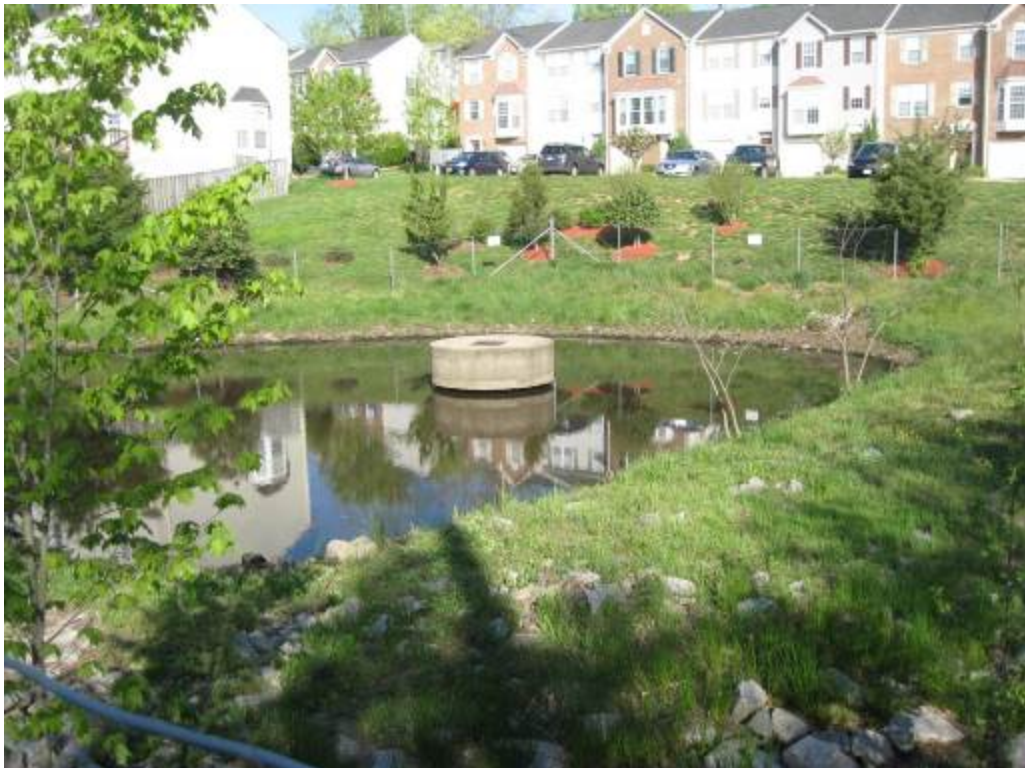
46. Facility 454. Looking at riser structure from the emergency spillway.

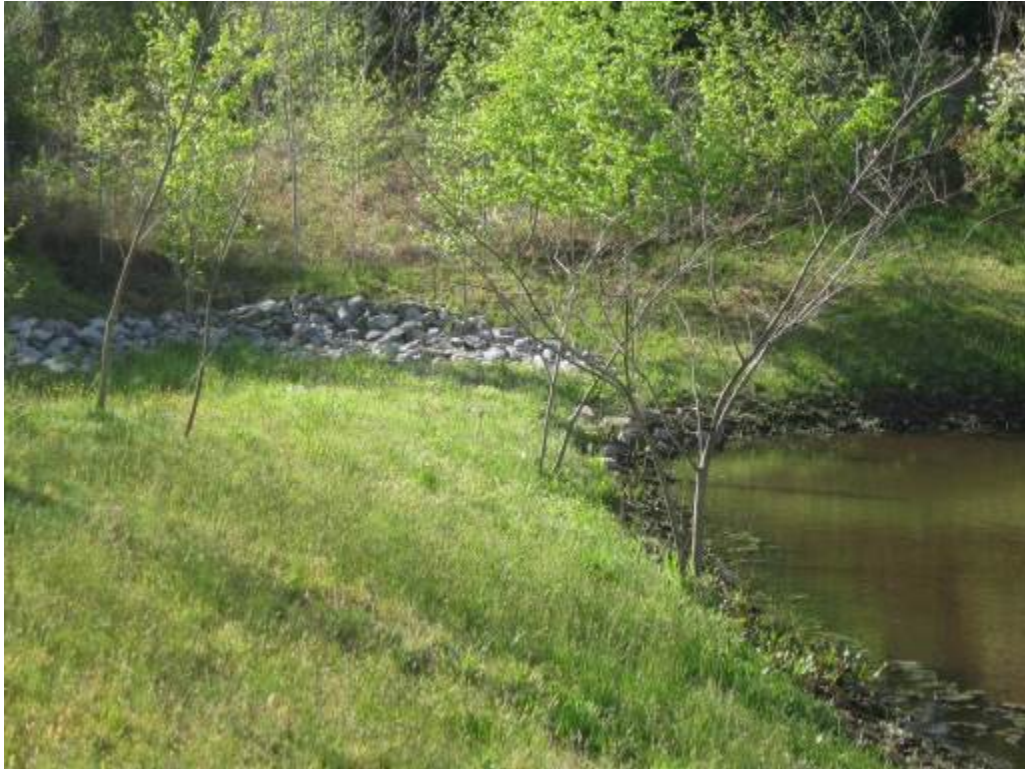
47. Facility 454. Looking at riprap along emergency spillway and small trees on dam.

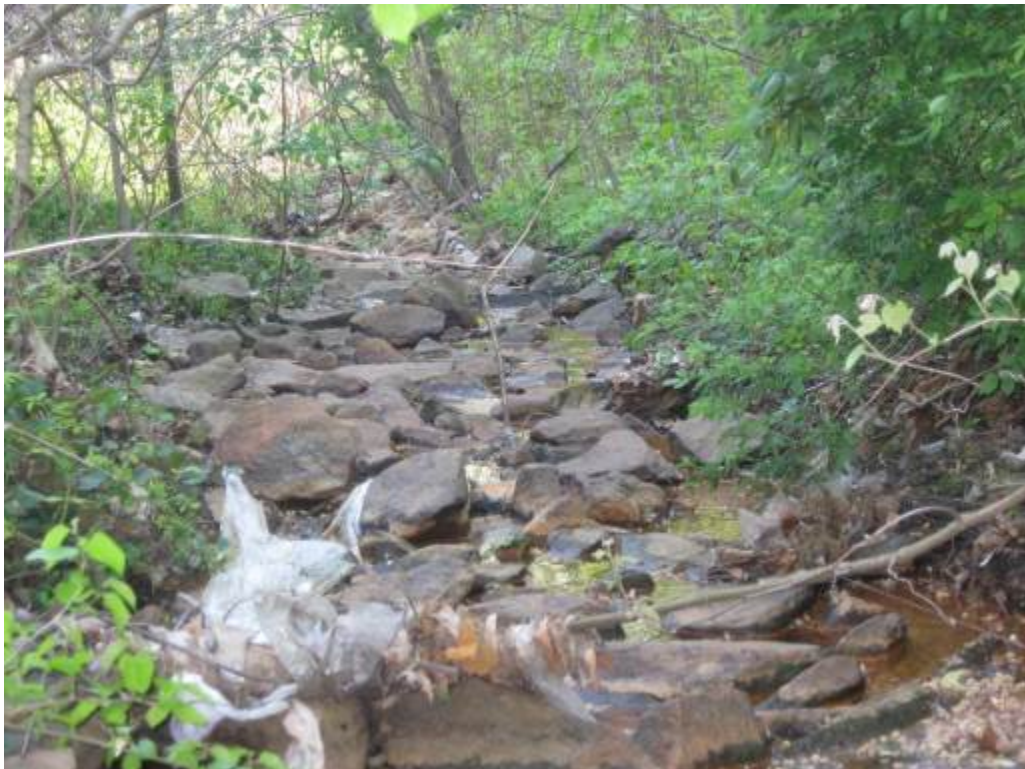
48. Facility 454. Receiving channel immediately downstream of the facility is stable with naturalized large rock.

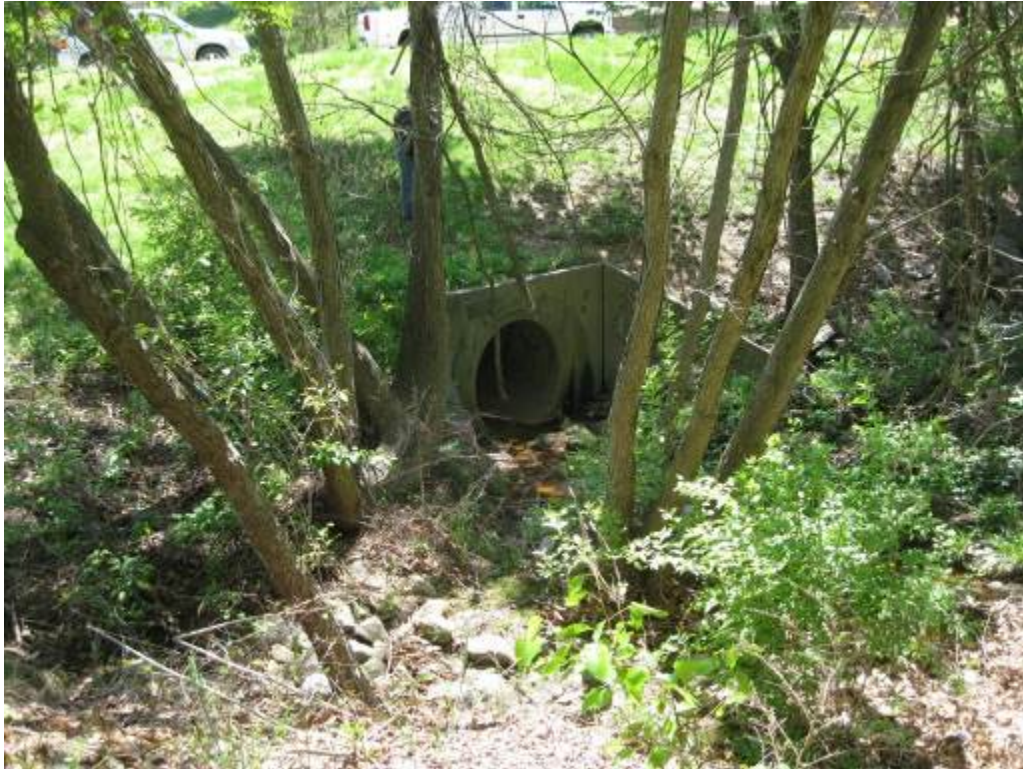
49. **Facility 457. This is not a facility. This culvert drains under Rolling Brook Drive into Facility 5047. There are no signs of inundation in the immediate upstream area.**

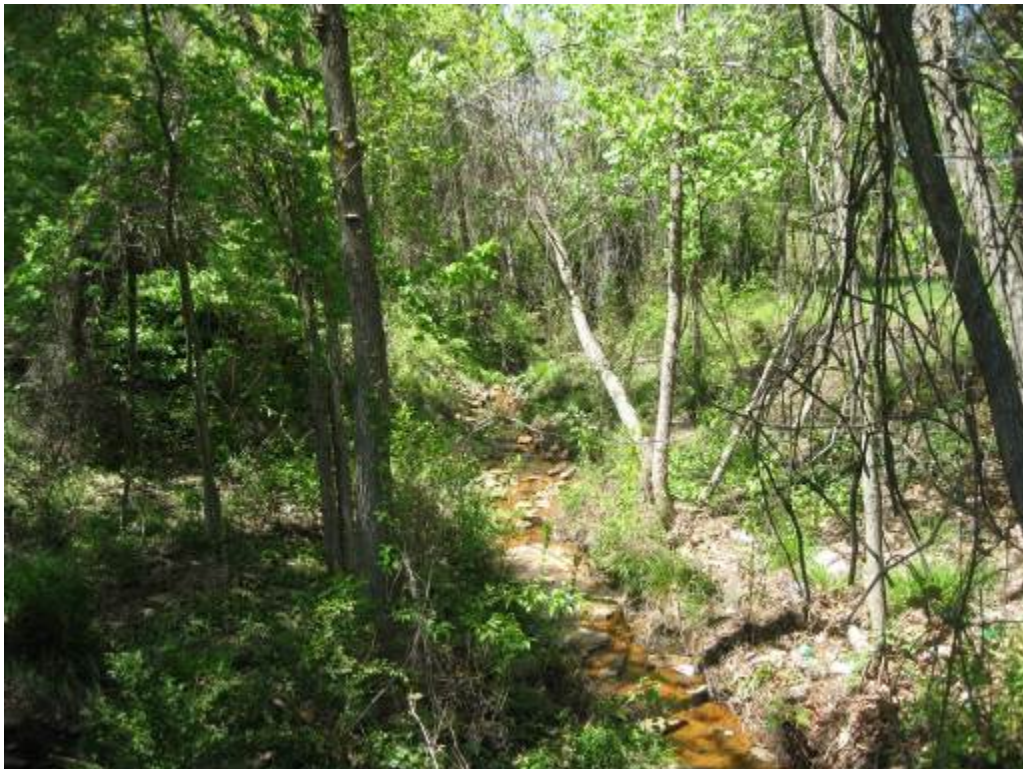
50. **Facility 457. Stable channel upstream of culvert under Rolling Brook Drive. No signs of inundation in overbank area.**

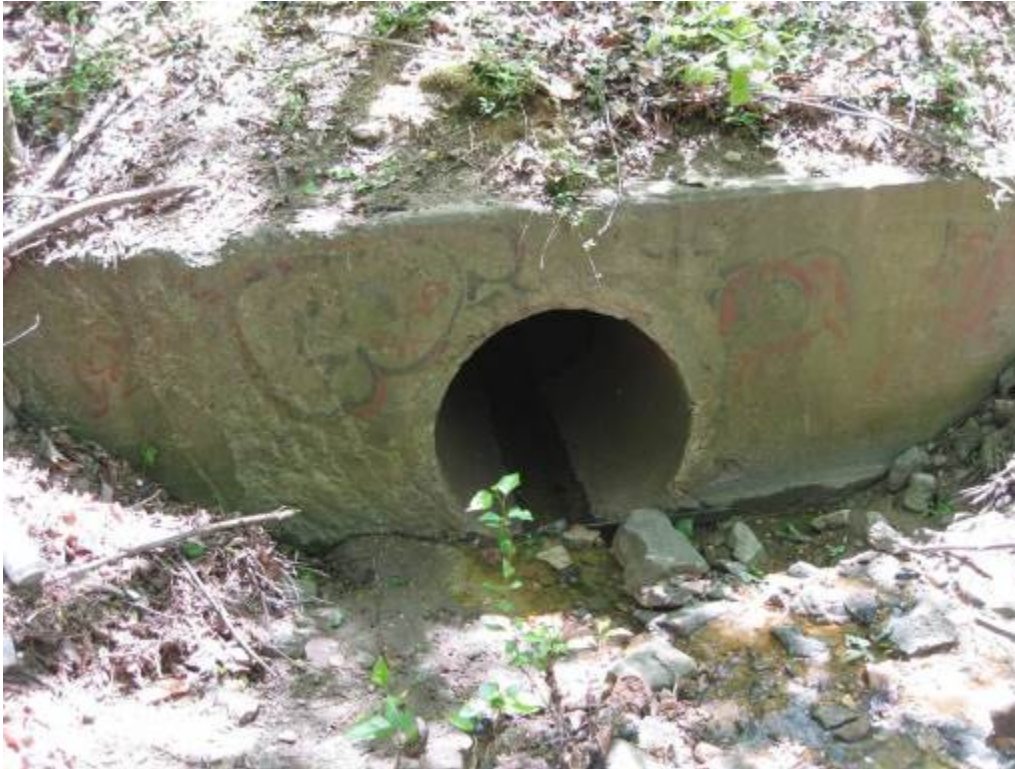
51. Facility 465. Looking at inlet into square concrete riser.

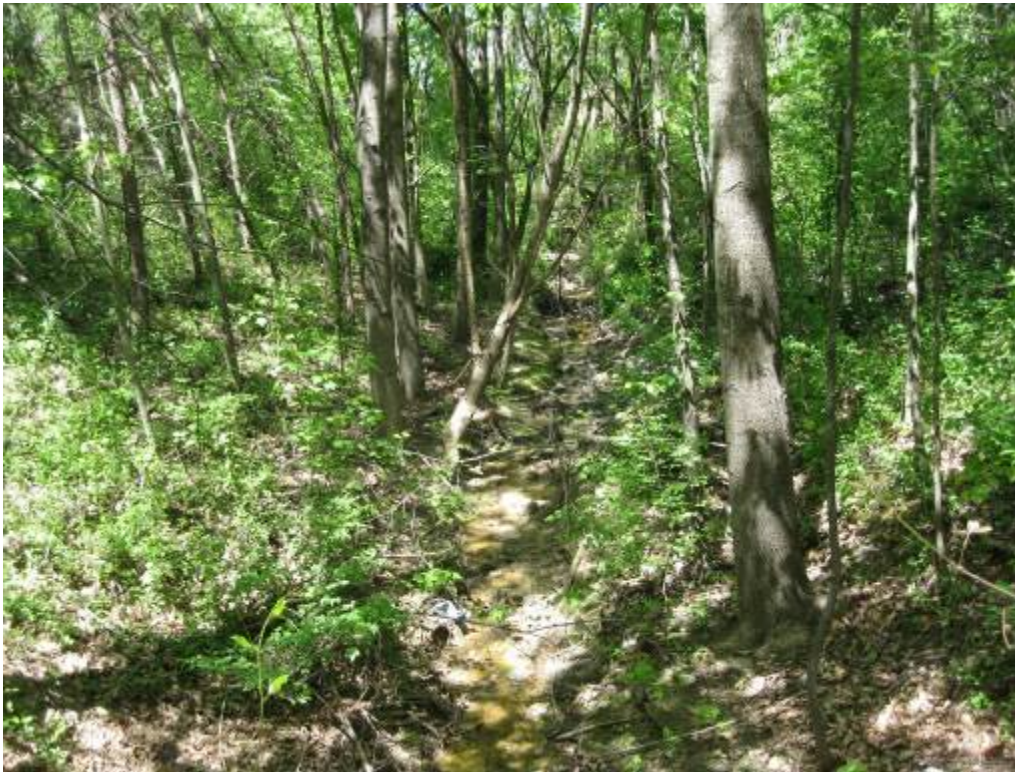
52. Facility 465. Looking upstream at stable channel and adjacent overbank areas within facility.

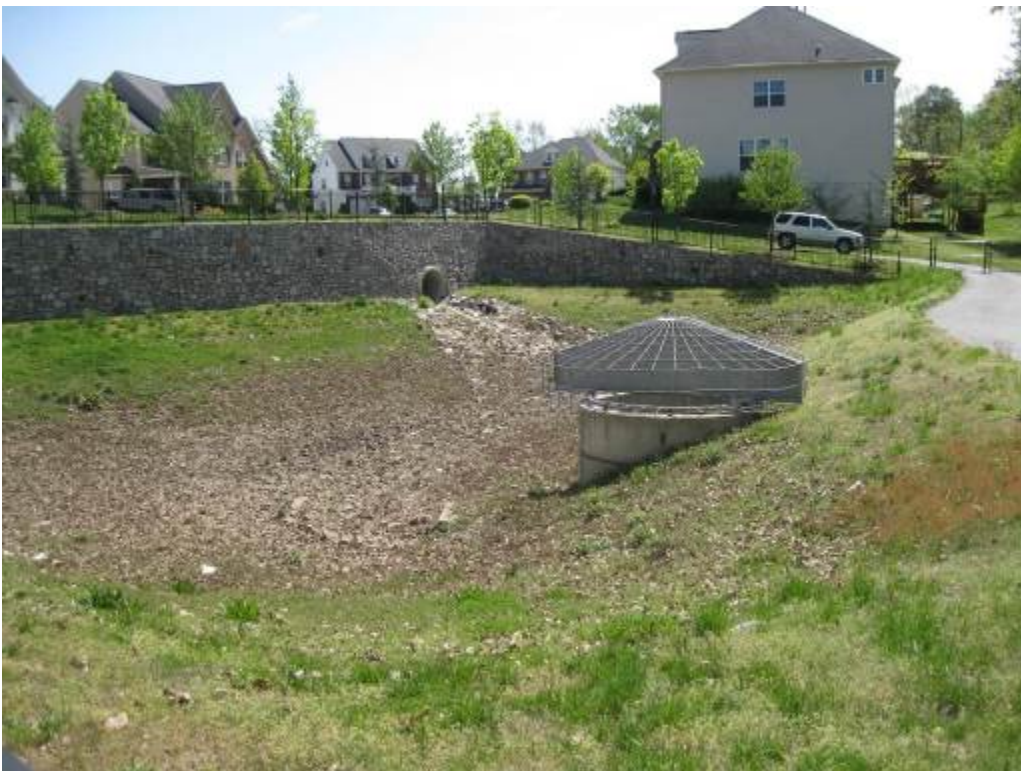
54. Facility 691. Looking at riser with anti-vortex plate and BMP orifice with extended trash rack.

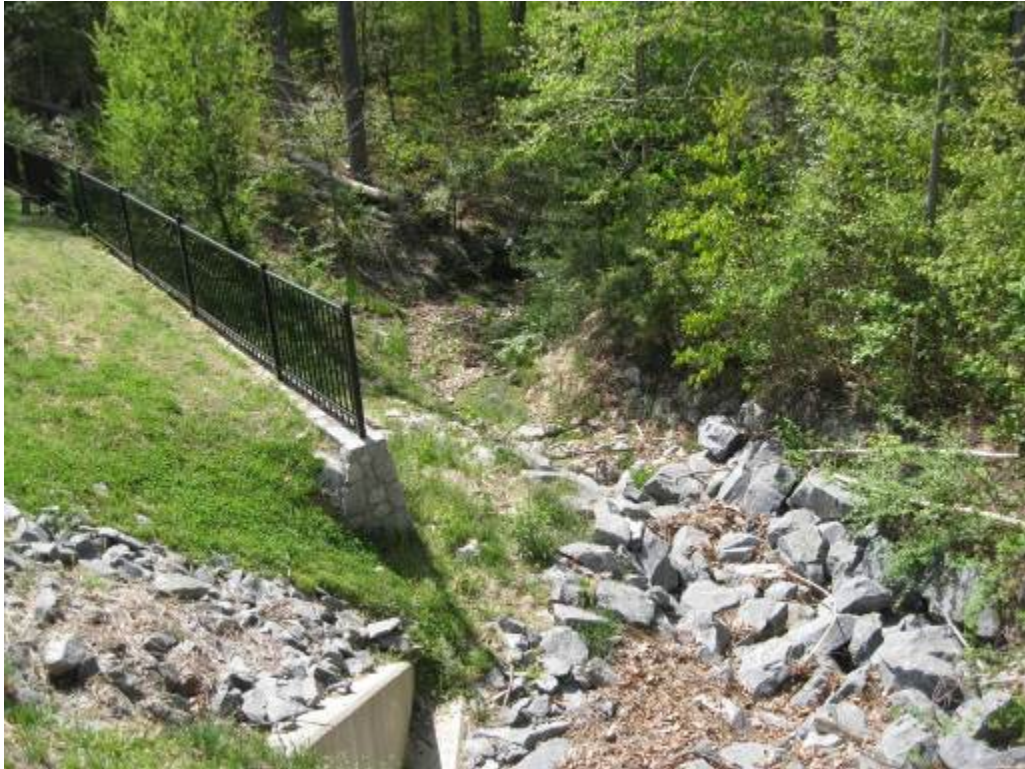
55. Facility 691. Looking at emergency spillway as it ties into stable, existing channel.

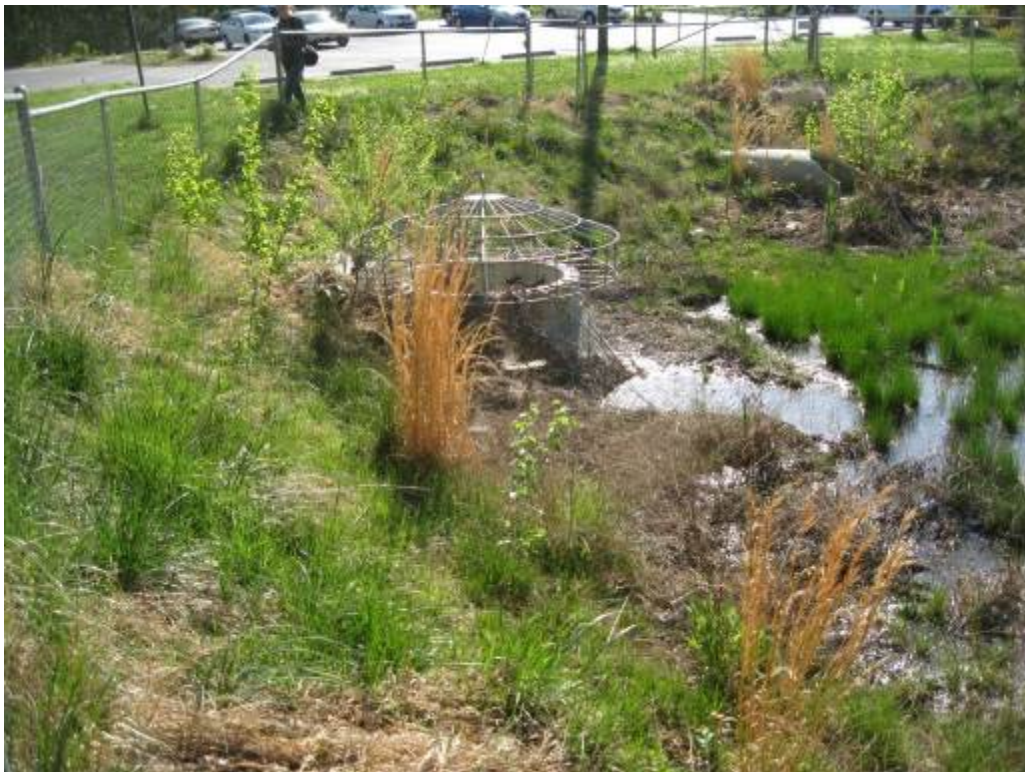
56. Facility 694. Looking at riser with anti-vortex plate and BMP orifice protected by a trash rack. Facility treats church parking lot behind the facility.

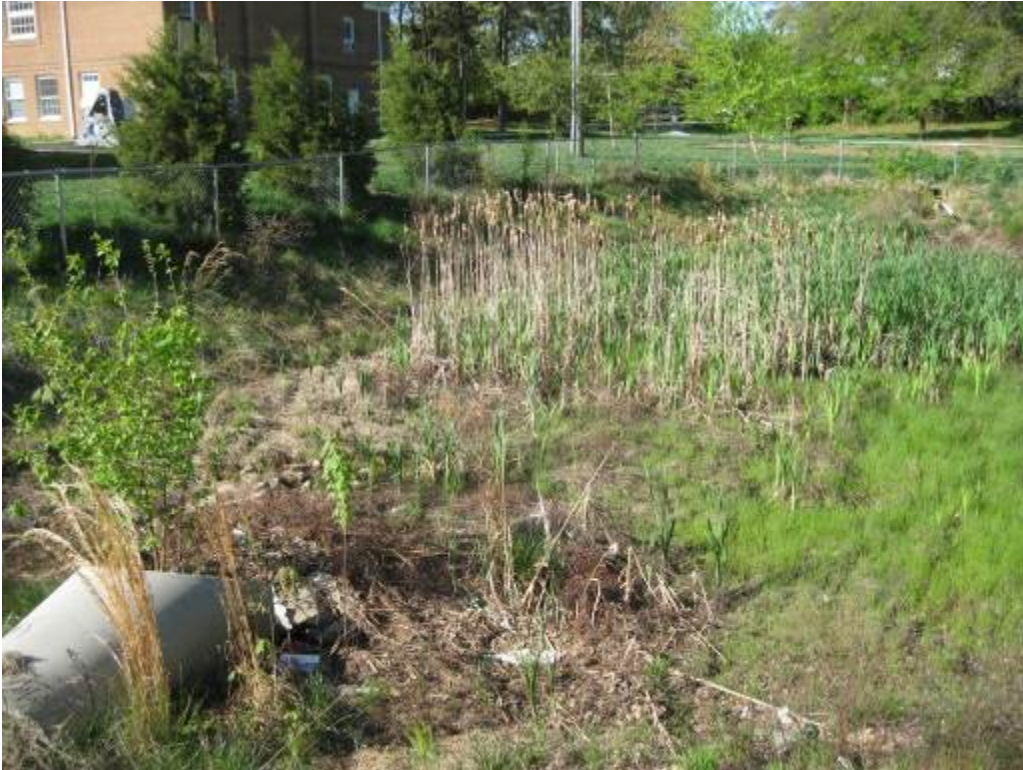
57. **Facility 694. Inlets into the facility include the culvert draining from parking lot in foreground and small PVC pipe in background. Ponding area was wet and there were no signs of short-circuiting.**
