Appendix D Index

SWM/BMP Facility Site Photographs

Appendix D
SWM/BMP Facility Site Photographs
Occoquan Watershed – Study of Four Subsheds
WSSI #25156.01

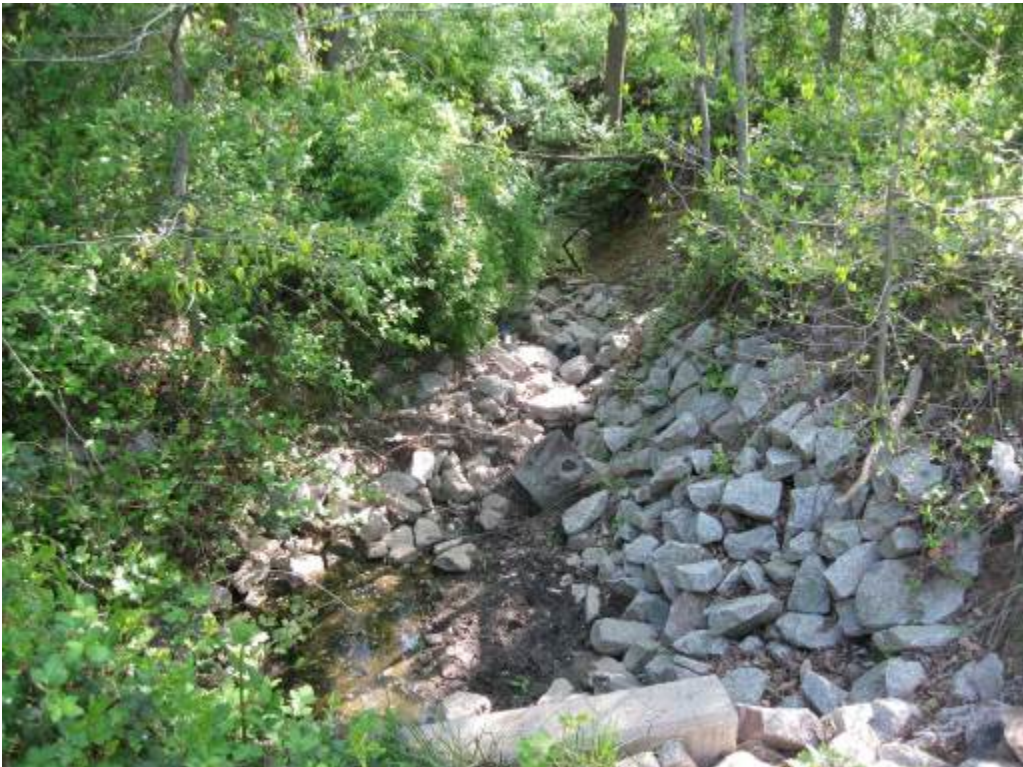
58. **Facility 694. Receiving channel immediately downstream of emergency spillway outlet. Channel has been recently stabilized with riprap. Channel is incised with some areas of raw, eroded banks, but appears to be stabilizing beyond immediate area of outlet.**

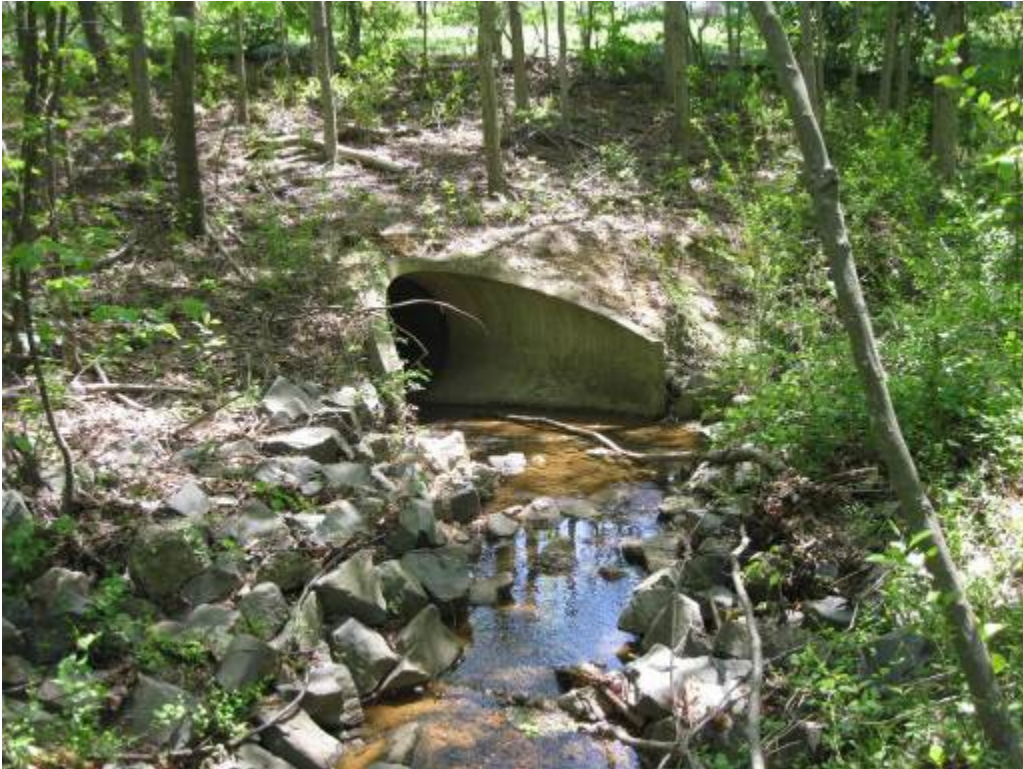
59. Facility 5047. This may not be a facility. There is no riser structure and there were no signs of inundation in area identified as facility.

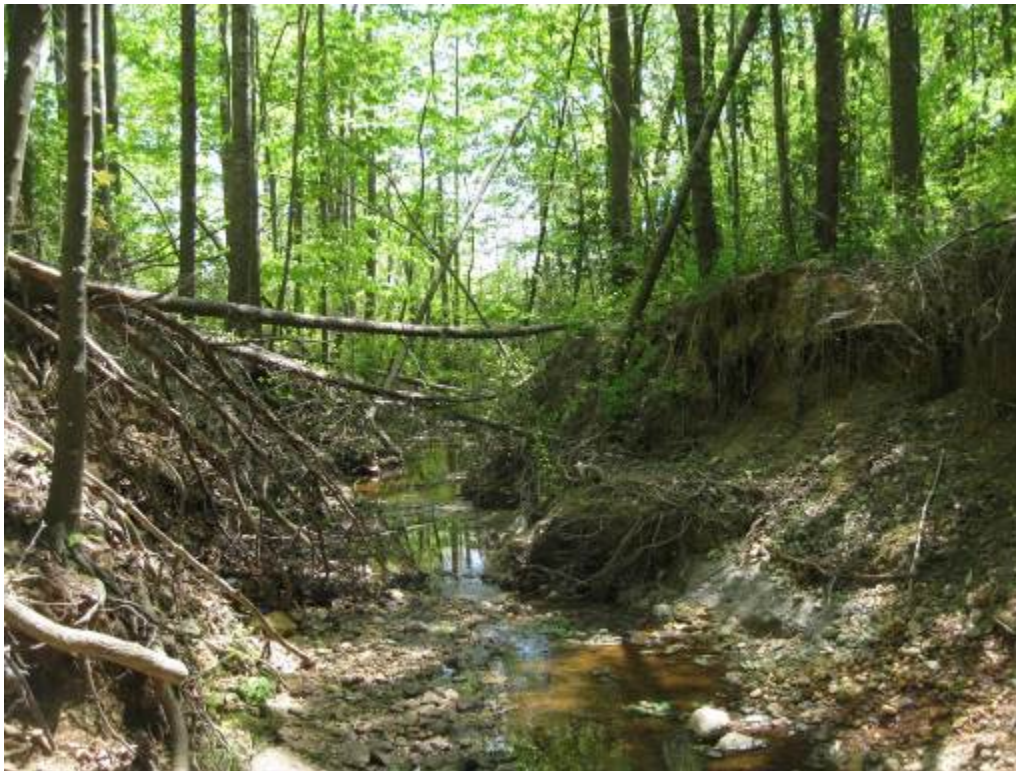
60. Facility 5047. Receiving channel downstream of facility is incised with vertical eroding banks.

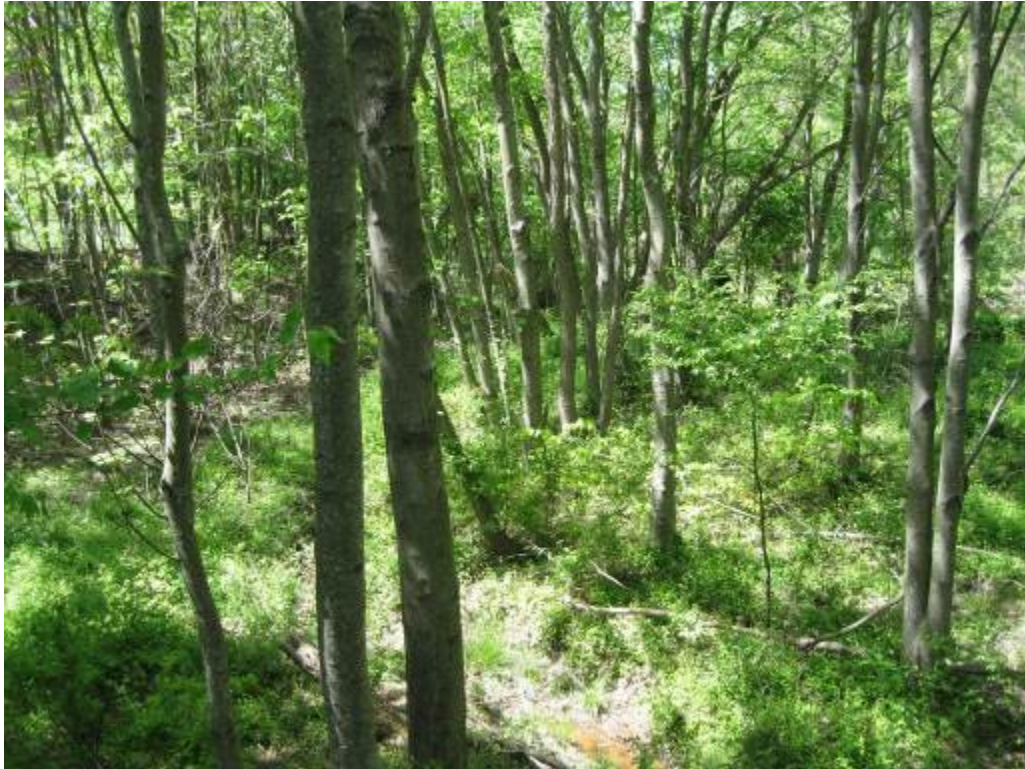
61. Facility 5047. Looking at overbank areas adjacent to the channel that runs through the area identified as the facility.

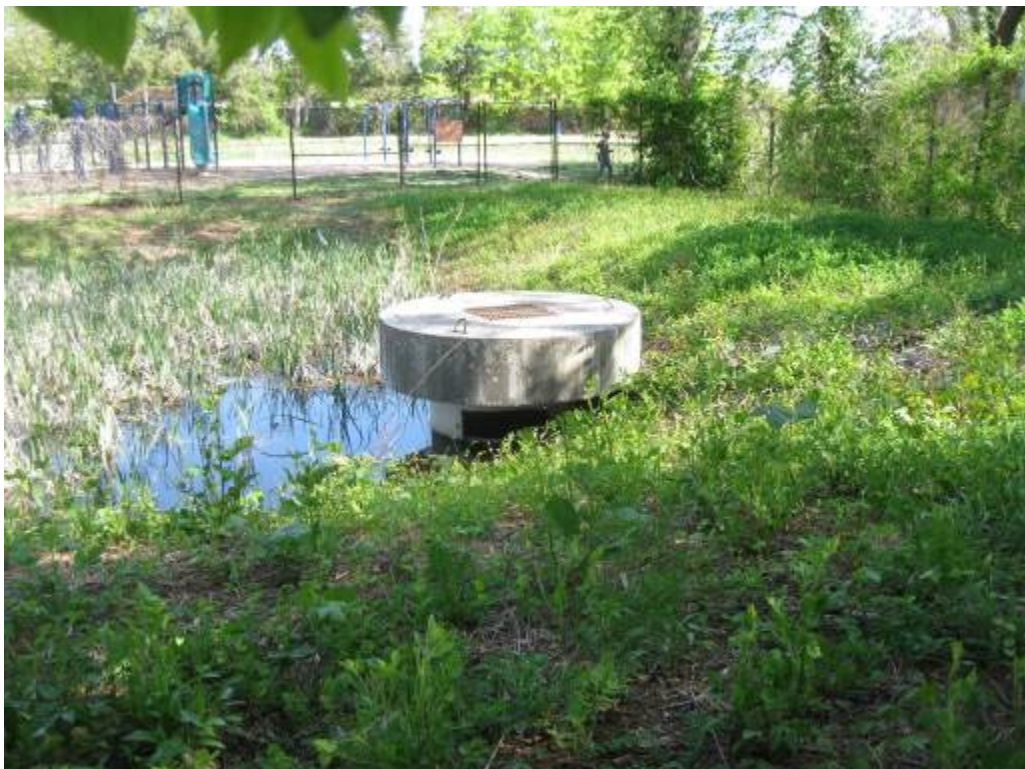
62. Facility 5153. Looking at concrete riser. Facility treats school lot, including buildings, parking lot, playground, and turf grass.

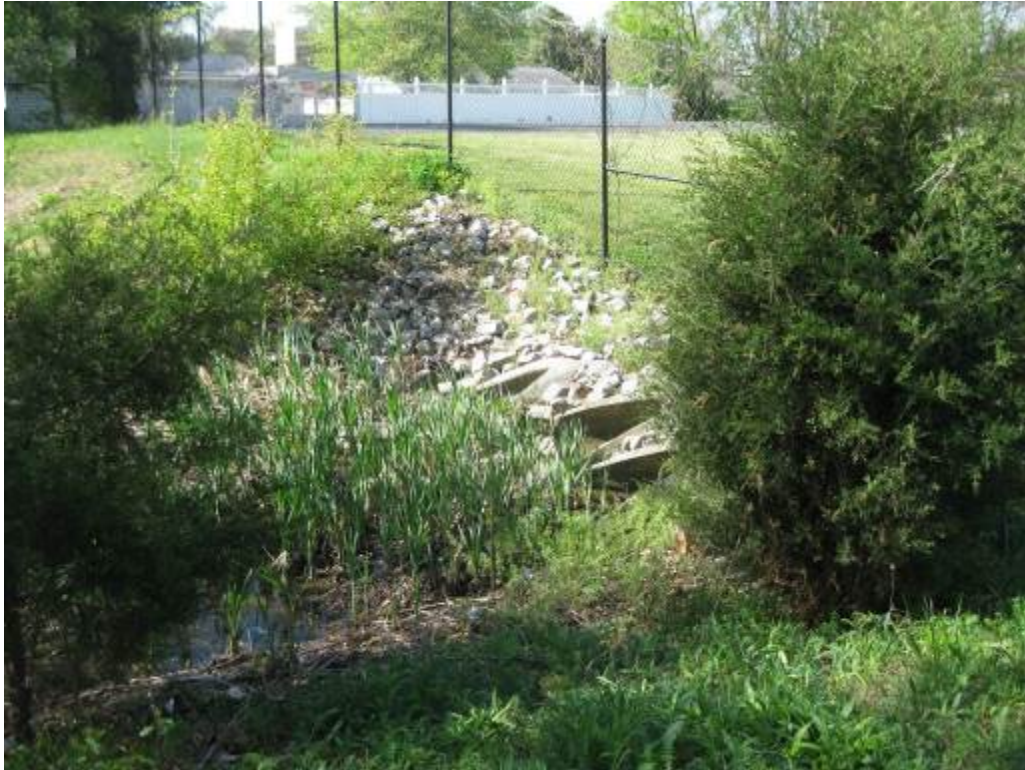
63. Facility 5153. Looking at stable inlet from school buildings.

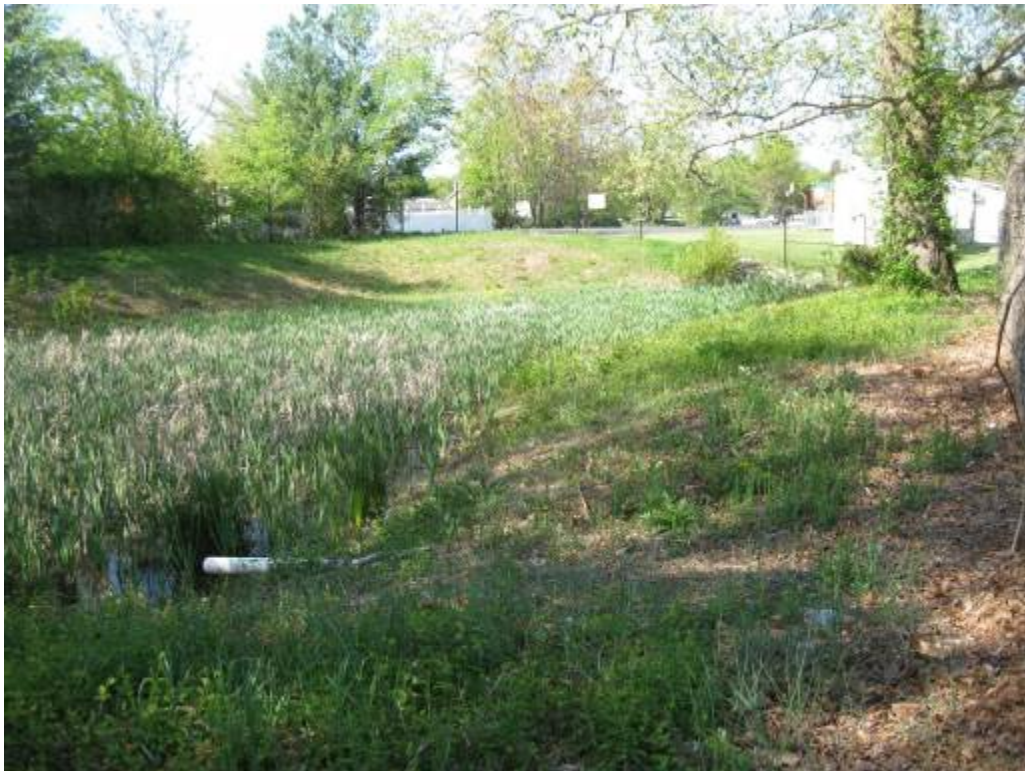
64. Facility 5153. Looking at pond area with dense vegetation. PVC pipe drains near playground.

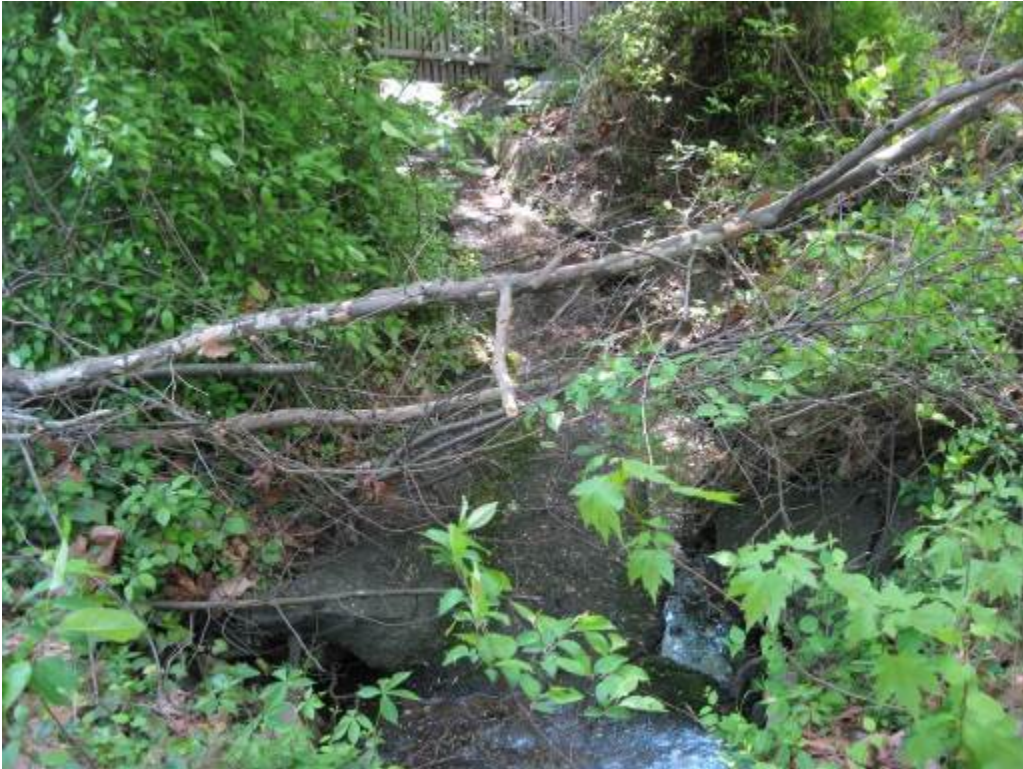
65. Facility 5153. Emergency spillway drains to existing asphalt channel.

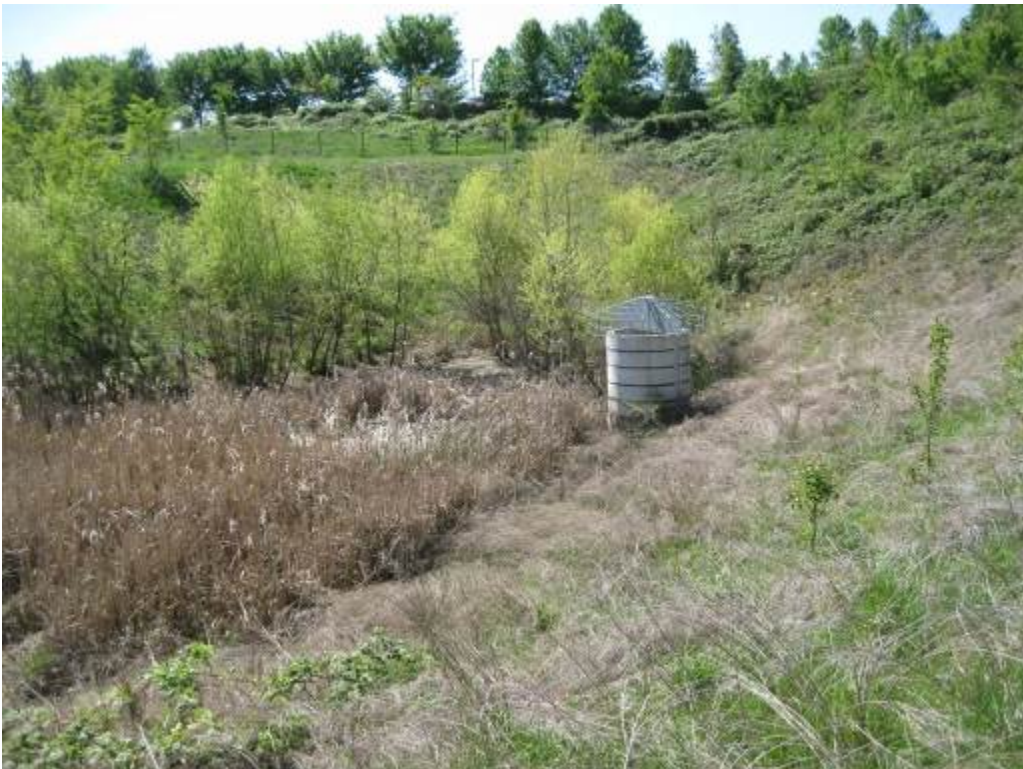
66. Facility. 5400. Looking at riser and wet ponding area.

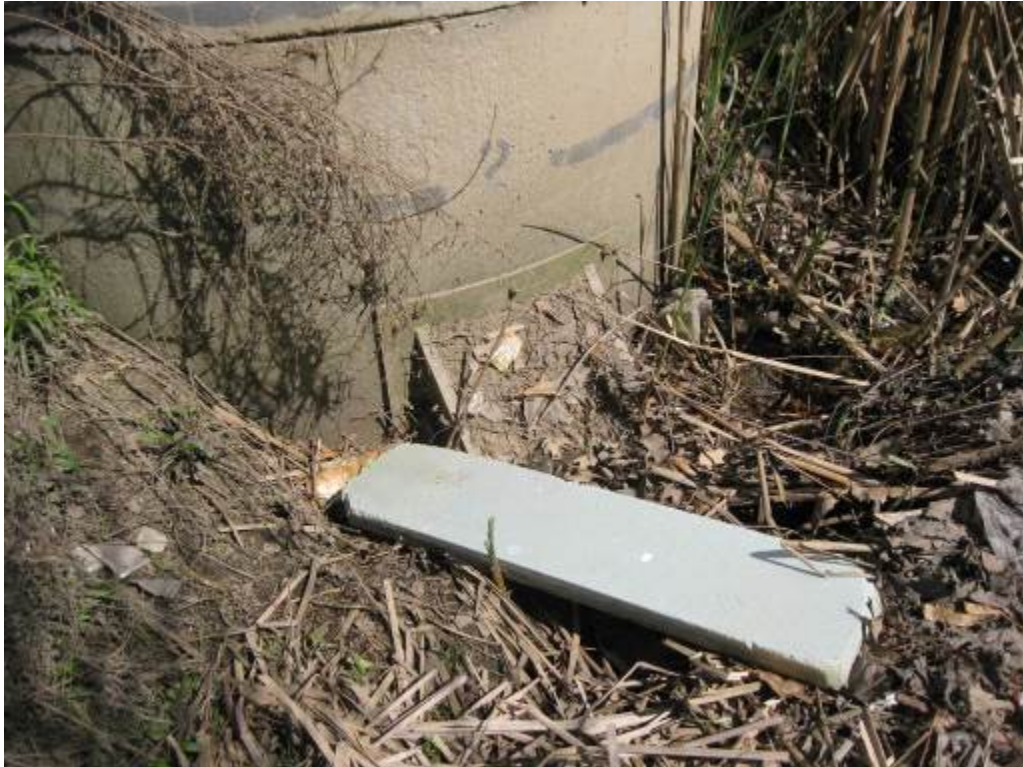
67. Facility 5400. Trash rack on low flow orifice was covered in sediment and debris, but was draining through riser structure.

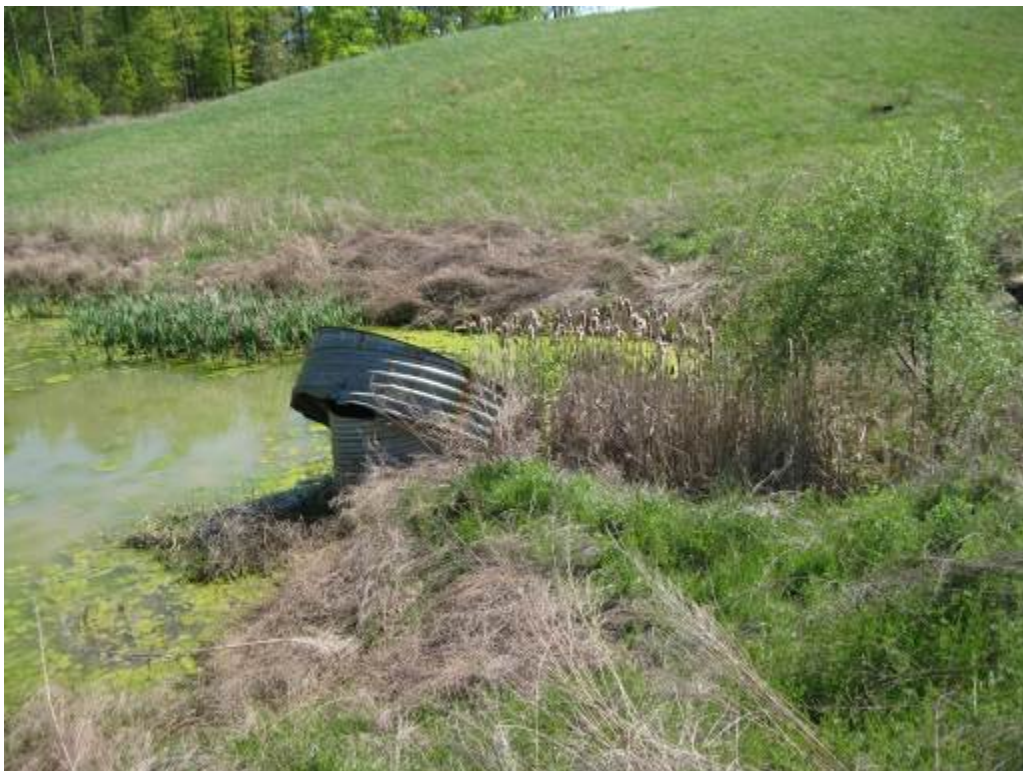
68. Facility 5400. This pond was not identified on the list, but is located immediately upstream of Facility 5400. The top of the riser was bent, and the perforations were sealed (indication facility is operating as a sediment basin).

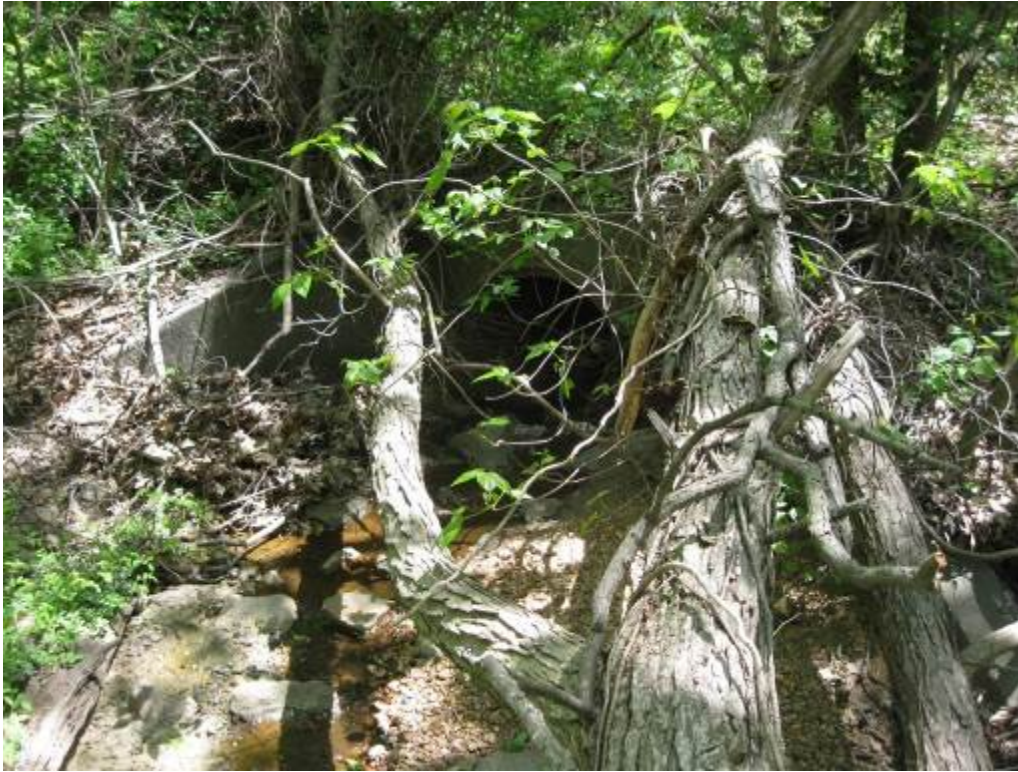
69. **Facility 5707.** This may not be a facility as there is no riser structure, and the outlet is a large culvert that runs under an existing dirt road.

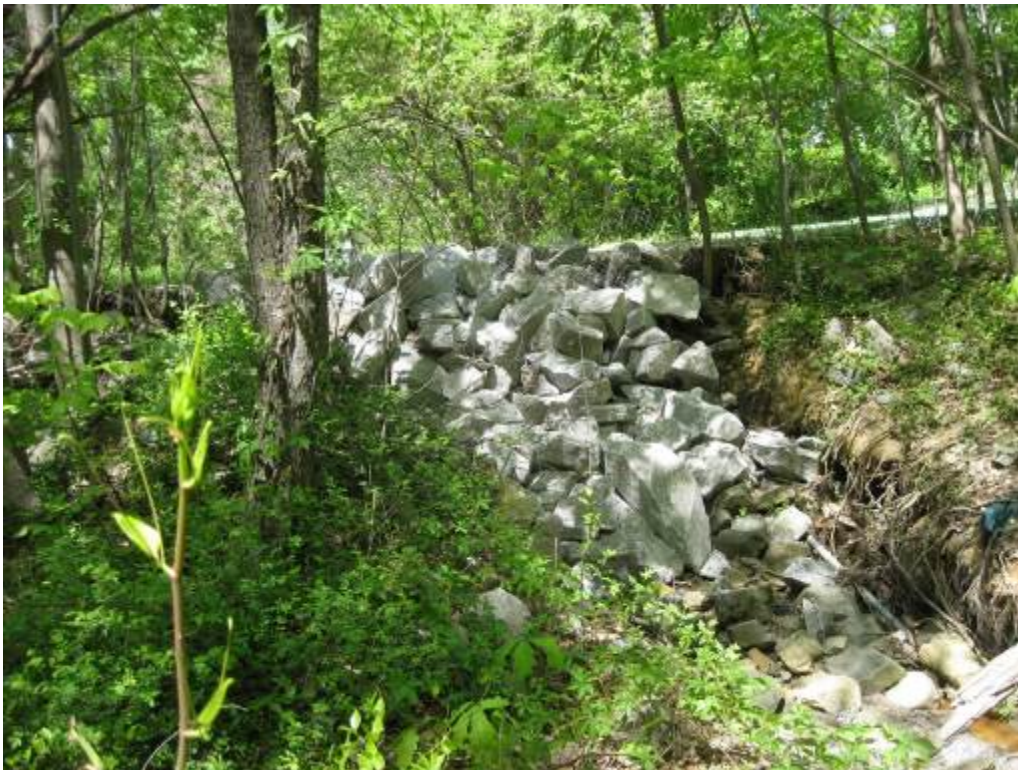
70. **Facility 5707.** Temporary repair of repair with riprap at dam and road failure immediately upstream of facility. Riprap is not flush with ground, and is impassable.

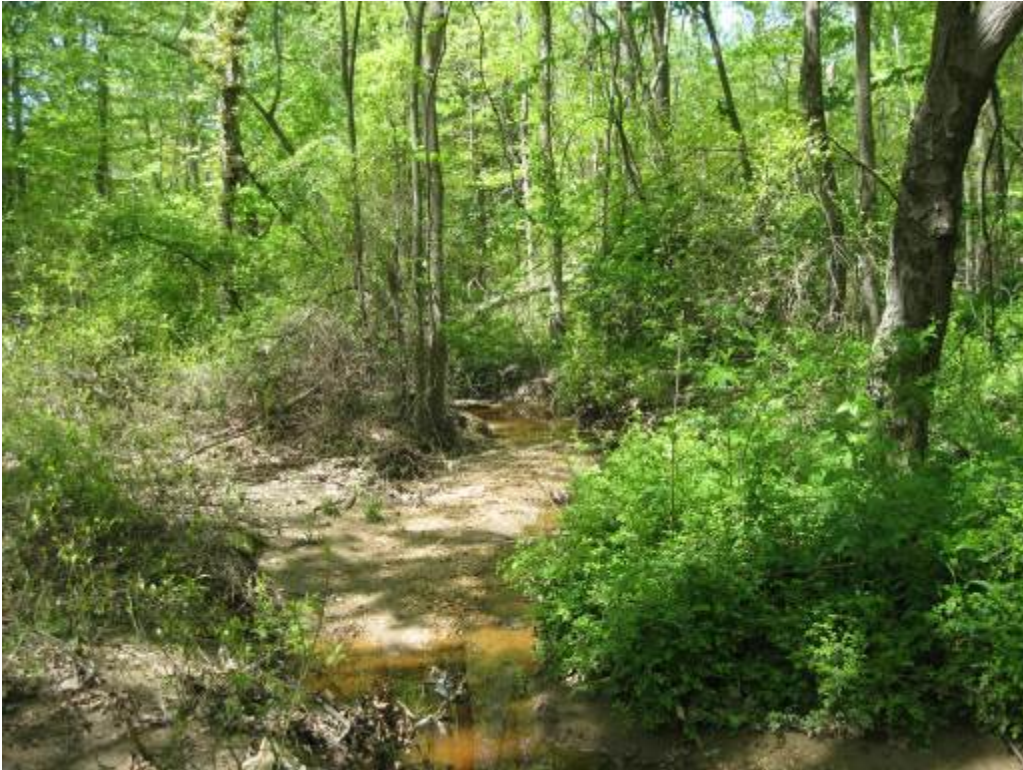
- 71. Facility 5707. Looking upstream at channel that runs through area identified as a facility. No signs of recent inundation in overbank areas.**
