APPENDIX A –REACH DESCRIPTIONS

Basin 615, South Fork of Quantico Creek - Project Reach Descriptions

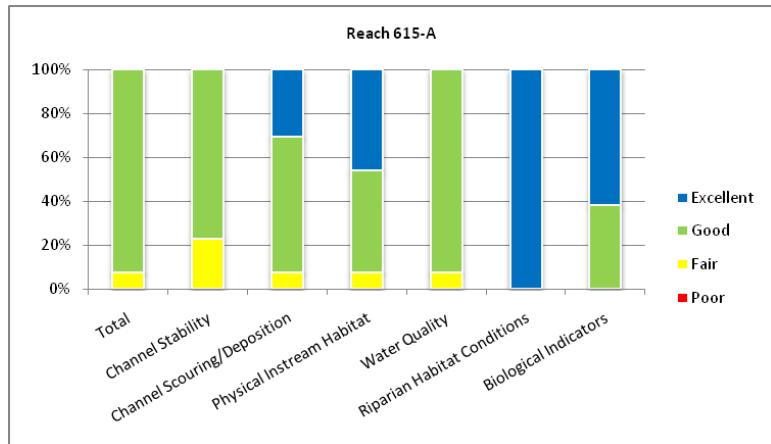
Reach Name: 615-A

Reach 615-A begins at a marked transition in channel morphology, from the steeply-sloped, bedrock and boulder dominated reaches located immediately upstream, to a gently meandering channel composed of predominantly gravel and cobble substrate. An average score of 6 points (based on thirteen sample locations) for channel stability, scouring/deposition, and physical in-stream habitat indicate a good quality stream that is

geomorphically stable. Approximately 80% of streambanks are stable, with only minor bank scouring, occurring opposite of gravel point bars. Approximately 25-49% of bed material is embedded gravel and cobble, with well-formed pools and riffles, and depositional point bars comprised of coarse gravel with minimal sand deposits.

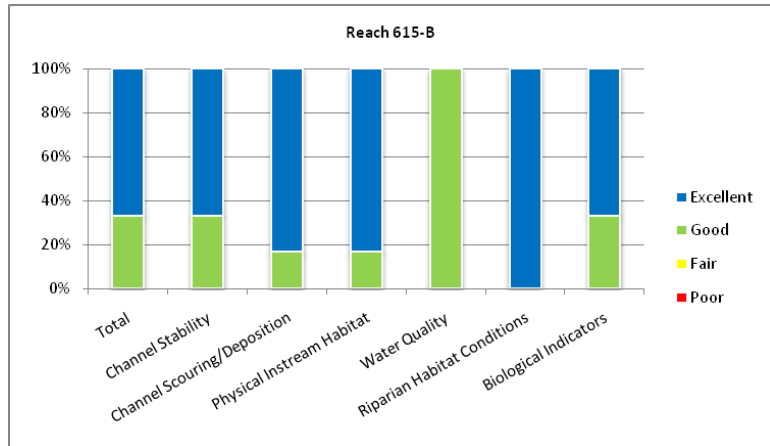
Reach Name: 615-B

Reach 615-B received the highest RSAT scoring of all the reaches included in the Quantico Creek Watershed Assessment, with an average total score of 43. Reach 615-B is characterized by stable, well-vegetated streambanks, a lack of bank sloughing or erosion, and highly resistant bed and bank materials, giving the reach an excellent channel stability rating. In addition, the boulder and cobble dominated stream provides a

varied depth and velocity regime, few depositional features, low embeddness of riffle material, and deep pools (providing refugia for fish and other aquatic organisms); all features that are representative of excellent scouring/deposition and physical instream habitat scores.

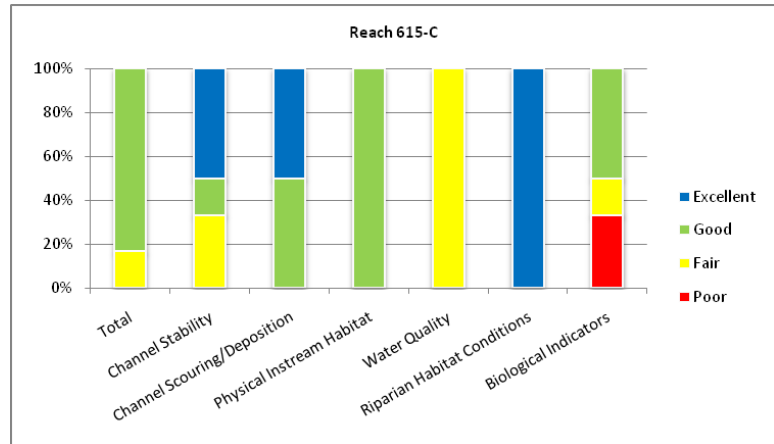
Reach Name: 615-C

Reach 615-C received an average total RSAT score of 33, indicating a good quality stream that is geomorphically stable. Overall, Reach 615-C has excellent channel stability, with approximately 80% of the streambanks stable, a general lack of bank sloughing or erosion, and highly resistant bed and bank materials. Channel scouring/deposition scores were good, with only 25-49% of the gravel and cobble bed material embedded,

well-formed pools and riffles, and depositional point bars comprised of coarse gravel with minimal sand deposits. Physical instream habitat was also good, with a varied velocity and depth regime, and a mix of riffles, runs, and pools.

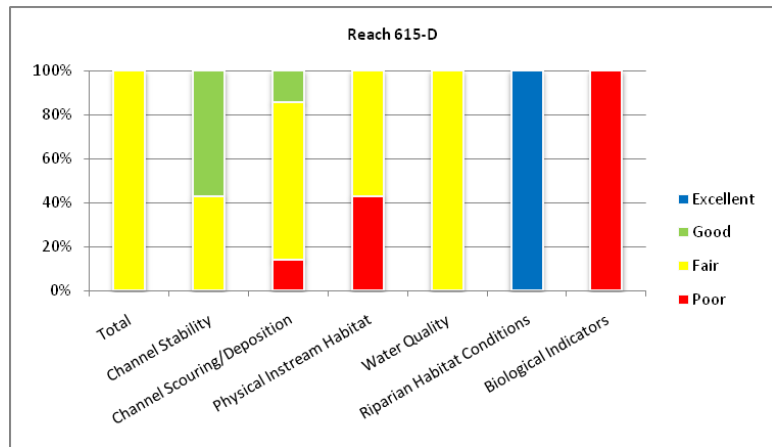
Reach Name: 615-D

Reach 615-D is a fair quality stream, with an average total RSAT score of 23. In general, Reach 615-D has good channel stability, with 71-80% of the streambanks stable, relatively little bank sloughing or erosion, and resistant bed and bank materials. Channel scouring/deposition and physical instream habitat scores were fair, with increased embeddness of riffle material, few deep pools and a shallow riffle and run dominated morphology.

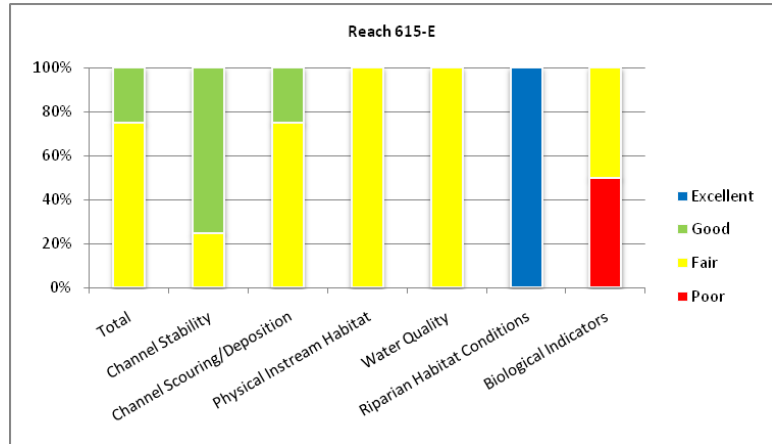
Reach Name: 615-E

Reach 615-E is a fair quality stream, with an average total RSAT score of 28. Reach 615-E has good channel stability, with 71-80% of the streambanks stable, relatively little bank sloughing or erosion, and resistant bed and bank materials. Channel scouring/deposition and physical instream habitat scores were fair, with increased embeddness of riffle material, few deep pools and a shallow riffle and run dominated morphology.

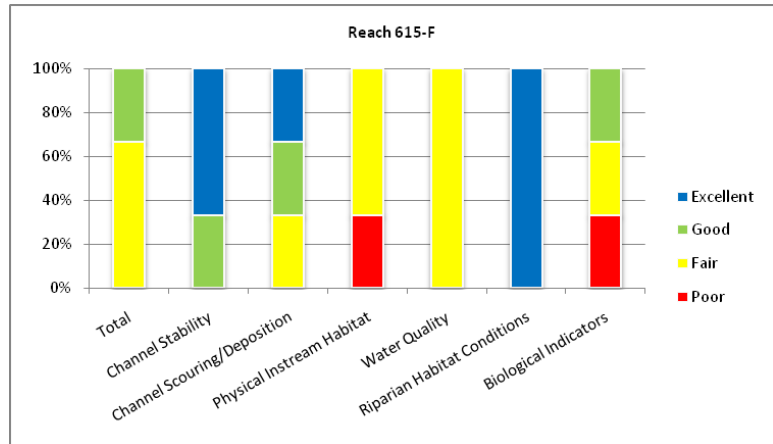
Reach Name: 615-F

Reach 615-F is a good quality stream, with an average total RSAT score of 30. Reach 615-F has good channel stability and scouring/deposition scores, due to stable streambanks, very little bank sloughing or erosion, and resistant bed and bank materials. Physical instream habitat scores were fair, with increased embeddness of riffle material, few deep pools and a shallow riffle and run dominated morphology.

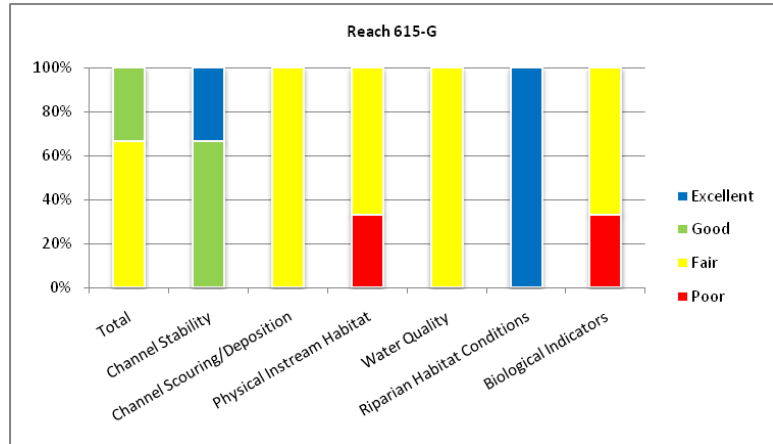
Reach Name: 615-G

Reach 615-G is a fair quality stream, with an average total RSAT score of 28. Reach 615-G has good channel stability, with stable streambanks, little bank sloughing or erosion, and resistant bed and bank materials. Channel scouring/deposition and physical instream habitat scores were fair, with increased embeddness of riffle material, few deep pools and a shallow riffle and run dominated morphology.

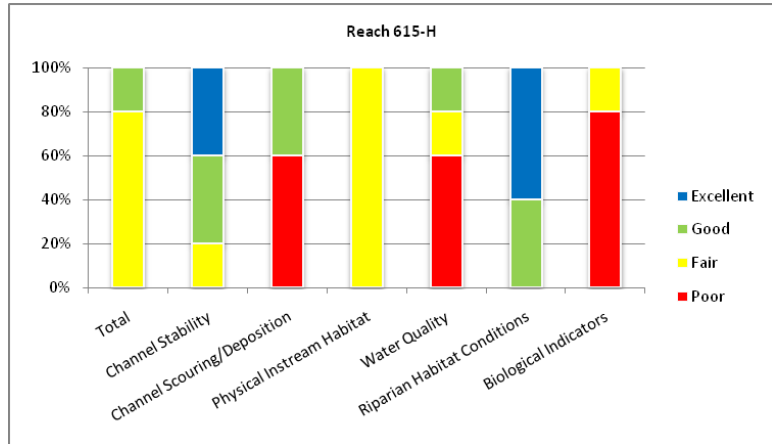
Reach Name: 615-H

Reach 615-H is a fair quality stream, with an average total RSAT score of 25. Reach 615-H has good channel stability, with 71-80% of the streambanks stable, relatively little bank sloughing or erosion, and resistant bed and bank materials. Channel scouring/deposition and physical instream habitat scores were fair, with increased embeddness of riffle material, few deep pools and a shallow riffle and run dominated morphology.

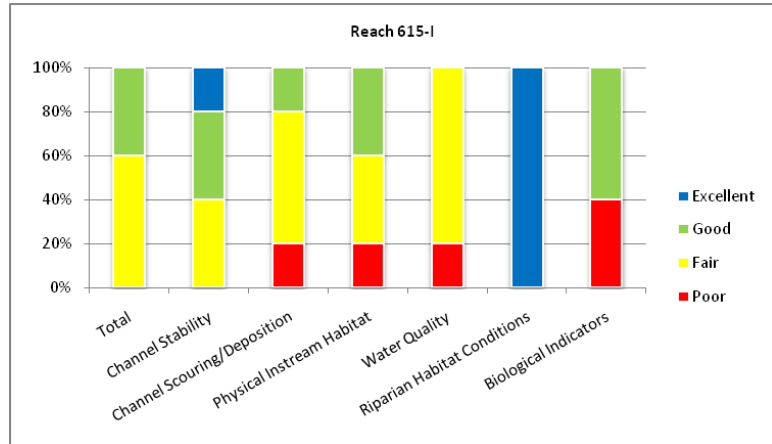
Reach Name: 615-I

Reach 615-I is a fair quality stream, with an average total RSAT score of 28. Reach 615-I has good channel stability, with stable streambanks, little bank sloughing or erosion, and resistant bed and bank materials. Channel scouring/deposition and physical instream habitat scores were fair, with increased embeddness of riffle material, few deep pools and a shallow riffle and run dominated morphology.

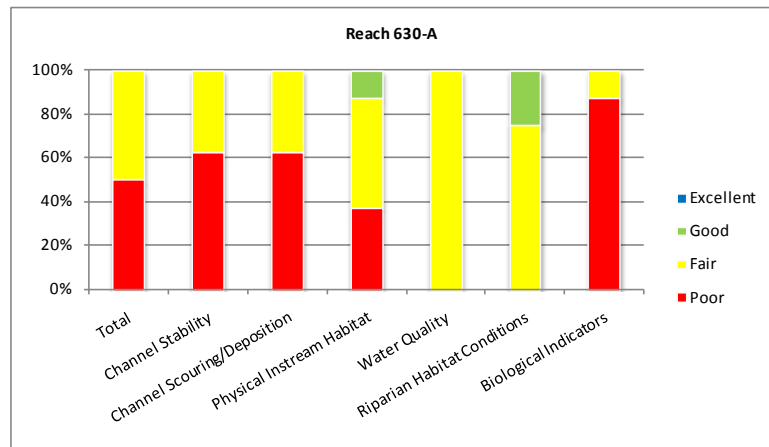
Reach Name: 630-A

Reach 630-A is an example of a poor quality stream, with an average total RSAT score of only 15. The low score is due mainly to widespread, systemic channel erosion, coupled with large amounts of sand and sediment deposition, and no available biological indicators. Channel stability along Reach 630-A had an average score of 2, with more than 50% of the streambanks experiencing sloughing or scour,

undercut streambanks, and frequent tree falls, with streambanks consisting of highly erodible, sandy soils. Bank erosion is particularly severe on the outside of bends, in areas where riparian vegetation is sparse, and alongside freshly deposited sand bars. Channel scouring/deposition and physical instream habitat scores were fair, with an increasing number of depositional features, nearly 75% embeddness of riffle material, few pools (most appeared to have been filled in with sediment).

- Channel incision and widening along the lower portion of the basin, from Tulip Tree Place to Possum Point Road, has resulted in widespread, systemic bank erosion.
 - Removal of the riparian forest, encroachment on the stream corridor, and dumping of debris has left streambanks susceptible to overbank runoff, gully erosion and localized bank erosion, behind Skip's Auto Parts at the intersection of Jefferson Davis Highway and Old Stage Coach Road.

- Sediment and debris (resulting from channel erosion upstream) has been deposited at the Possum Point Road culvert, severely restricting flow, reducing flood capacity, and posing a risk to public safety and infrastructure.

- Restore more than 4300ft of stream, from Tulip Tree Place to Possum Point Road, using fabric and plant bank treatment with live fascines or brush mattress to provide immediate vegetative cover, and up to 14 rock riffles for permanent grade stabilization.

- Remove debris and rubble from the streambanks behind Skip's Auto Parts (at the intersection of Jefferson Davis Highway and Old Stage Coach Road) and restore the riparian buffer zone with seed, straw and container plants (at a planting density of up to 1200 stems/acre) along 250 linear feet of channel. Establish a conservation easement, or permanent deed restriction area, to protect the buffer zone to a minimum of 100ft from the channel.

- Repair or retrofit the culvert at Possum Point Road with up to 4 rock weirs or wing deflectors and a floating trash rack to focus the flow, enhance sediment transport, trap woody debris, and prevent siltation of the culverts.

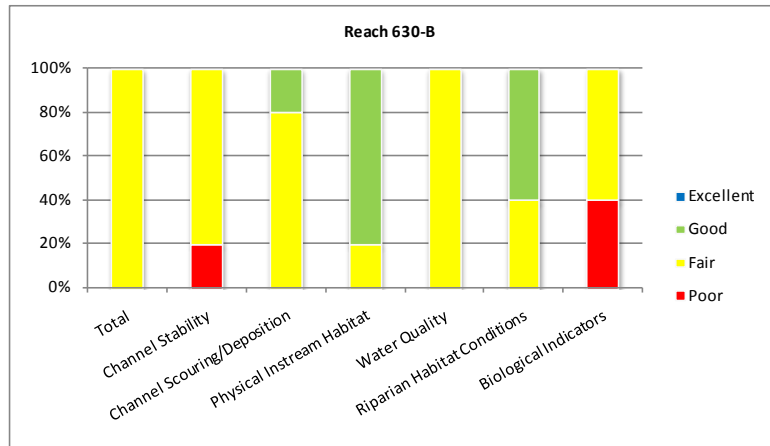
Reach Name: 630-B

Reach 630-B is a fair quality stream, with an average total RSAT score of 22. Channel widening is responsible for low channel stability scores (with an average value of 4) and widespread bank erosion along approximately 50% of the reach. Channel scouring/deposition scores were fair, with increased deposition of sand and sediment and increased embeddness of riffle material. Physical instream habitat was in good condition, despite systemic erosion and subsequent deposition downstream. A good mix of riffles, runs and pools is present, along with a heterogeneous mix of bed materials, consisting of cobbles, gravel, sand and sediment.

- Channel incision and widening has resulted in systemic streambank erosion, downstream from Jefferson Davis Highway to the upstream end of Reach 630-A.
 - A large woody debris jam, approximately 100 feet downstream from Jefferson Davis Highway, has resulted in localized bank erosion, which threatens to undermine an existing utility pole on the left descending (north) bank.
 - Channel incision along an unnamed tributary, south of Wayside Drive and west of Mountain Laurel Loop, has undermined an existing concrete pipe outfall and headwall along the left descending bank, creating a vertical drop of more than 8 feet.

- Restore more than 2300ft of stream, from Jefferson Davis Highway to Tulip Tree Place, using fabric and plant bank treatment with rock toe to stabilize eroding streambanks, and up to 6 rock riffles for permanent grade stabilization.
 - Relocate an undermined utility pole along the left descending (north) bank, remove a large woody debris jam, and restore approximately 100 feet of eroded streambank downstream from Jefferson Davis Highway.
 - Stabilize 200ft of tributary, south of Wayside Drive and west of Mountain Laurel Loop, using fabric and plant bank treatment with rock toe, and replace the undermined pipe outfall and headwall.

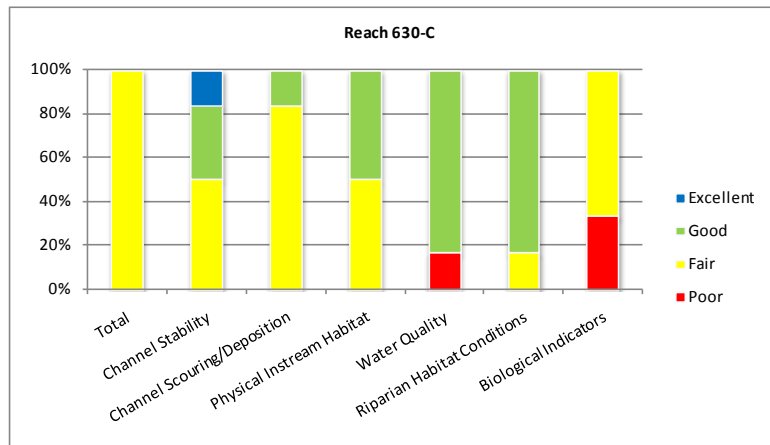
Reach Name: 630-C

Reach 630-C is a fair quality stream, with an average total RSAT score of 26. Reach 630-C has good channel stability, with relatively stable streambanks, little bank sloughing or erosion, and resistant bed and bank materials. Channel scouring/deposition scores were fair, with increased deposition of sand and sediment and increased embeddness of riffle material. Physical instream habitat was in good condition, with a mix of riffles, runs and deep pools present, along with a heterogeneous mix of bed materials, consisting of cobbles, gravel, sand and sediment.

- Localized bank erosion and subsequent deposition of coarse gravel and sediments threaten adjacent properties between Interstate I-95 and Jefferson Davis Highway.
 - Streambank erosion is particularly severe in the vicinity of the apartment/condominium complex at Briarwood and Interstate Drives.
 - Removal of riparian vegetation and loss of associated root mass has left the streambank vulnerable to continued erosion and mass wasting, along a temporary access road on the right descending bank, downstream of Interstate Drive to Dry Powder Circle.

- Enhance nearly 3800ft of degraded stream, from Interstate 1-95 to Jefferson Davis Highway, using fabric and plant bank treatment and up to 12 rock weirs or wing deflectors to reduce bank scouring.

- Restore the riparian buffer zone with seed, straw and container plants (at a planting density of up to 1200 stems/acre) along 1000 linear feet of channel, downstream of Interstate Drive to Dry Powder Circle. Establish a conservation easement, or permanent deed restriction area, to protect the buffer zone to a minimum of 100ft from the channel.

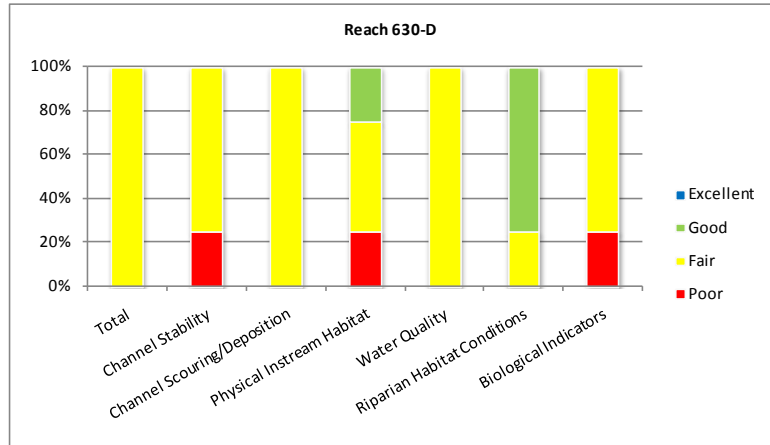
Reach Name: 630-D

Reach 630-D is a fair quality stream, with an average total RSAT score of 21. Channel incision and widening is responsible for low channel stability scores and bed and bank erosion along nearly 50% of the reach. Channel scouring/deposition and physical instream habitat scores were fair, with an increase in deposition, increased embeddness of riffle material, and a low number of deep pools.

- Channel incision and widening has resulted in systemic streambank erosion, and exposure of a previously buried sewer line parallel to the stream, south of Four Seasons Drive to the culvert at Interstate I-95.
 - Illegal dumping of concrete rubble, tires and other debris (via an access road from Old Stage Road) has created and impoundment in the channel, interfering with the flow of water and sediment.

- Realign and restore more than 2800ft of stream channel, along the sewer line south of Four Seasons Drive to the culvert at Interstate I-95, using fabric and plant bank treatment with rock toe to stabilize eroding streambanks, and up to 7 rock riffles for permanent grade stabilization.
 - Remove dumped rubble, tires and other debris, creating an impoundment near the access road from Old Stage Road, prior to restoration.

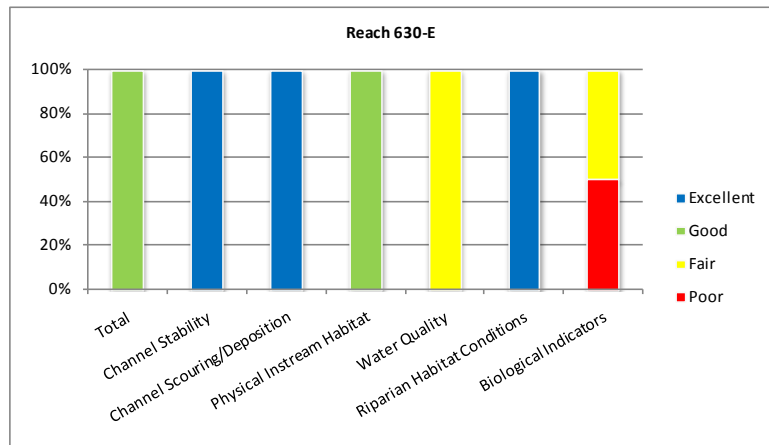
Reach Name: 630-E

Reach 630-E is a good quality stream, with an average total RSAT score of 36. Reach 630-E has excellent channel stability and scouring/deposition scores, due to stable streambanks, few signs of bank sloughing or erosion, and resistant bed and bank materials. Physical instream habitat scores are good, with a mix of riffle, run and pool habitat, and a varied velocity and depth regime.

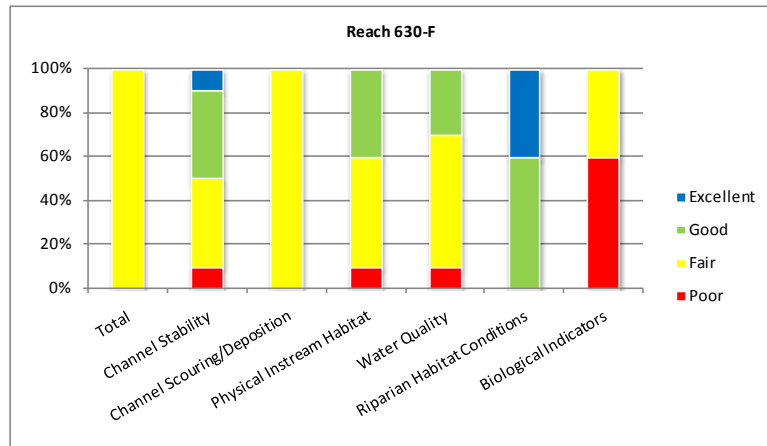
Reach Name: 630-F

Reach 630-F is a fair quality stream, with an average total RSAT score of 24. Channel incision is responsible for low channel stability scores and bed and bank erosion along nearly 50% of the reach. Channel scouring/deposition and physical instream habitat scores were fair, with an increase in deposition, increased embeddness of riffle material, and few deep pools.

- Moderate channel incision has been slowed by woody debris jams (that act as natural *de facto* grade control) and bank stabilization provided by a wide riparian forest buffer, from the upstream end of the reach at Telescope Lane, to the confluence with Reach 630-C near Dry Powder Circle.

- Purchase, preserve and monitor the existing riparian corridor with a permanent deed restriction or conservation easement, along more than 5300ft of stream, from the upstream end of the reach at Telescope Lane, to the confluence with Reach 630-C near Dry Powder Circle.

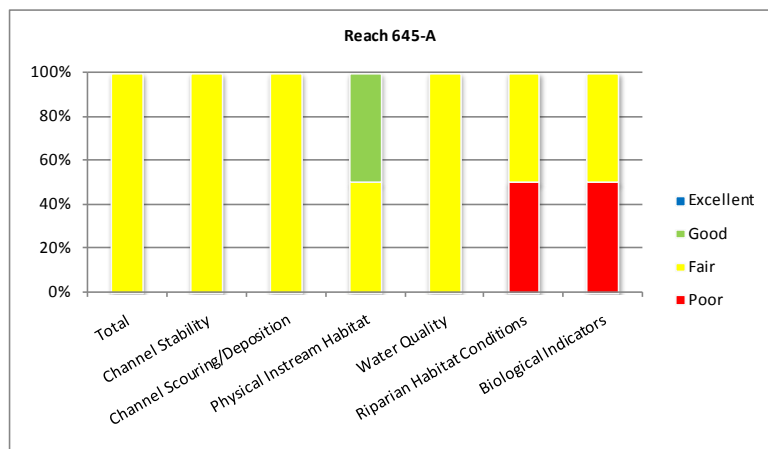
Reach Name: 645-A

Reach 645-A is a fair quality stream, with an average total score of 18. Channel stability scores along this reach are influenced significantly by localized bank erosion, with approximately 50-70% of the streambanks experiencing sloughing or scour. Bank erosion is particularly severe near Creek Road, where residential development has encroached on the stream corridor and riparian vegetation has been removed.

- Removal of riparian forest and encroachment on the stream corridor has prompted localized bank erosion and mass wasting from Creek Road to the parking lot at First Assembly of God Church.

- Enhance approximately 950ft of degraded stream, from Creek Road to the parking lot at First Assembly of God Church, using fabric and plant bank treatment and up to 3 rock weirs or wing deflectors to reduce bank scouring.

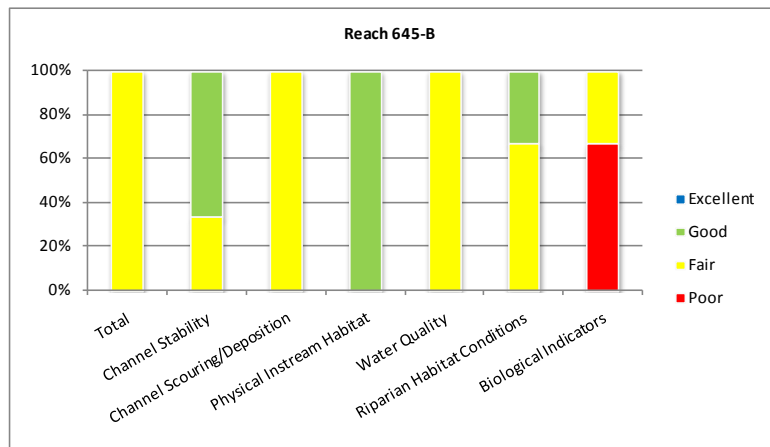
Reach Name: 645-B

Reach 645-B is a fair quality stream, with an average total score of 22. Channel stability scores along this reach are influenced significantly by localized bank erosion and channel widening, with approximately 50% of the streambanks experiencing sloughing or scour. Bank erosion is particularly severe along the lower portion of this reach, approaching Creek Road, where residential development has encroached on

the stream corridor and riparian vegetation has been removed. Channel scouring/deposition and scores were fair, with an increasing number of depositional features and increased embeddness of riffle material. Physical instream habitat scores are good, with a mix of riffle, run and pool habitat, and a varied velocity and depth regime.

- Removal of riparian forest and encroachment on the stream corridor continues upstream of Creek Road, to the culvert at Interstate I-95, accelerating localized streambank erosion.

- Enhance nearly 1300ft of degraded stream, upstream from Creek Road to the culvert at Interstate I-95, using fabric and plant bank treatment and up to 4 rock weirs or wing deflectors.

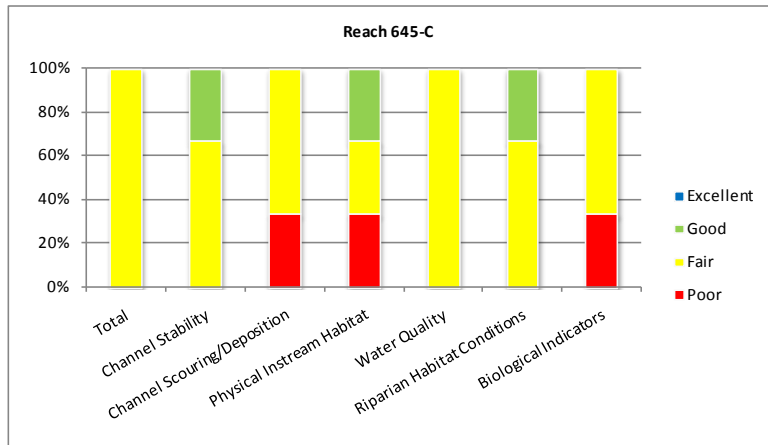
Reach Name: 645-C

Reach 645-C is a fair quality stream, with an average total score of 19. Reach 645-C has fair channel stability, with approximately 50% stable streambanks, and scour concentrated on the outside bends of the stream. Channel scouring/deposition and physical instream habitat scores were fair, with an increasing number of depositional features, increased embeddness of riffle material, and few deep pools.

- Removal of riparian forest, followed by mowing to the top of the streambank, has left the channel susceptible to localized bank erosion and prompted mass wasting, upstream from Interstate I-95 to Williams Road.

- Enhance approximately 1500ft of degraded stream, upstream from Interstate I-95 to Williams Road, using fabric and plant bank treatment and up to 5 rock weirs or wing deflectors.

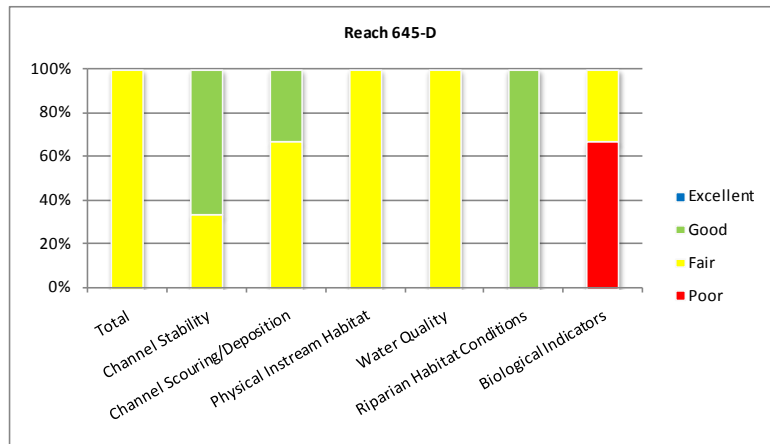
Reach Name: 645-D

Reach 645-D is a fair quality stream, with an average total RSAT score of 24. Reach 645-D has good channel stability, with relatively stable streambanks, little bank sloughing or erosion, and resistant bed and bank materials. Channel scouring/deposition and physical instream habitat scores were fair, with an increasing number of depositional features, increased embeddness of riffle material, and few deep pools.

- Moderate channel incision has been slowed by woody debris jams and bank stabilization provided by the existing riparian forest, from Park Entrance Road to Williams Road.

- Purchase, preserve and monitor the existing riparian corridor with a permanent deed restriction or conservation easement, along nearly 1300ft of stream, from Park Entrance Road to Williams Road.
