# Appendix E

## Stream Restoration Opportunity

# Neabsco Creek Watershed Study

## Stream Restoration Project Opportunity

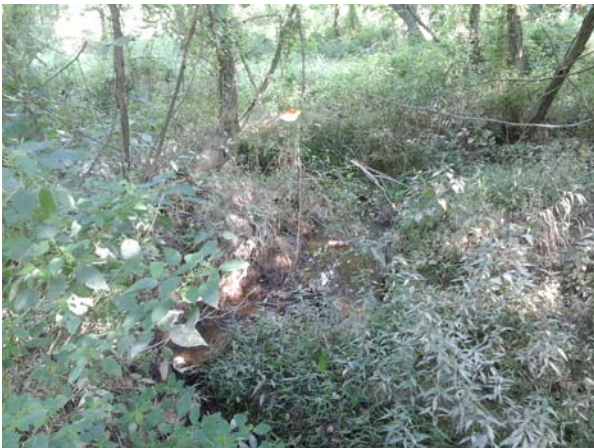
The candidate stream restoration encompasses approximately 1,600 feet of the mainstem of Neabsco Creek, running generally between Trident Lane and Tapestry Drive (excluding wetlands), and upstream of the culvert under Dale Boulevard. In general, the reach is severely downcut, exposing near vertical banks. Restoration of the reach would remedy severely eroded and incised areas and reconnect the stream with the local floodplain.

Downcut section of stream in potential restoration project

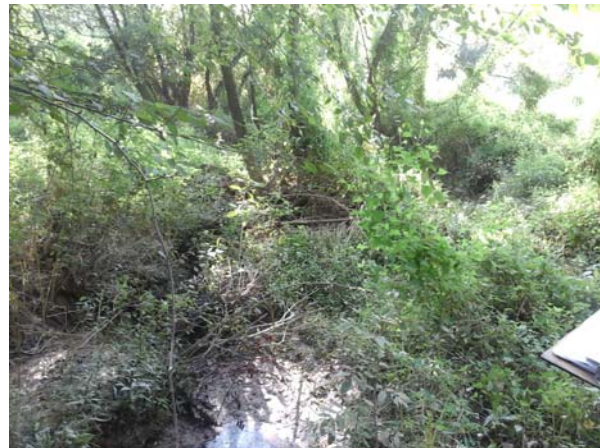
Impacted stream in overgrown area

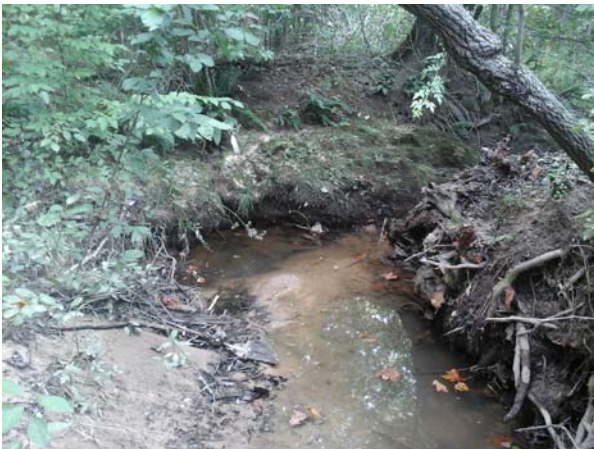
This candidate reach, a tributary of Neabsco Creek, encompasses approximately 1,220 feet of impacted stream. It begins on the downstream side of a crossing under Hoadly Rd. and ends at a culvert under Trentdale Dr., just upstream of the confluence with Neabsco Creek. The stream is in an upland area, consisting mainly of downcut channel with low aggradation.

Eroded area of stream channel

Restoration is recommended to correct stream instability and re-establish standard stream features. Restoration will control erosion and reconnect the stream with the surrounding floodplain.

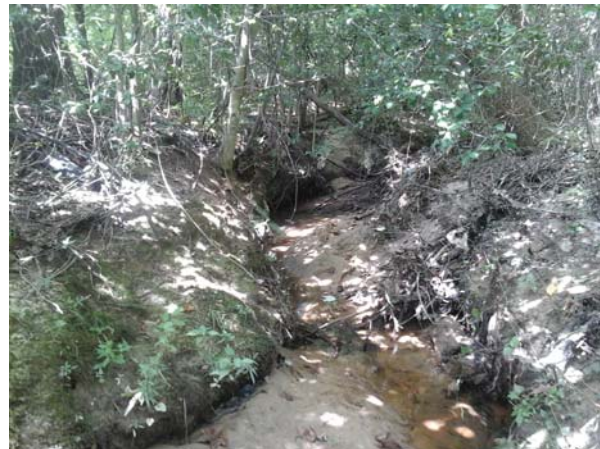
Stream channel showing aggradation

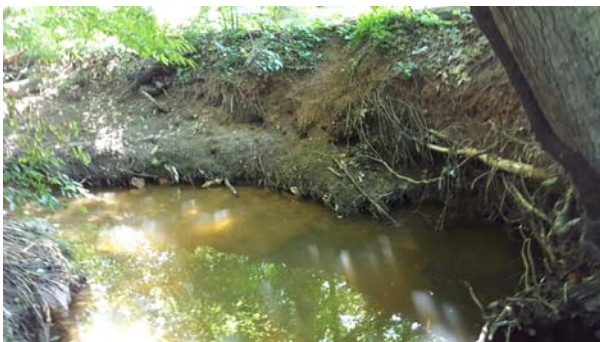
This impacted drainage channel originates at an outfall at the intersection of Karen Rd. and Delaney Rd. The total impacted length is approximately 2,600 feet, however, the most severely impacted area is immediately downstream of the outfall between residences along Kirkdale Dr. and Kurtz Rd. The stream channel in this area is unstable with no healthy stream features apparent. The damage to the channel is readily apparent from lack of habitat structure and deposition of urban trash. The stream bed has downcut, exposing a sanitary sewer line. The downstream half of the channel enters the floodplain of Hoadly Run and is less impacted.

Upstream portion of reach near residences showing severe erosion

Restoration of the reach would involve raising the stream bed to protect buried sanitary sewer infrastructure. Upstream remedies would include repairs to the existing stream channel to correct the effects of chronic erosion. Upstream restoration should also include consideration of new practices in the neighborhood to manage stormwater prior to entry into the storm sewer system.

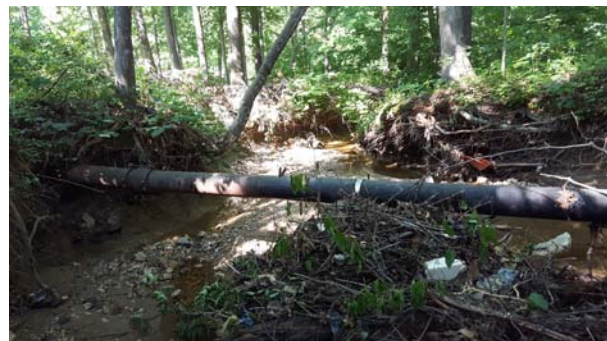
Downstream portion of reach showing exposed sanitary sewer line

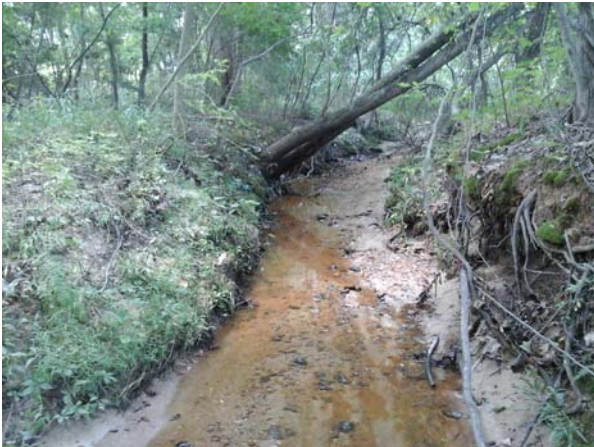
The candidate restoration reach consists of approximately 2,500 feet of degraded stream extending from downstream of the Oaklawn Lane crossing to near Trident Lane and bisected by Dale Boulevard. The reach conditions alternate between areas of active downcutting and downstream deposition of sediment, indicating adverse impacts to the stream due to development. The overall erosion condition was rated high.

Eroded area of stream channel

Restoration remedies would correct stream instability brought about by migrating headcuts, erosion, and deposition, and reintroduce a more natural morphology. Restoration should be coupled with construction of new stormwater controls in the headwaters areas in the neighborhoods.

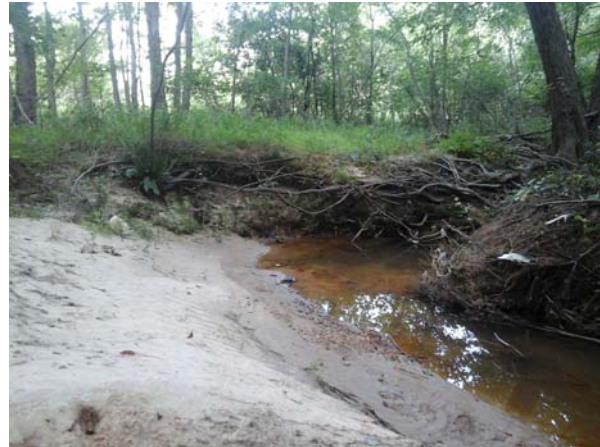
Eroded outer bank of stream channel,  
exposing root systems

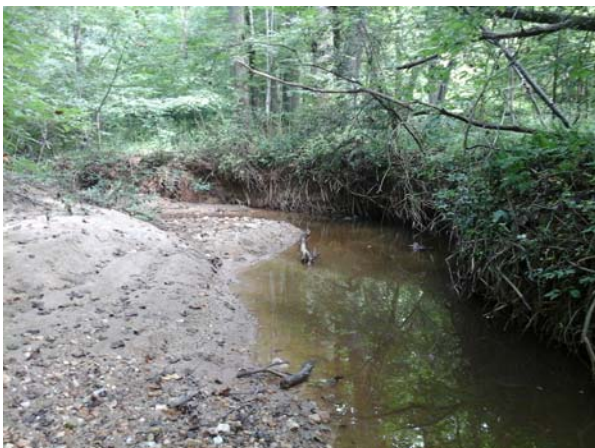
The potential restoration reach, encompassing approximately 1,500 feet, receives drainage from Beville Middle School and surrounding residential communities. In this reach, the banks are sandy and highly erosive. Little vegetation is present on the banks and the banks will consequently continue to erode. Investigators noted that sediment that is transporting out of this reach is accumulating in a major dry pond facility to the west of Delaney Road and situated in a transmission line right of way. There are three outfall channels in this reach near the school (one on the east, just north of Lockwood Ln, another on the west towards Langley Ct, and the last to the southwest near Linsey Ct), that should be stabilized in addition to the main stem reach.

Impacted stream reach showing undercut bank

Stream restoration would address the effects of stream instability caused by uncontrolled storm runoff. Restoration would halt the effects of stream widening and erosion, reduce sediment transport, and improve instream habitat.

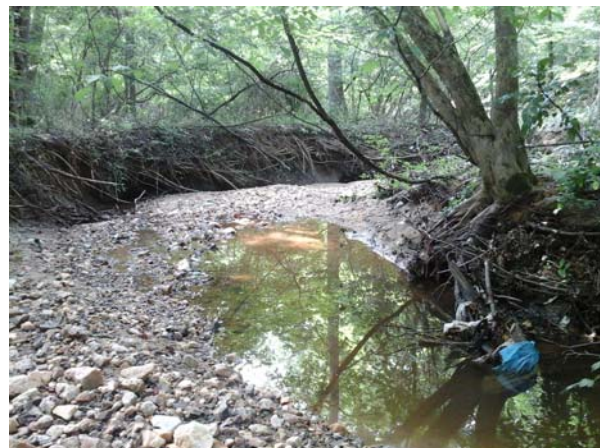
Impacted stream with gravel and cobble deposit

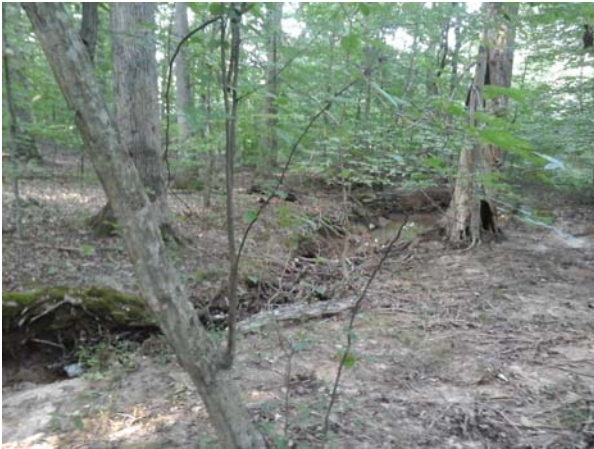
Presently, the channel does not have recognizable stream features and is undergoing active erosion. The restoration of the channel, coupled with new BMP recommendations within Logan Park as described elsewhere in this report, would reduce the progression of erosion.

Downcut section of candidate restoration reach

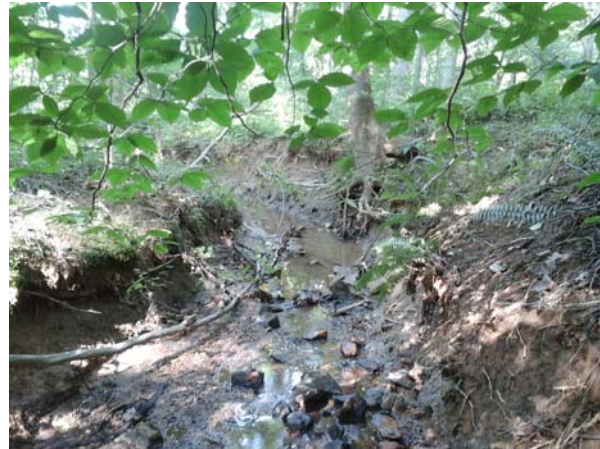
Unstable section of reach showing active erosion

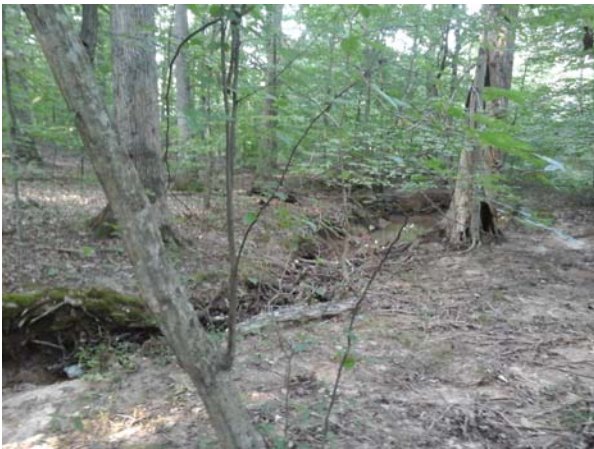
Field investigators noted that erosion is in its early stages and could continue if not addressed. Restoration would reconnect the stream to its local floodplain and arrest erosion. A new BMP, described elsewhere in this report, is recommended for installation at the end of Baneberry Circle and would reduce stormwater volume input to the channel.

Impacted reach, showing downcutting in upland area

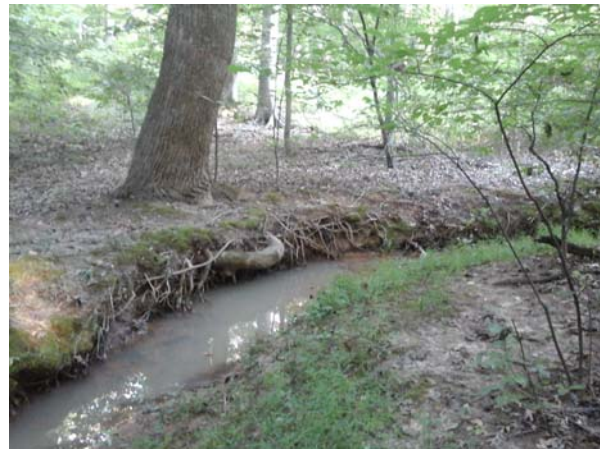
Reach showing downcutting and exposed root systems

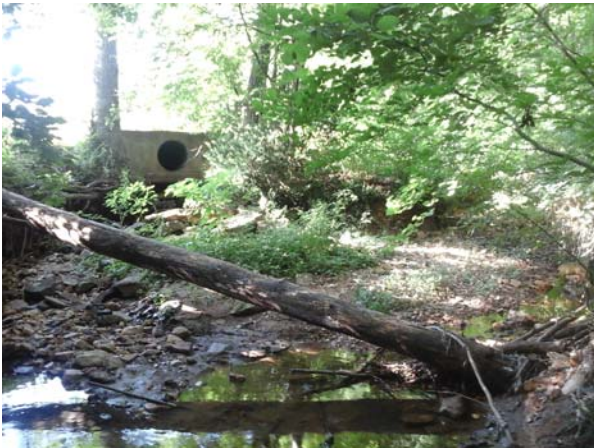
The area to be potentially restored is an approximately 740-foot reach downstream of an existing dry pond facility at the end of Golden Court. The erosion condition is moderately high overall. The concrete apron at an upstream outfall has been eroded out and undercut.

Impacted area downstream of outfall

At present, the channel has been straightened to perform as a stormwater runoff conduit. Recommended for inclusion in the stream restoration is the introduction of bends to increase the flow path and reduce the energy of storm flows. Though the upstream dry detention facility is not recommended for conversion in this report, conversion of the facility along with restoration would provide additional improvement along the entire stream reach and better control storm flows.

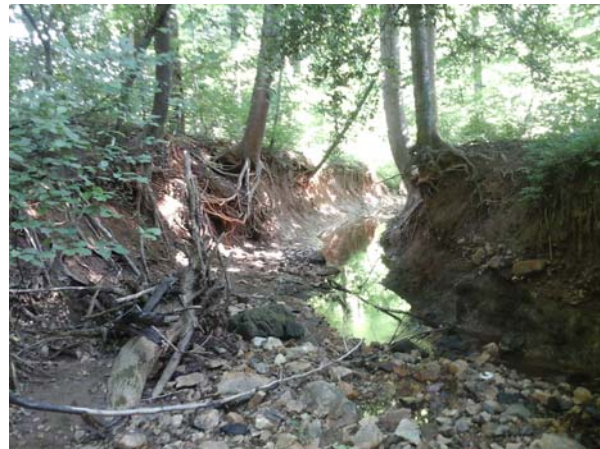
Section of stream showing damage to both banks

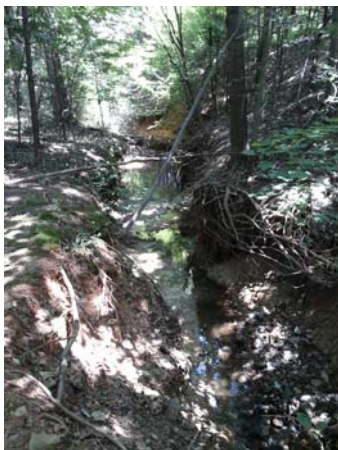
This impacted reach is approximately 940 feet long and is located between residences on Reardon Lane and a transmission line right of way. Portions of the channel are armored with concrete and rip rap, but ongoing channel erosion is evident.

Reach undergoing downcutting

Restoration of the reach would improve natural stream function and reduce transmission of erosive energy to points downstream. The restoration could also potentially remove a stand of kudzu.

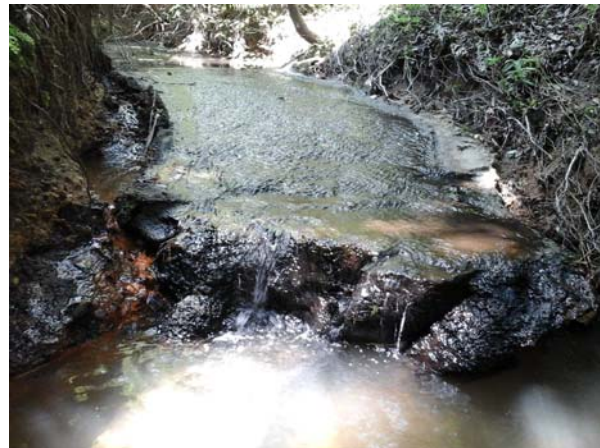
Restoration opportunity showing concrete stream bottom

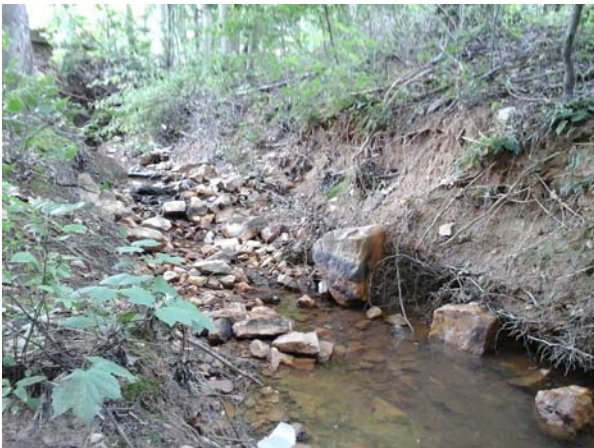
The candidate reach flows ~1,700 feet between Quate Ln and Keystone Rd and is downstream of new housing development. Stormwater outfalls within the reach were not significantly eroded but could be potential pollution hotspots. Several areas with depleted buffers and one area with dead mature trees. Channel was downcutting and widening. Debris removal and tree planting would go a long way toward improving this reach is construction is infeasible.

Exposed and eroded bank

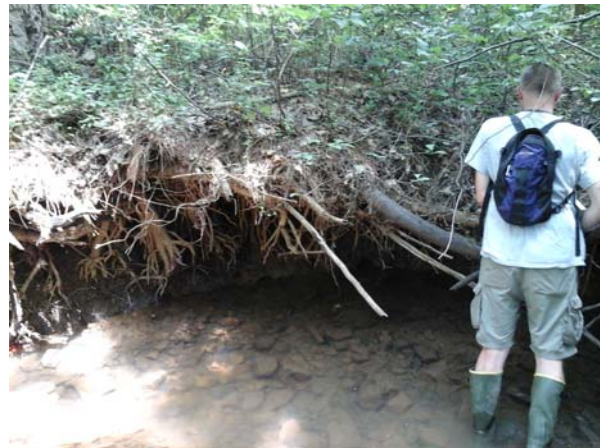
Stream channel widening and downcutting

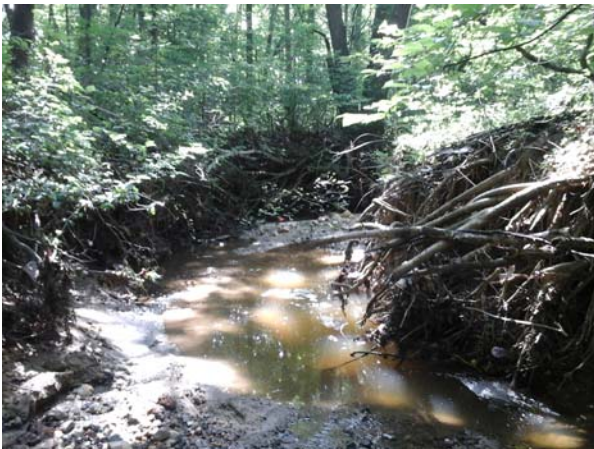
This approximately 1,100-foot reach is upstream of Beville Middle School and downstream of Dale Boulevard. Just downstream of the culvert under Dale Boulevard, the riprap armoring of the plunge pool has been eroded and is washing downstream. Overall, the reach shows moderate erosion; however, the stream is actively widening. Downstream of the culvert, the stream channel alternates between eroded and aggraded sections, showing a highly dynamic system affected by uncontrolled stormwater runoff.

Area of moderate erosion along reach

The reintroduction of a stable, more natural stream system can be accomplished through restoration measures. Restoration will reconnect the stream to the surrounding floodplain and reduce scour and re-deposition within the degraded channel.

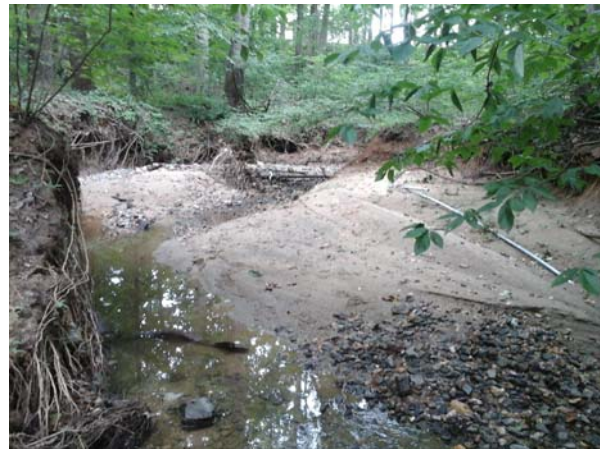
Area of aggradation along reach

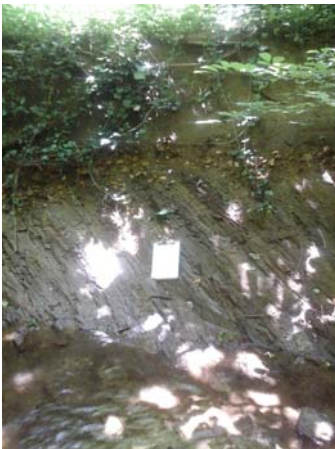
The candidate restoration reach consists of 1,340 feet of degraded stream that runs generally parallel between Gilbert Road and Granby Road. The overall erosion condition is moderately high; however, locally the channel is severely degraded, with some eroded banks as high as eight feet. The stream bed is mostly exposed bedrock. Sanitary sewer lines are exposed in the channel, but are armored.

Exposed and bare bank

A restoration project in this area would reverse the long-term effects of erosion, introduce a more natural stream system, and potentially reinforce the stream banks. Since the stream degradation is severe and especially evident, the introduction of stormwater controls at the neighborhood level is recommended.

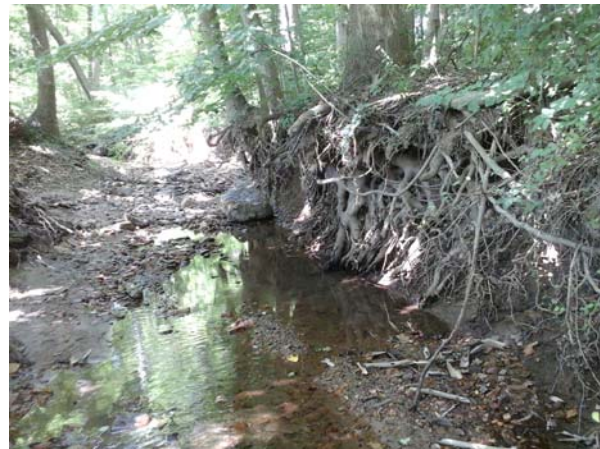
Exposed root systems in widening stream channel

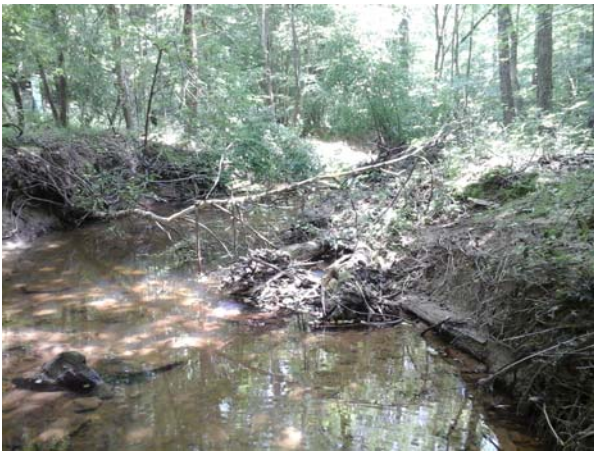
This degraded stream reach is located upstream of Pearson Drive and the confluence of Neabsco Creek. The overall length is approximately 1,400 feet and is moderately eroded with steep banks. The stream has downcut and is no longer connected to the floodplain.

Eroding section of reach

Among other benefits, a stream restoration project would reconnect this stream with the surrounding floodplain and thereby reduce the potential for down-cutting and scour caused by high-volume storm flows.

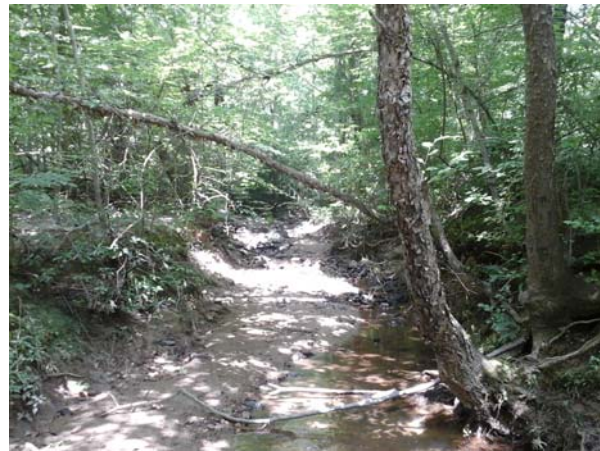
Widened and downcut section of reach

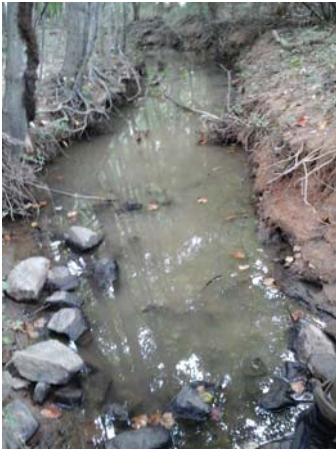
Investigators identified this approximately 410-foot channel that is undergoing active erosion. The area in question is located near the end of Surrydale Drive and downstream of a dry pond facility. Investigators noted deep downcutting downstream of the culvert that drains the dry pond.

Downcut channel with exposed roots and bare bank

Stream restoration will address downcutting and instability within the channel, reconnect it with the surrounding floodplain, and reduce sediment transport. Conversion of the upstream dry pond facility described elsewhere in this report (BCON 107) will provide additional water quantity control in the receiving channel.

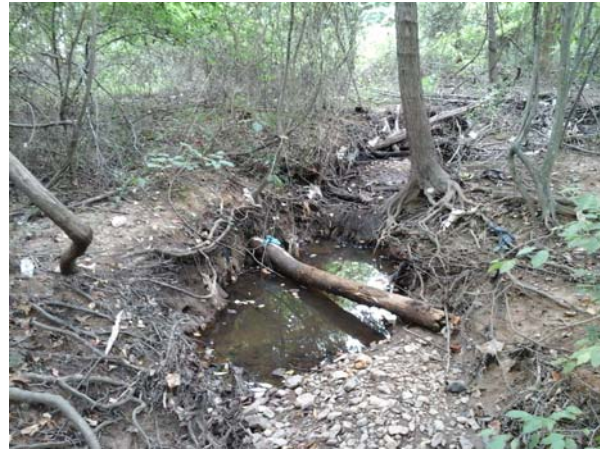
Damaged channel showing aggradation, erosion, and debris

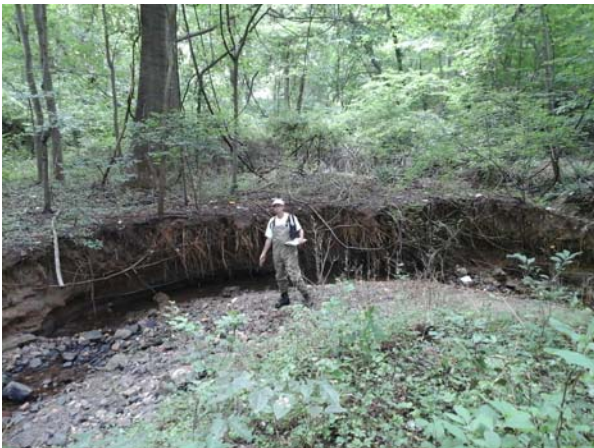
The degraded area of this stream consists of a tributary of Neabsco Creek that generally runs parallel to Delaney Road and is downstream of Beville Middle School. Along the 360-foot reach, banks are moderately eroded to a depth of four feet. A portion of this reach flows within a concrete channel.

Outside bank erosion in reach
