Appendix D

Tributary to Broad Run (250) Subwatershed Project Conceptual Design Narratives

Project: Agricultural Headwater Wetland / Stream Protection

Project: Rocky Branch 250-3 Pond Restoration / Stream Enhancement

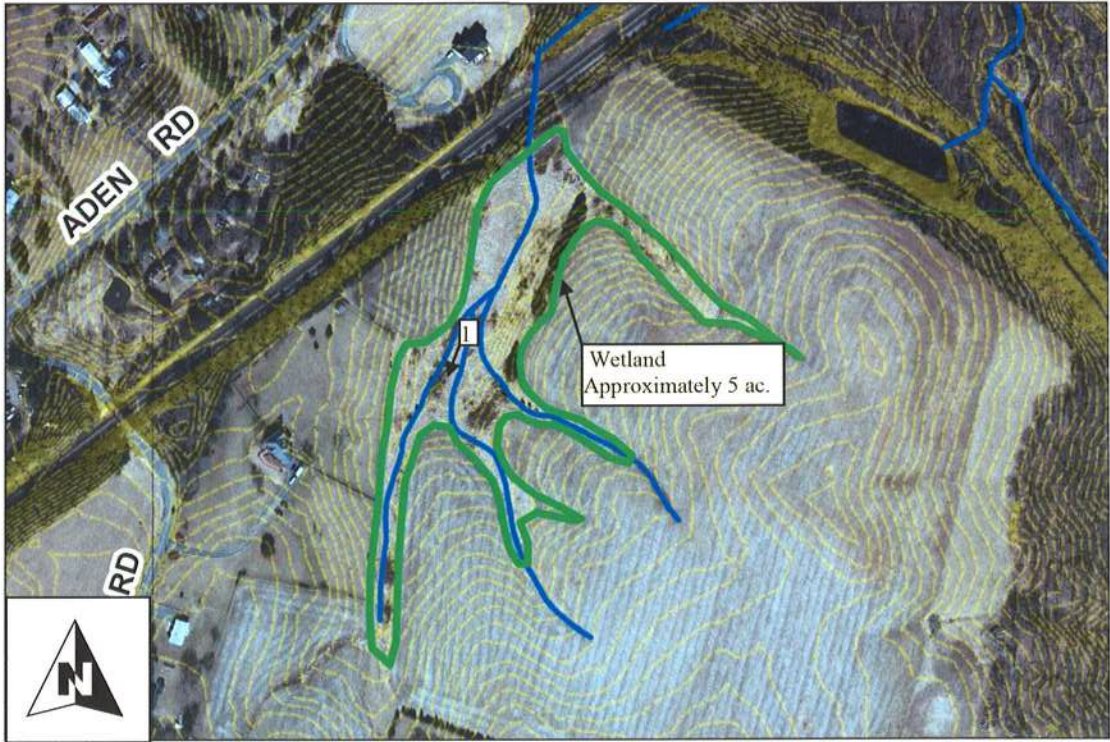
Site 272-3: Example of “headwater streams” in rural crescent which are actually wetlands

Problem Description: Site 272-3 and 250-2 are typical of headwater stream/wetland sites within the agricultural areas of Broad Run watershed. These wetland systems are located at the head of small stream systems, and provide important ecological functions to the entire downstream system. The County's current GIS layers do not adequately identify these wetlands. Some of these headwater wetlands are indicated in the County GIS as a stream channel however these wetlands lack a well-defined stream channel. Without additional protection these wetland are subject to drainage, agricultural runoff, and mechanical disturbance.

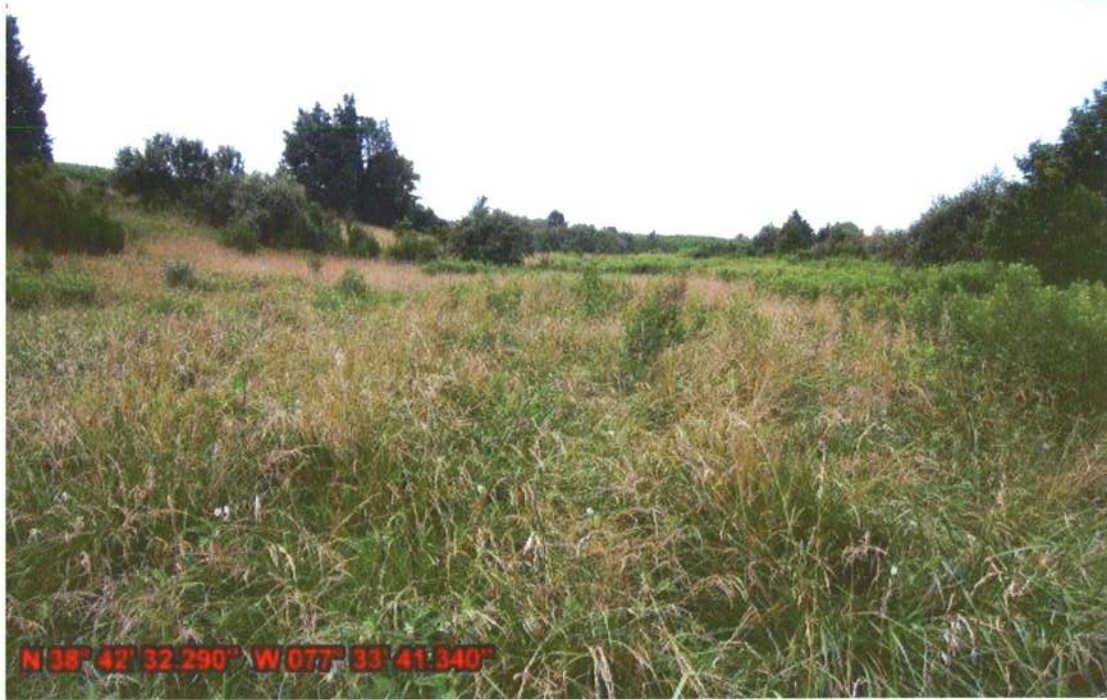
Photo 1: A large (approximately 5 acres) headwater wetland (site 272-3) with minimal impact

Within Subwatershed 272, there are approximately 23 acres of headwater wetlands within agricultural lands. These wetlands were identified based on aerial photography and site visits. In addition, there are >2,000 linear feet of stream channels within agricultural lands which lack a riparian buffer or agricultural filter strips. In most cases, the wetland or stream is surrounded by active corn or soybean fields. This subwatershed also contains 270 acres of forested wetlands, as identified by NWI, and 412 acres of hydric soils as identified by NRCS. This subwatershed has more wetlands than any other subwatershed in Kettle Run.

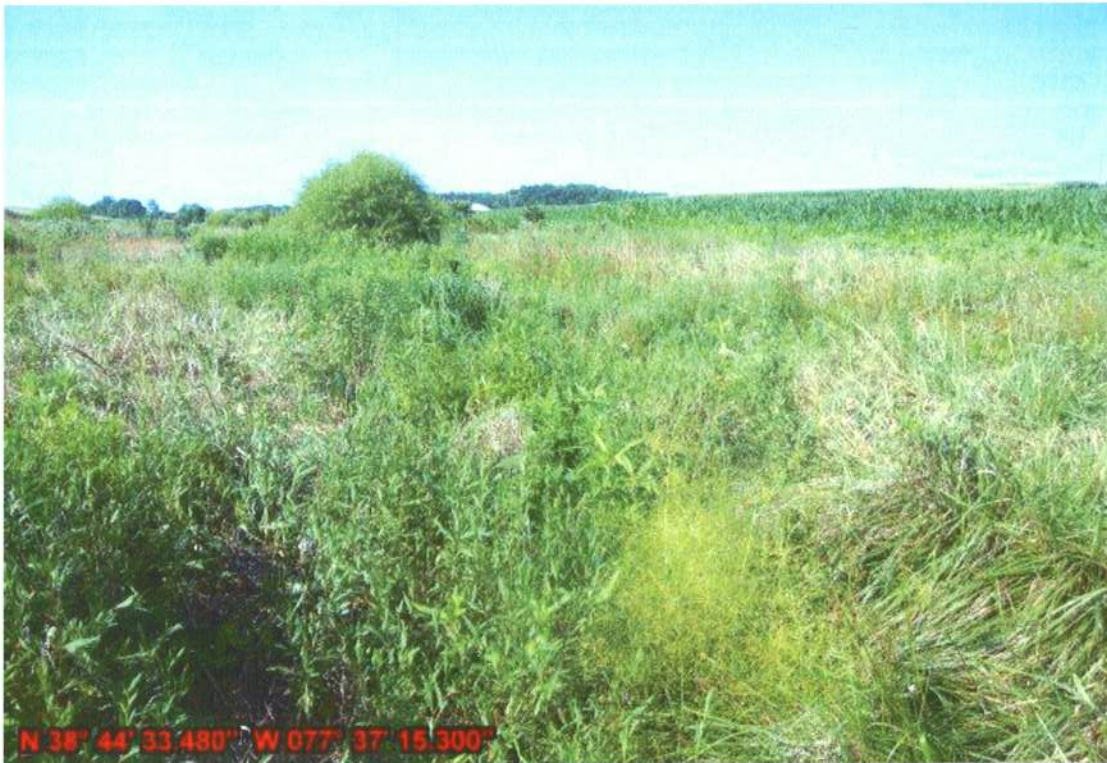
Photo 2: A large (Approximately 9 acres) headwater wetland (site 250-2) without buffer

Within Subwatershed 250, there are 13 acres of headwater wetlands and approximately 9,000 linear feet of stream channels within agricultural lands which lack a riparian buffer or agricultural filter strips. In most cases, the wetland or stream is surrounded by active corn or soybean fields. This subwatershed has significantly fewer wetlands than subwatershed 272 due to the dominance of hydrologic group A and B soils which are typically well drained.

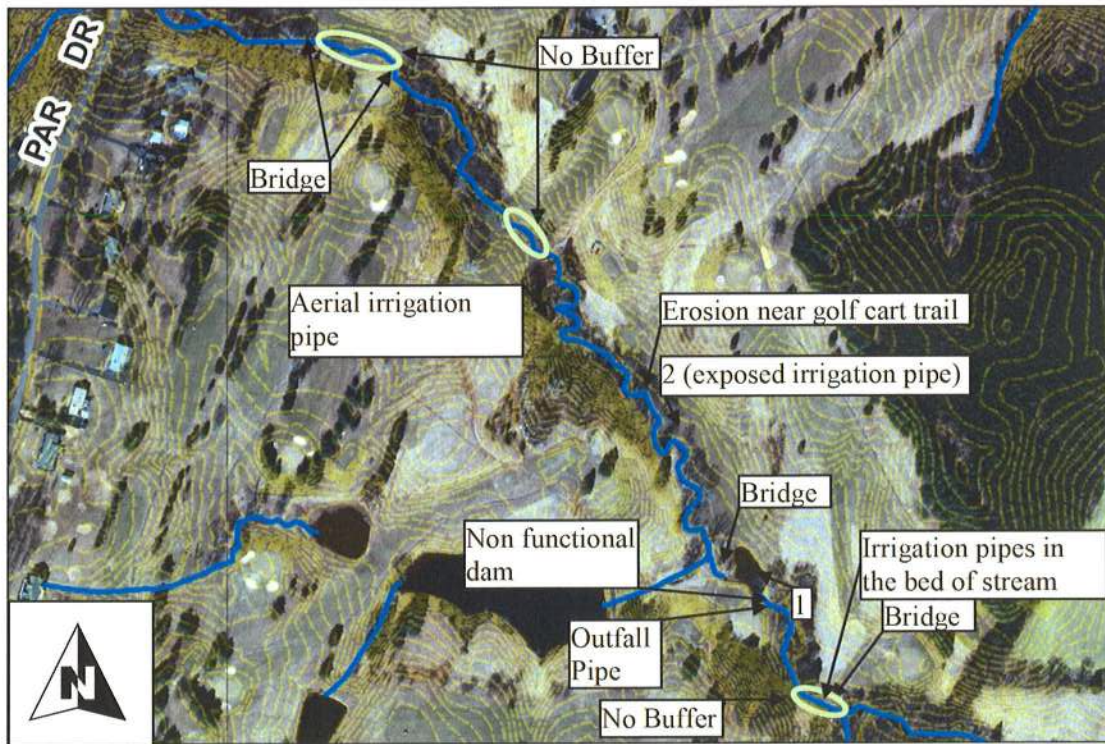
Existing Condition: Stream channel through County golf course is experiencing erosion,

The stream channel has eroding outer meander bends and a narrow riparian buffer. In some areas, the managed turf of the golf course extends to the banks of the stream channel, which results in poor bank stability and potentially high inputs of nutrients to the channel. At several locations irrigation pipes are exposed where the stream channel is actively eroding the stream banks. There is about 600 linear feet of stream that lacks wood buffers.

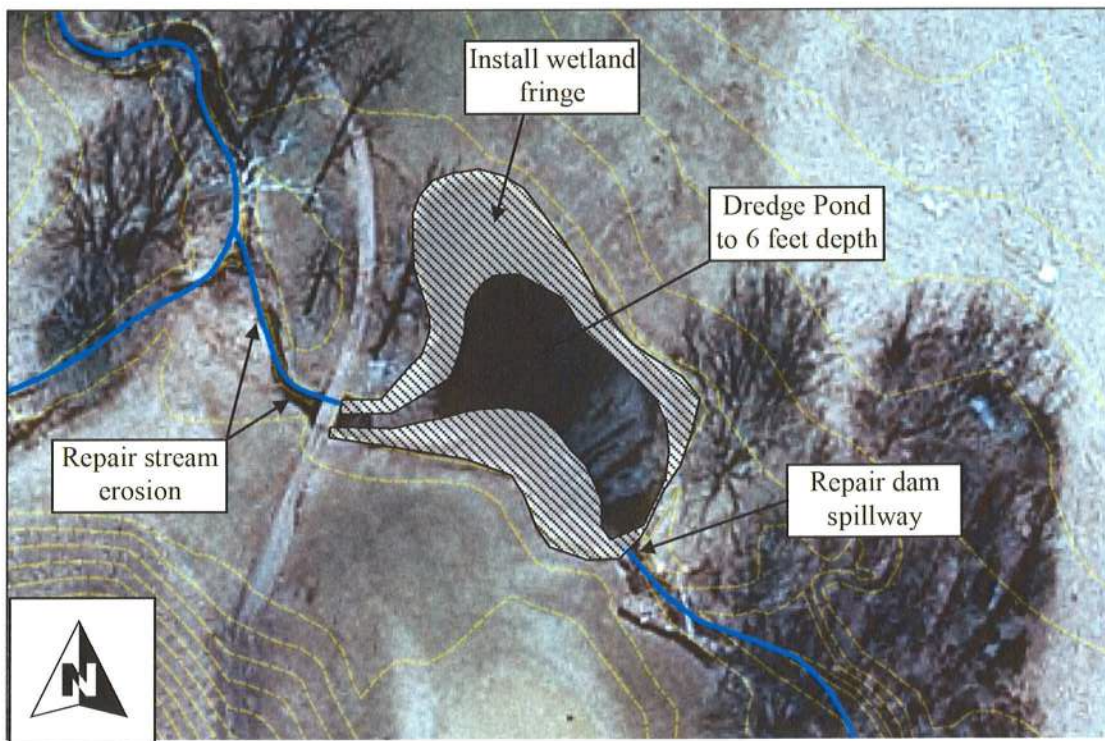
Conceptual Plan: In-stream Pond Renovation

Project Description: The in-stream pond could be renovated to provide partial water quality treatment for the stream flow coming from the golf course. The sediment would be removed, and the pond contoured to provide deep water areas and fringing wetlands. A minimum depth of 6 feet should be provided, with 8 feet preferred.

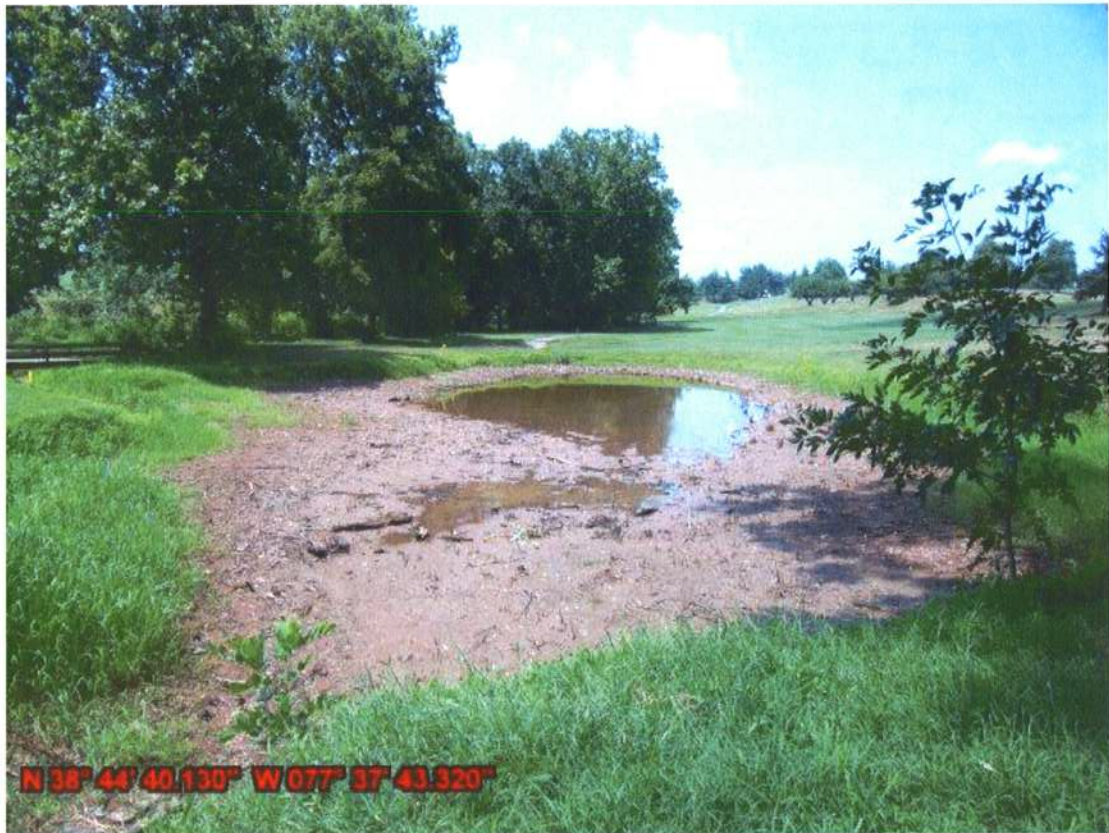
Photo 1: In-stream pond on County Golf course in very poor condition

Problem Description: This project has two components: an in-stream pond, and eroding stream banks. The instream pond is approximately 0.2 acres and less than 3 feet deep. It is filled with sediment and does not have sufficient depth to provide aquatic habitat during periods of low stream flow.

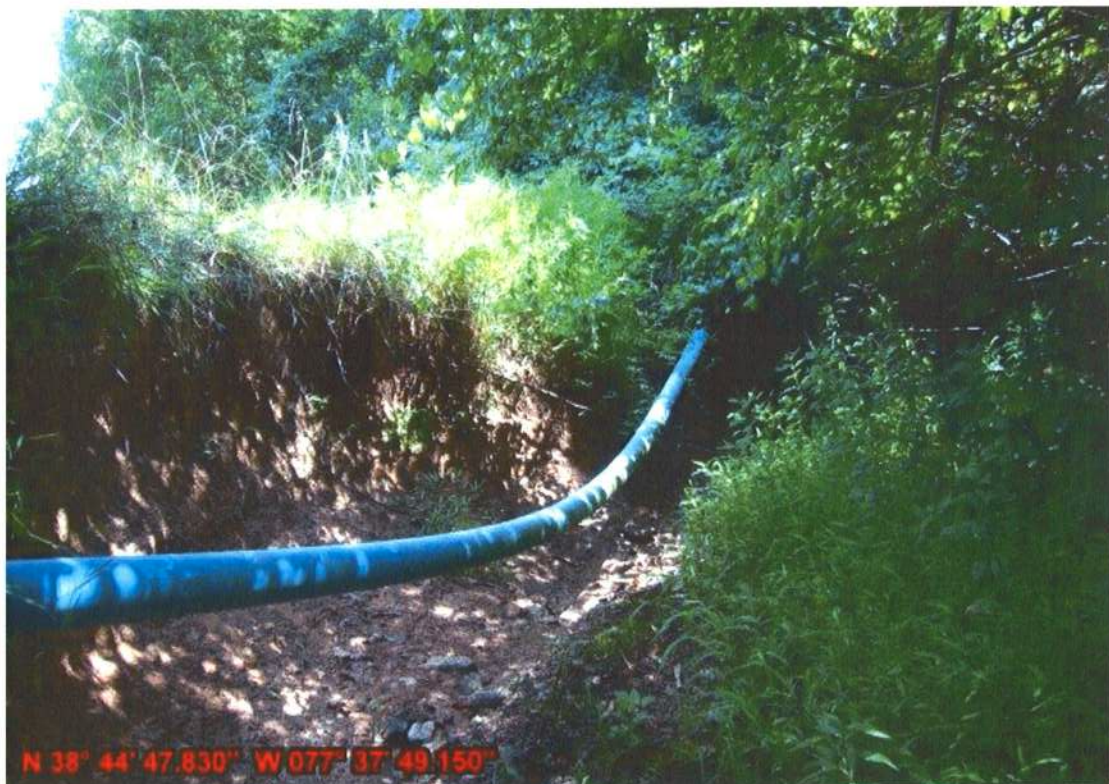
Photo 2: Exposed irrigation piping is common along the stream channel

The stream channel should be surveyed in detail, and the eroding banks stabilized. The exposed irrigation piping should be relocated away from meander bends. Where the riparian buffer is entirely managed turf grass, management of these areas should be changed to encourage deeper rooting species and woody vegetation where compatible with in play areas.
