**Marumsco Creek and Farm
Creek Watershed Stream
Corridor Improvement Projects**

MARUMSCO CREEK AND FARM CREEK WATERSHED MANAGEMENT PLAN

Stream Corridor Improvement Project

Project ID: 905-SCIP-01

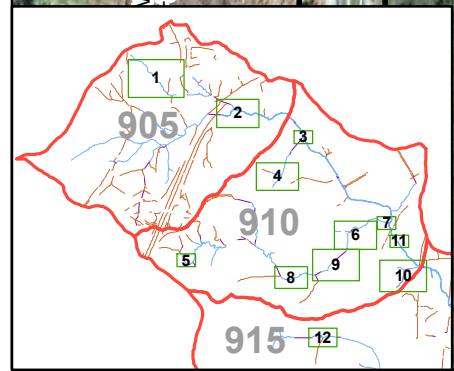
2B-905-34TR & 2B-905-35-TR

Trash and debris dumping areas observed along the upper portion of the project reach. Observed trash includes tires, metal tanks, and yard waste. Total volume of trash is estimated to be less than 5 truck loads.

Illegal Dumping. Tires, tanks and yard waste found in the stream and on the right bank.

The project concept also incorporates trash and debris clean up and removal in the vicinity of the stabilization site and at the dumping sites. Properties owners should be notified of the dumping and advised to develop prevention measures for their property.

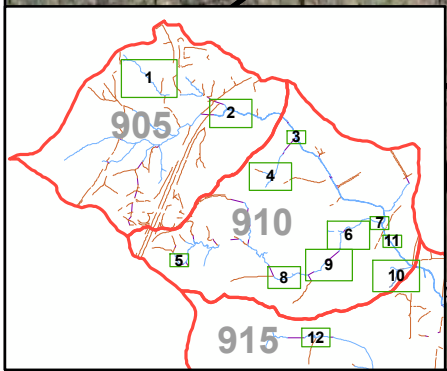
2C-905-52ER

Bank erosion. 3-foot high erosion observed on the left bank along a total reach length of 100 ft. 3-foot high erosion observed on the right bank along a total reach length of 180 ft.

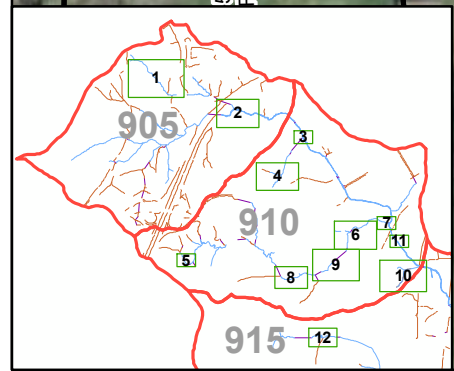
3C-910-117OT

Outfall foundation undermined and failing.
Bank erosion around the outfall.

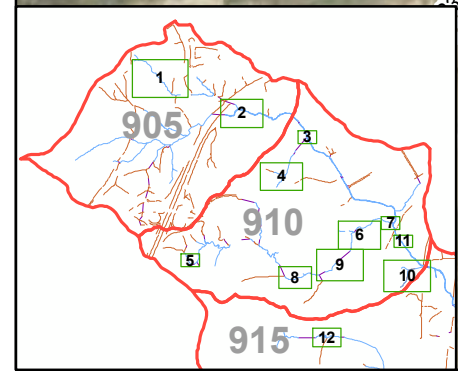
Bank erosion and widening observed. 4-foot high erosion observed on the left bank along a length of 230 ft. 4-foot high erosion observed on the right bank along a total reach length of 240 ft.

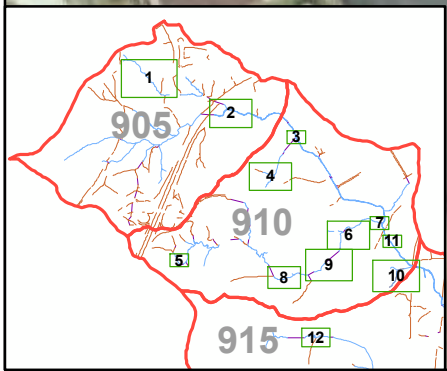
Bank widening and headcutting. 1-foot high erosion observed on the left bank and right banks along a total reach length of 100 ft.
