**Marumsco Creek and Farm
Creek Watershed Stream
Corridor Improvement Projects**

MARUMSCO CREEK AND FARM CREEK WATERSHED MANAGEMENT PLAN

Stream Corridor Improvement Project

Project ID: 910-SCIP-06

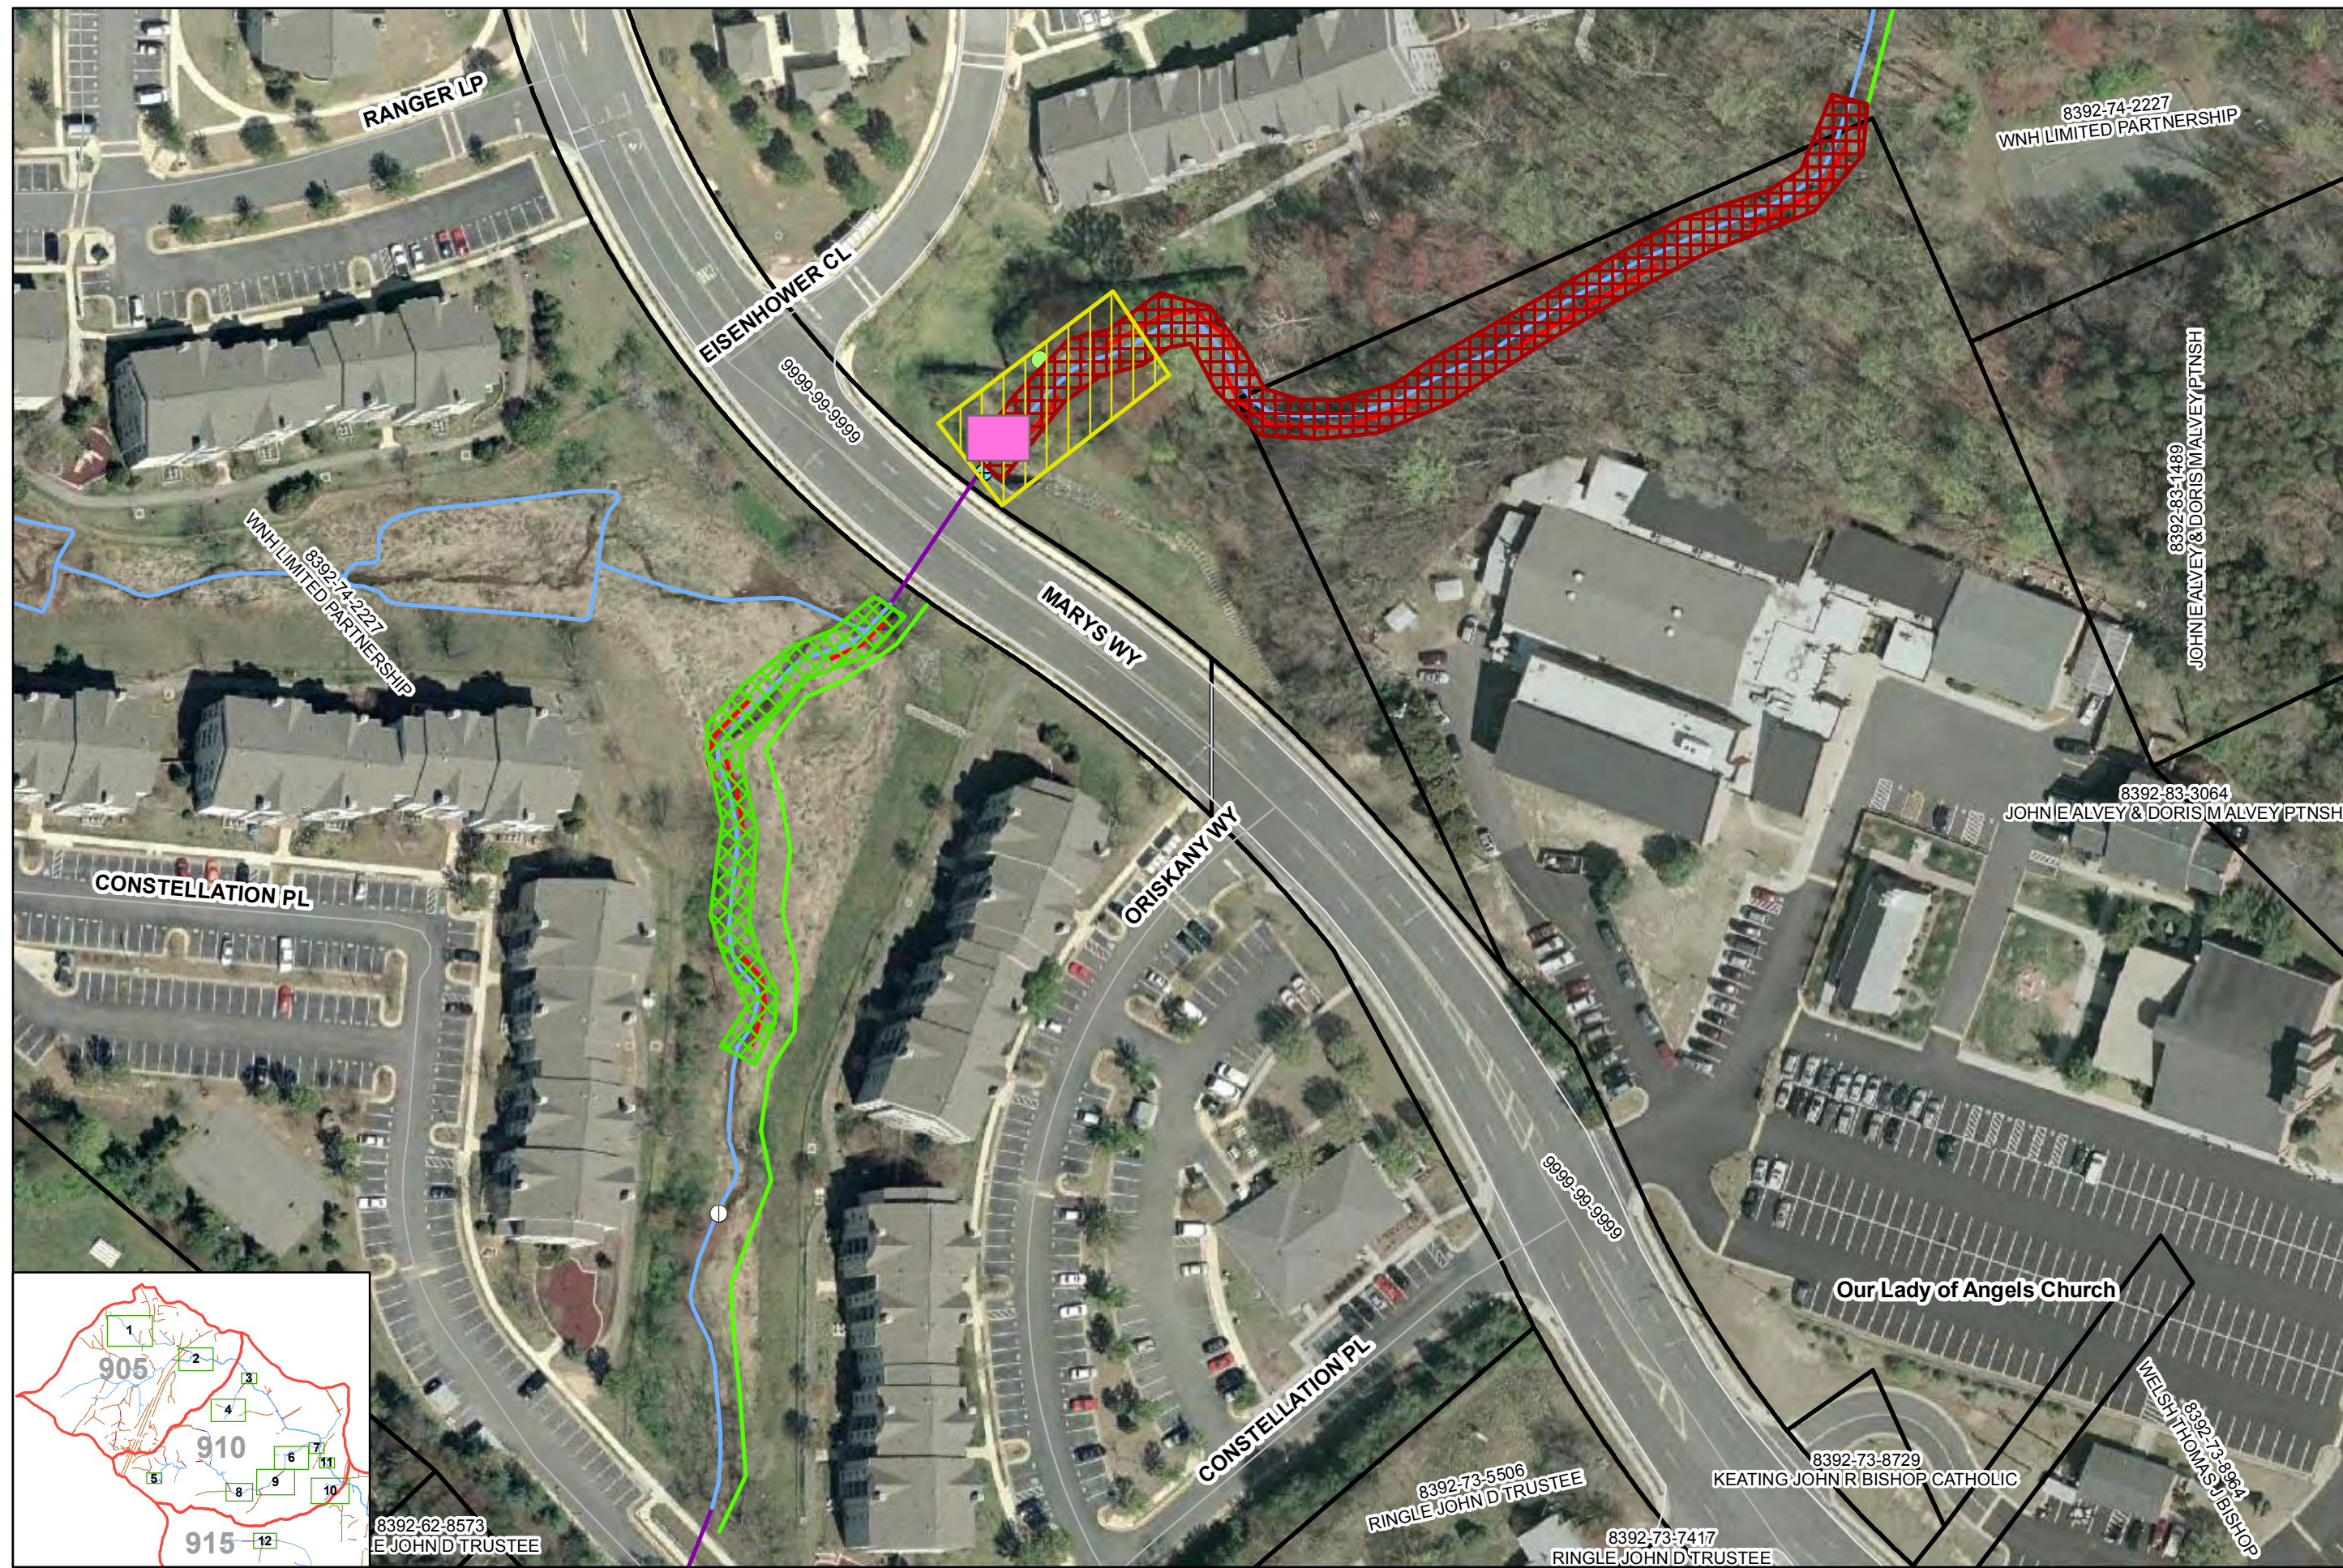
Eroding banks along the upper portion of the project reach. Average of 3-foot high erosion observed on left and right banks along a total reach length of 20 ft on the left bank and 80 ft on the right bank.

Failed metal culvert pipe or stormdrain pipe. Source of pipe is unknown. Pipe is creating a jam and collecting trash and debris.

Bank erosion along the lower project reach. Average of 5-foot high erosion observed on the left bank along a total reach length of 80 ft. Average of 8-foot high erosion observed on the right bank along a total reach length of 210 ft.

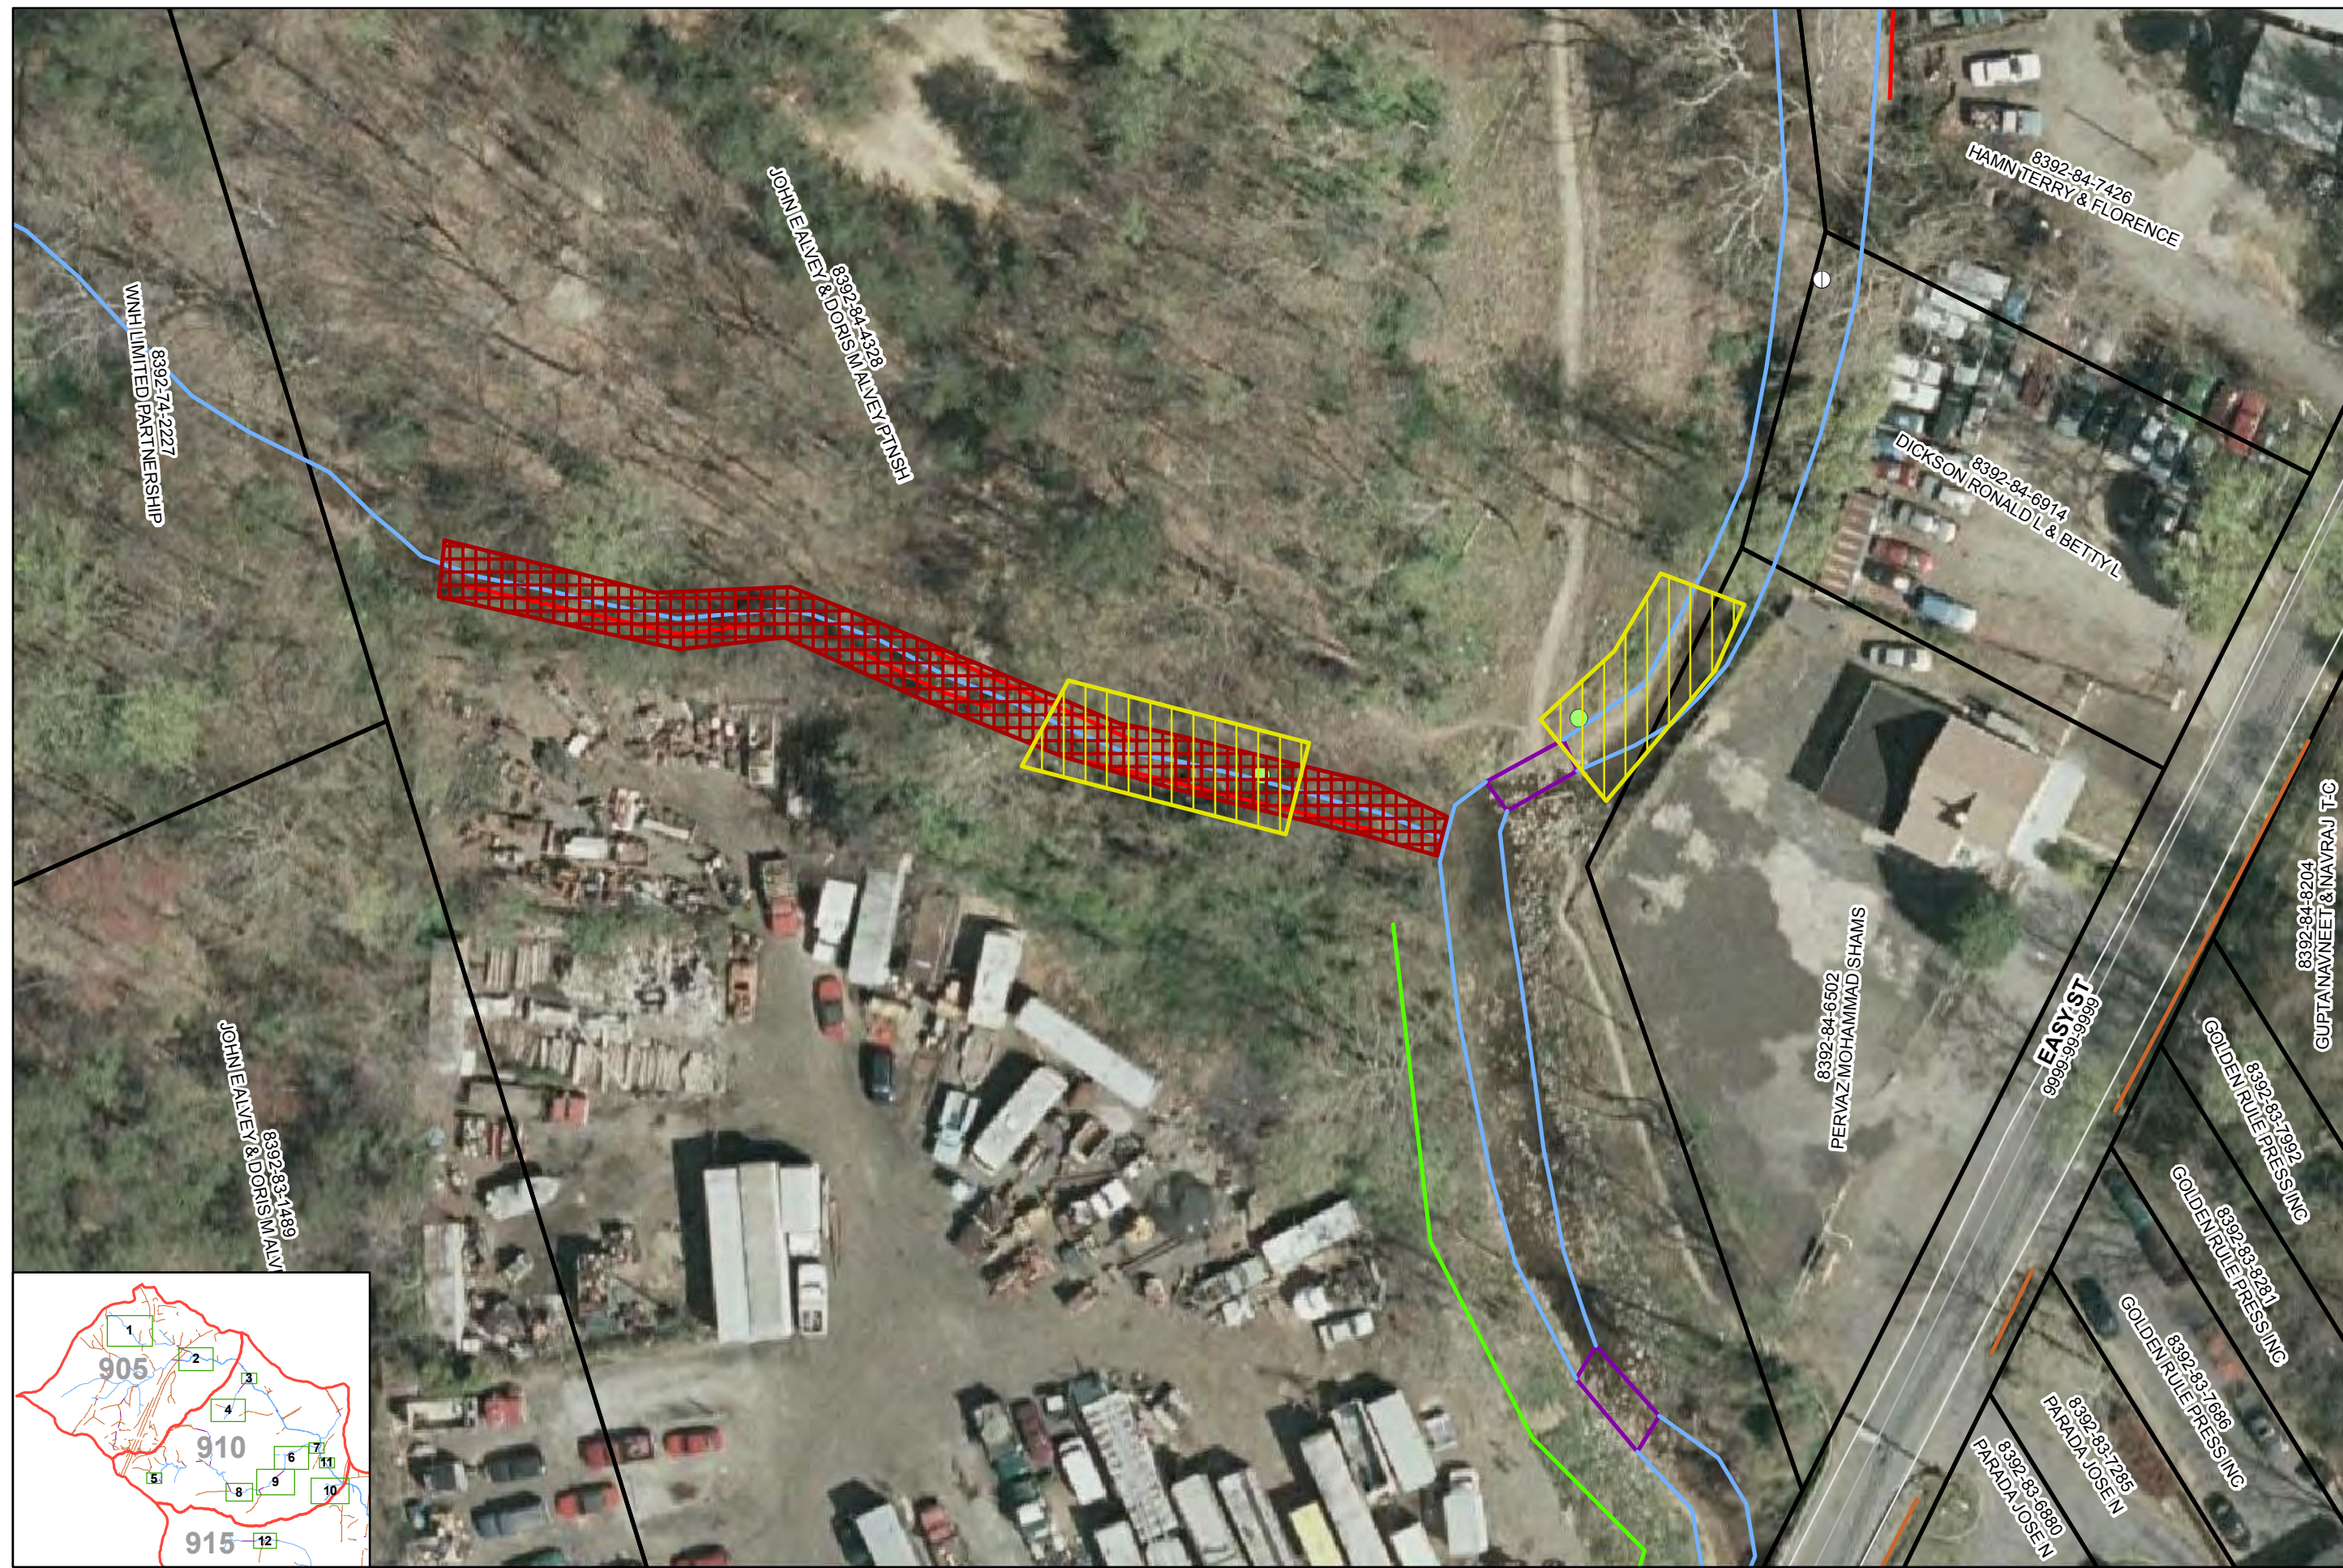
Bank failure. 8-foot high erosion observed on the left bank along a total reach length of 100 ft. Average of 6-foot high erosion observed on the right bank along a length of 140 ft.

Illegal dumping. There is evidence of squatting. Plastic, clothing, metal, yard waste, and 3 RCP culvert pipes were found in the stream and on the riparian area.

Illegal dumping. Plastic waste, tires, appliances, yard waste, metal and mattresses found in the stream.

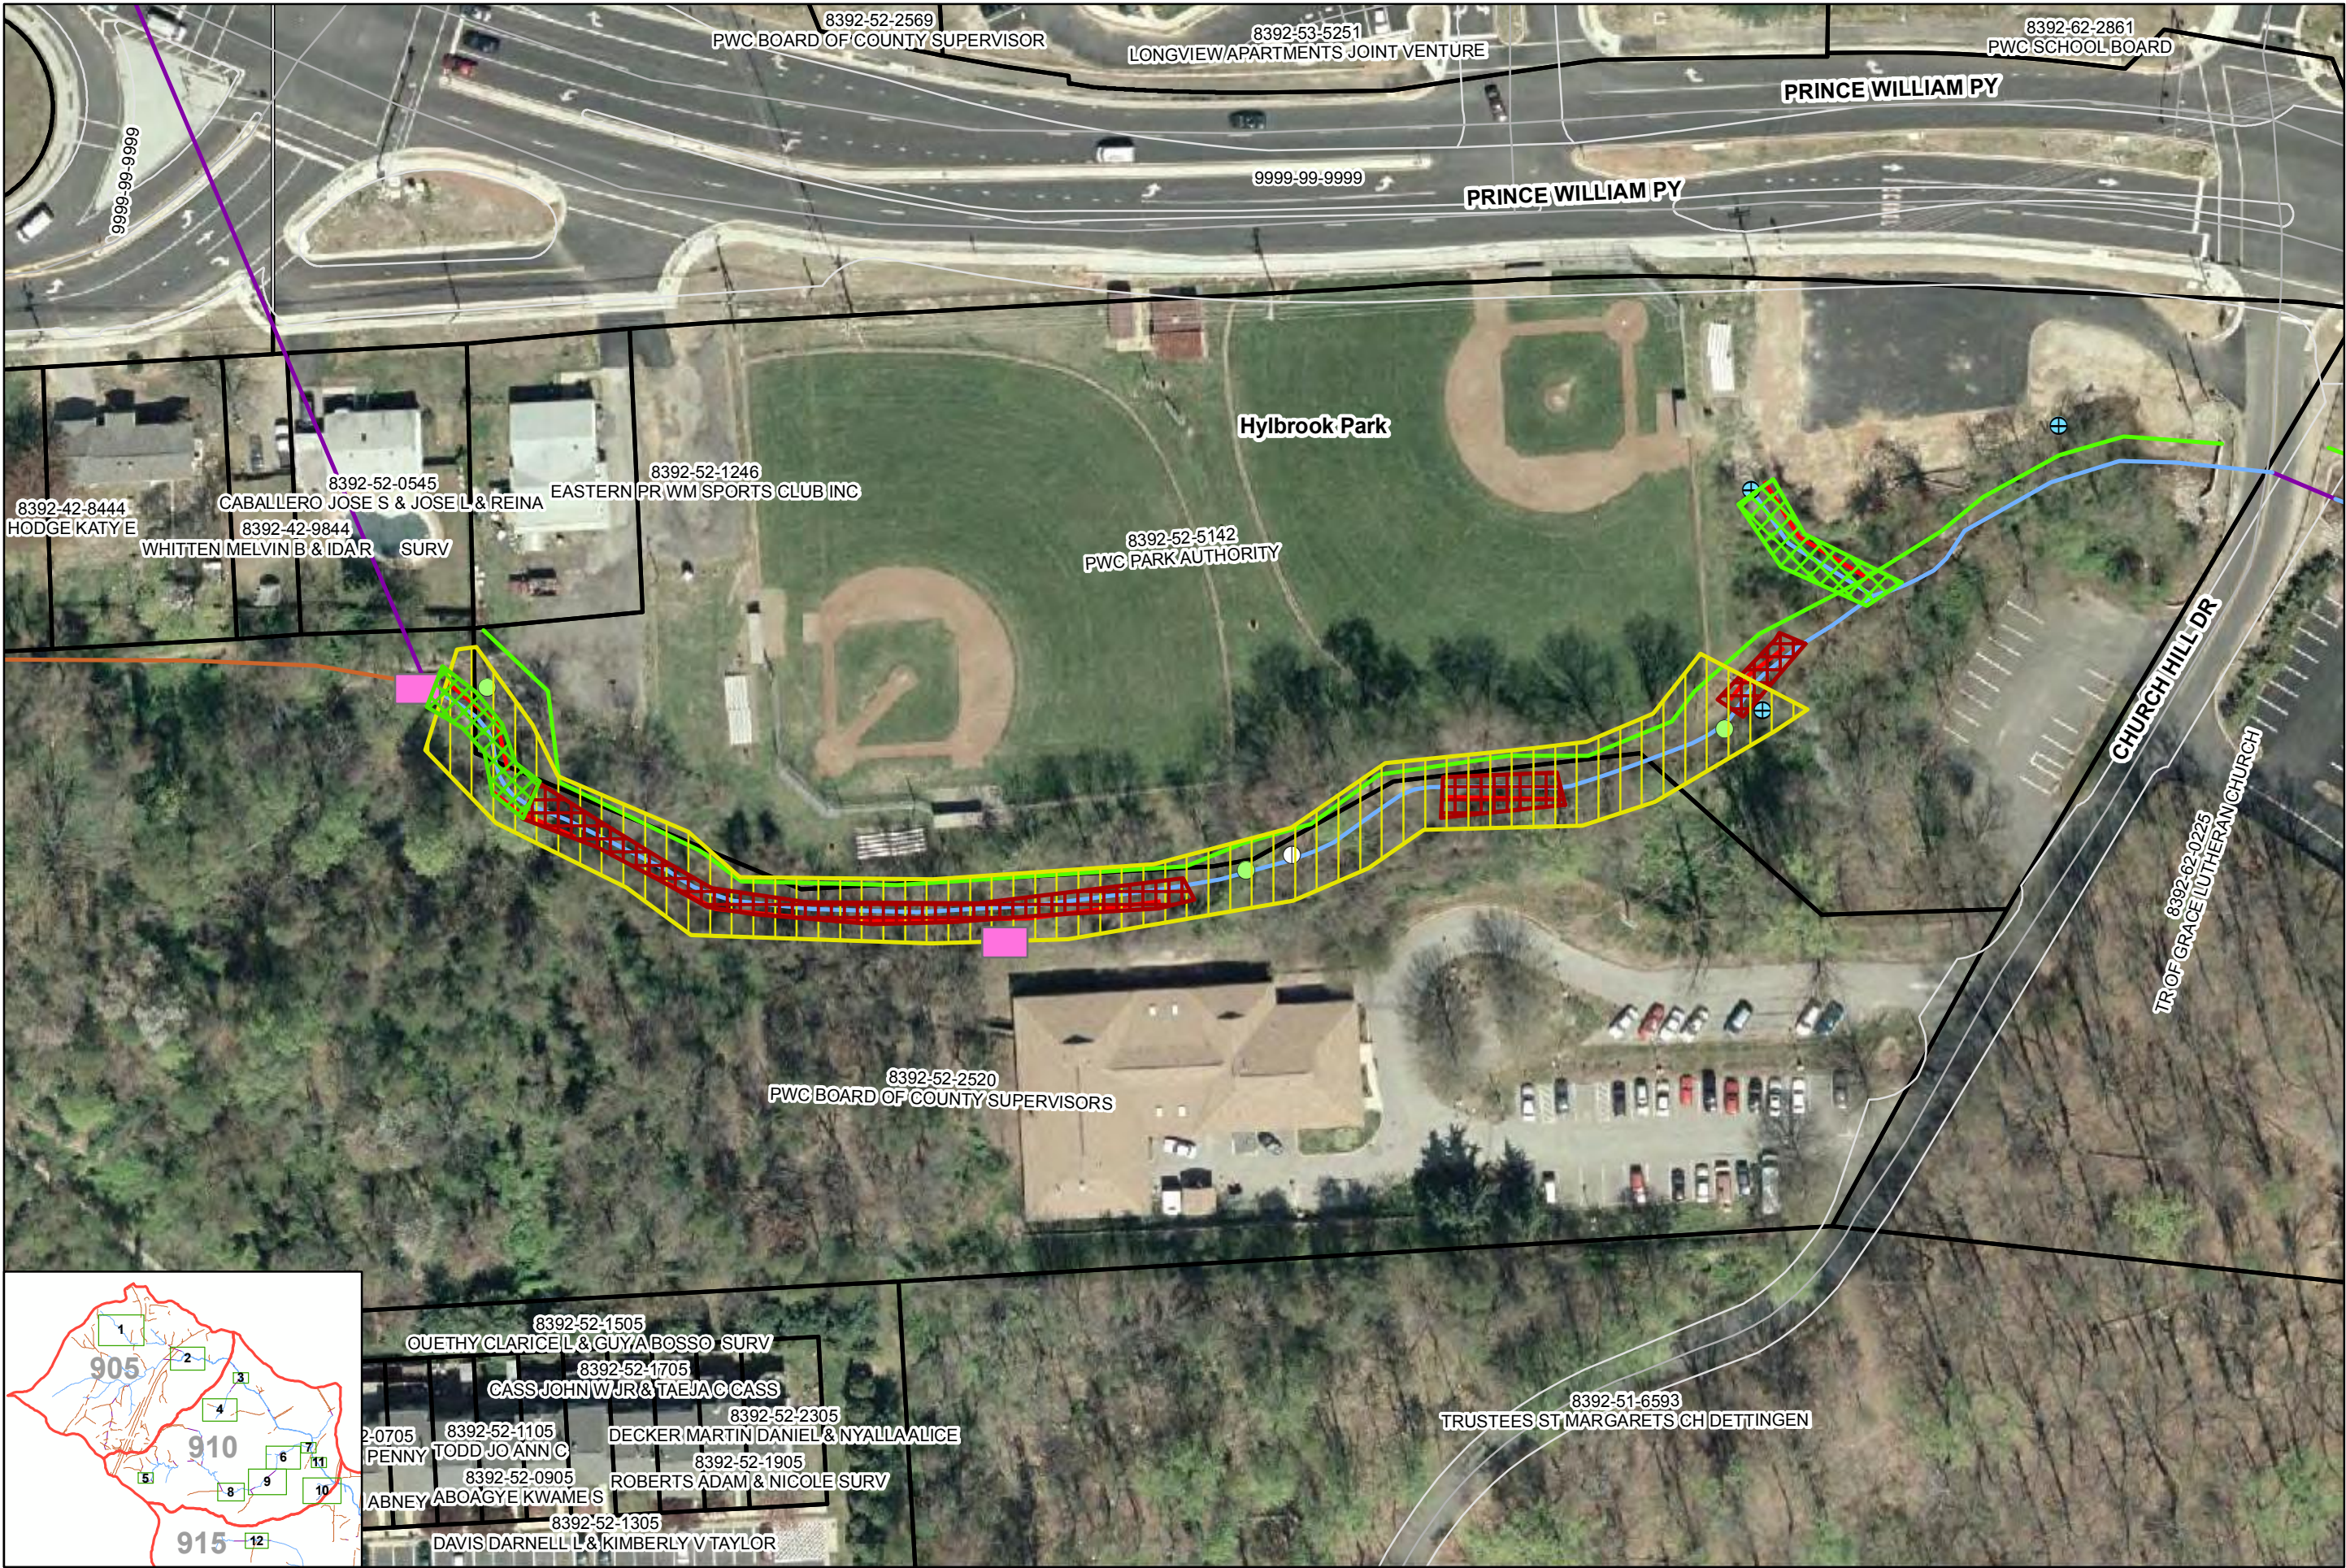
Plastic waste, construction waste, yard waste and metal found in the stream and on the riparian area on the left bank.

Bank widening. Erosion towards commercial property. 4-foot high erosion observed along a total reach length of 40 ft on the left bank and 295 ft on the right bank.

Rusting corrugated metal pipe outfall.
Riprap slope protection held in place with
wire fencing.

Bank widening. Average of 5-foot high
erosion observed along a total reach length
of 40 ft on the right bank

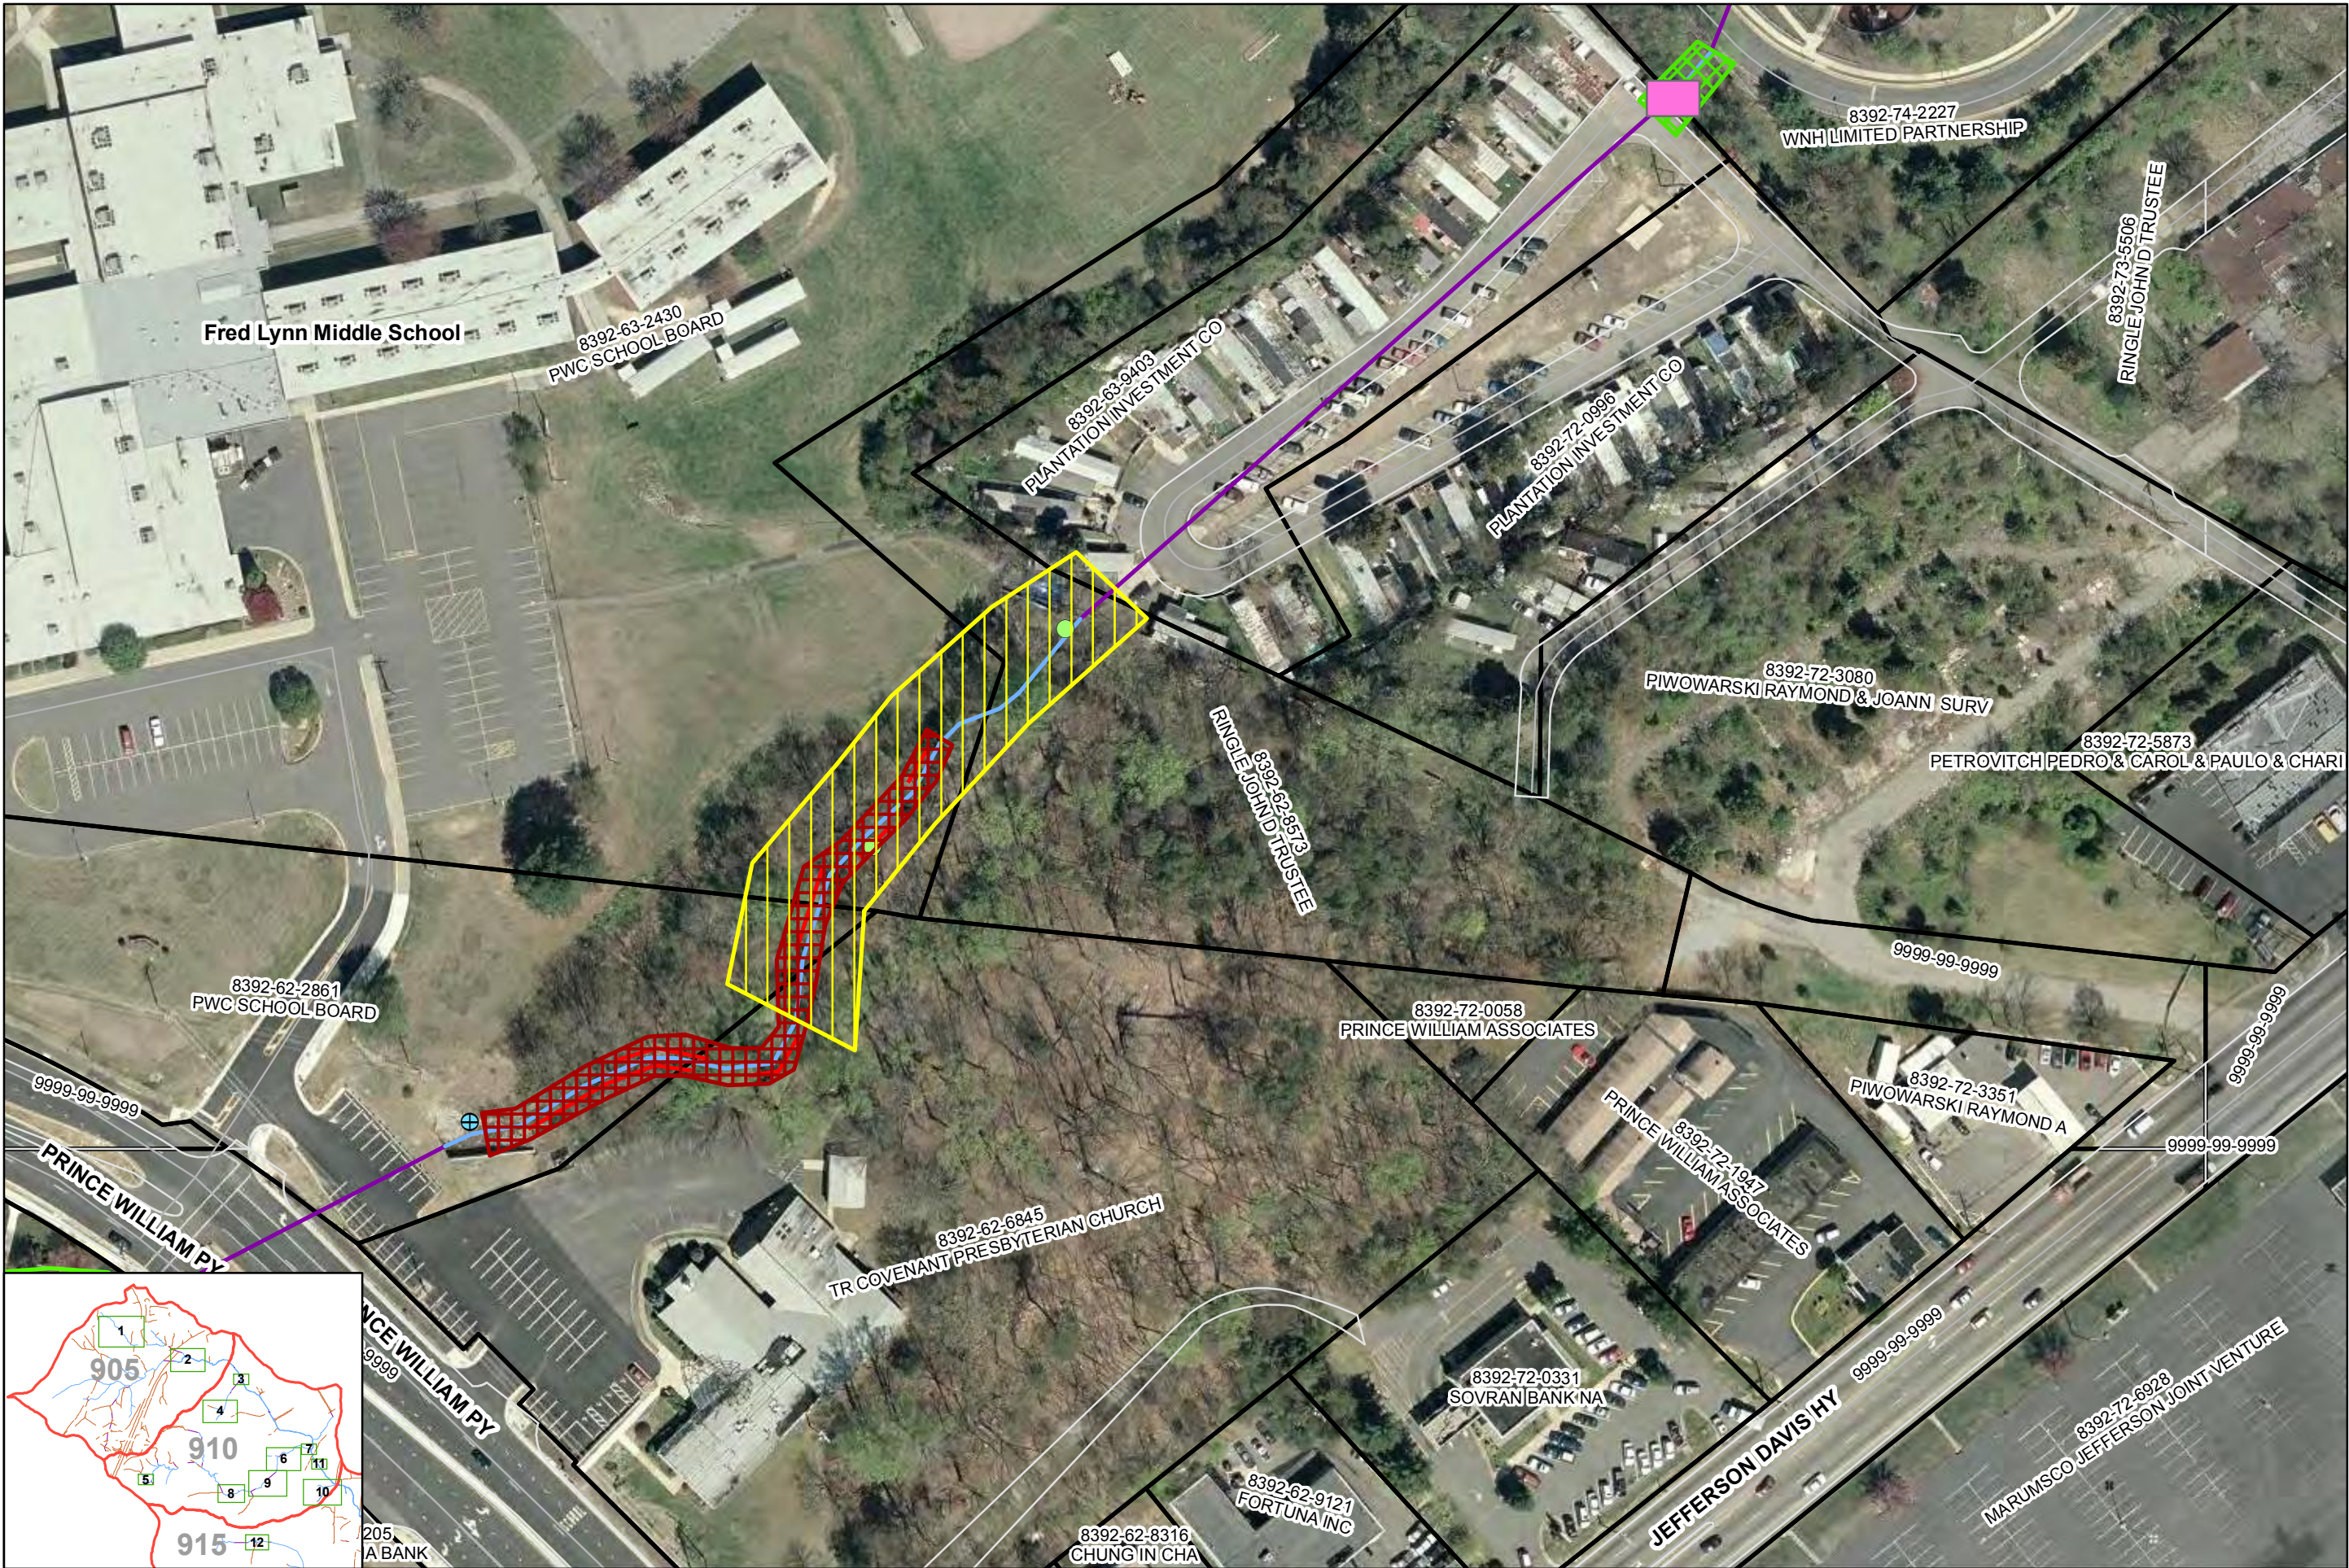
4D-910-36ER

Average of 4-foot high erosion observed along a total reach length of 100 ft on the left bank and 150 ft on the right bank.

Appliances, metal waste, plastic and paper floatables are found throughout this reach of stream.

Plastic waste, appliances, tires and yard waste found in the stream and on the right bank near the trash racks.

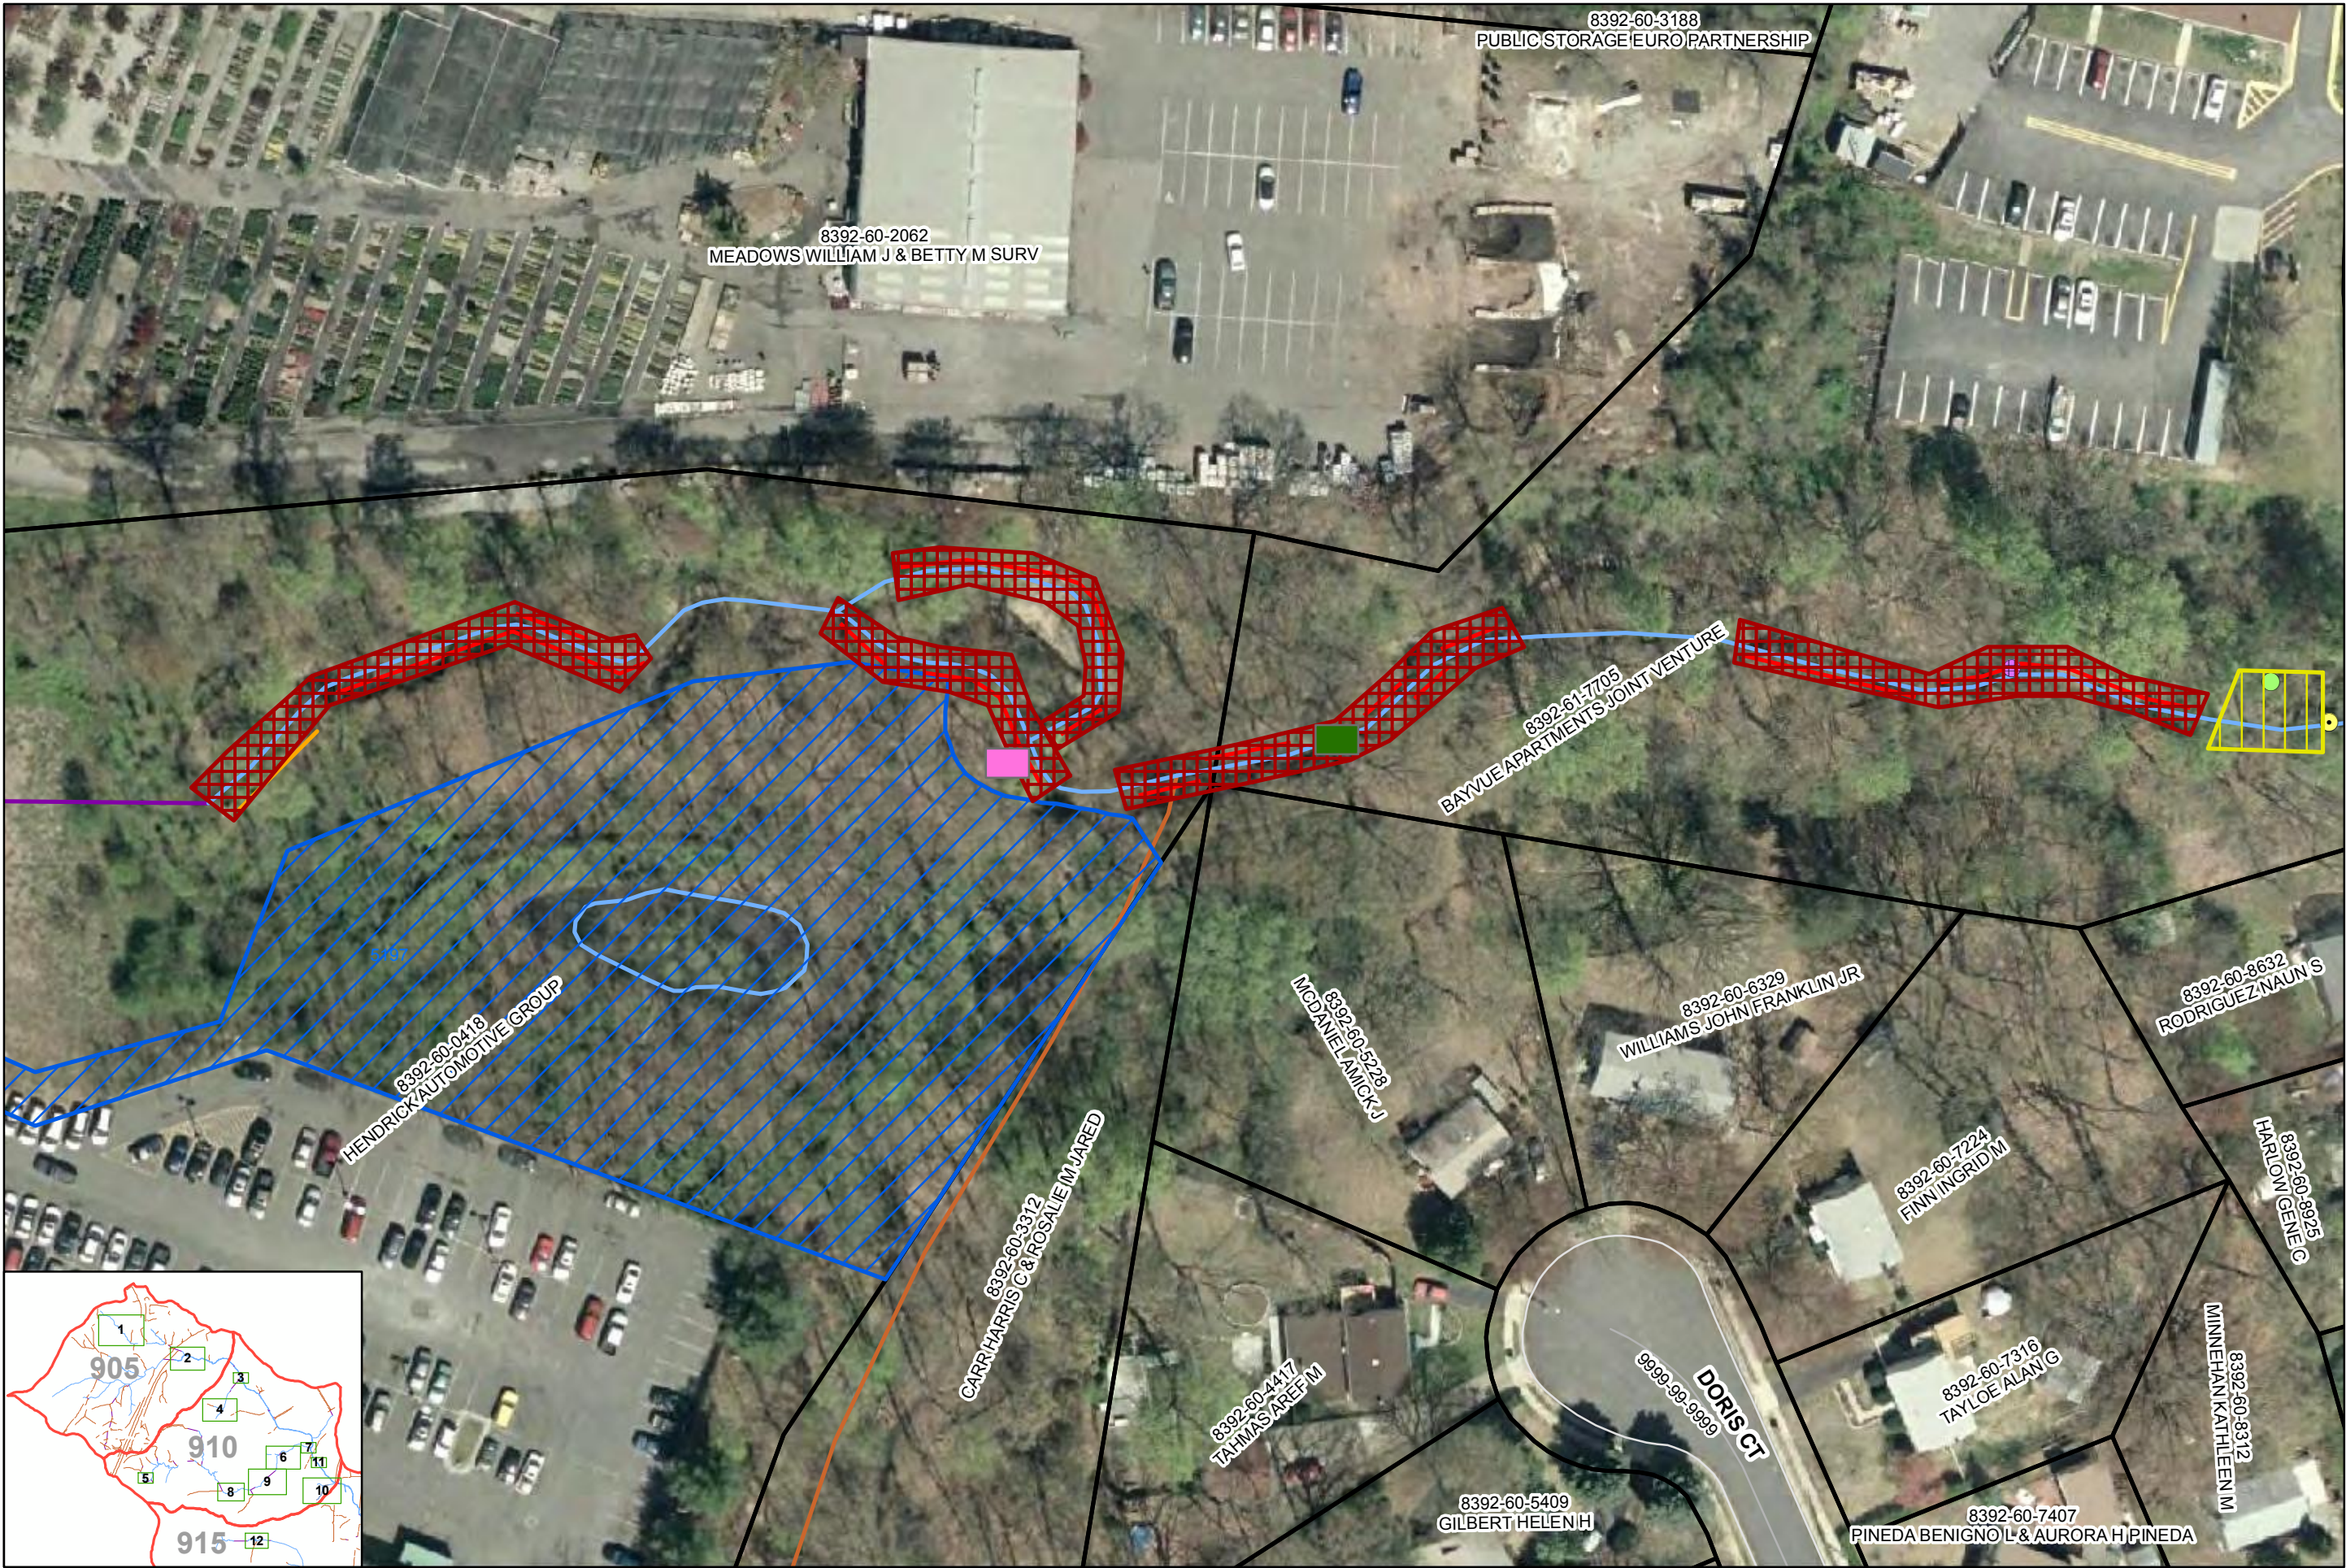
Corrosion observed. Grouted riprap apron failing with a headcut downstream.
