Appendix E

Dawkins Branch (262) Subwatershed Project Conceptual Design Narratives

Project: Dawkins Branch 262-13 Major Repair

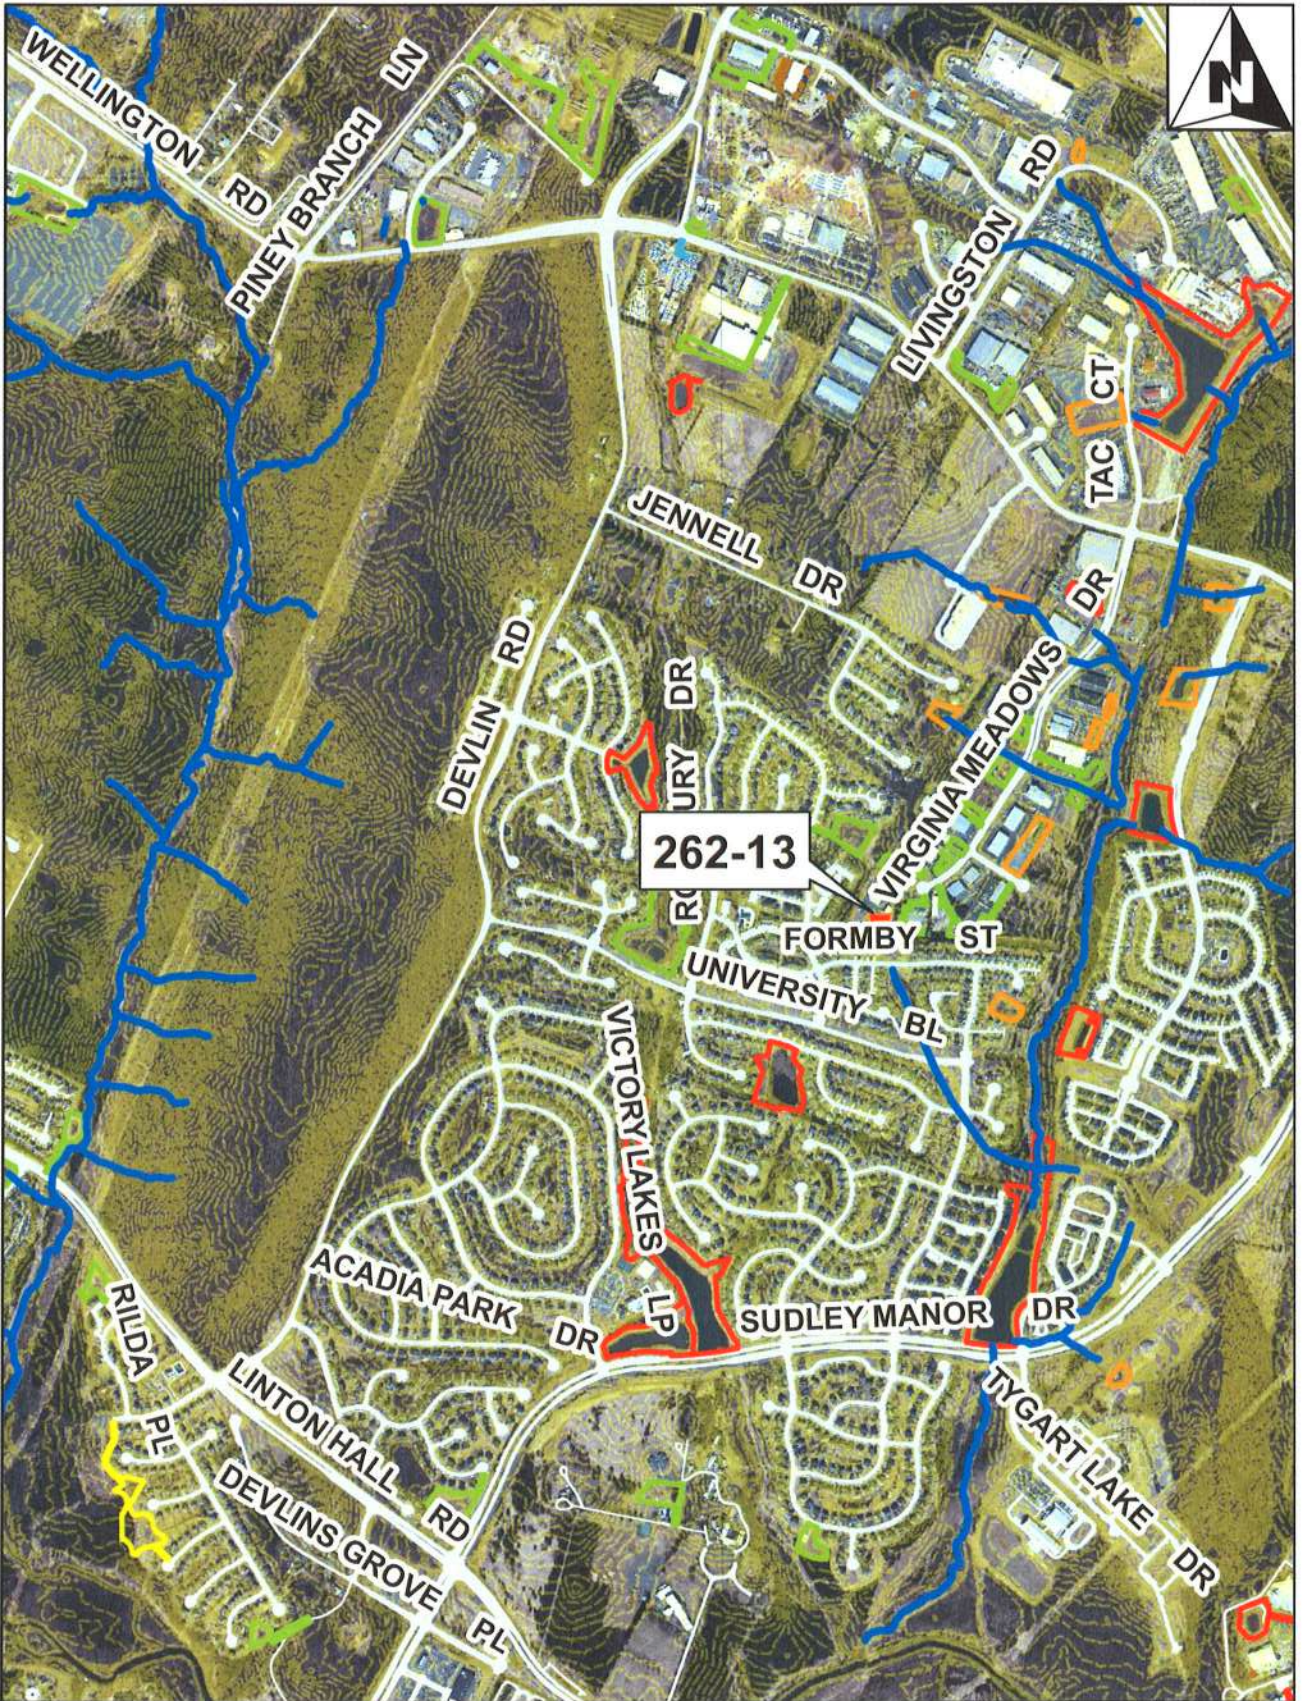
Watershed: Dawkins Branch
Site ID#: 262-13
BMP #: 13
ADC Map (25th edition): Map 8, Page 13, grid coordinate B6

Problem Description: This facility's function has degraded over time due to a lack of proper maintenance. The low flow orifice is damaged, and a ring of riprap has been installed around the riser. Dense woody vegetation has been allowed to grow in the center of the facility, making inspection and maintenance of the riser difficult. The higher elevations of the basin are routinely mowed, as are the surrounding side slopes and berm. Sediment has accumulated at the inlet. The riser is a small drop inlet only about 1 foot above the basin bottom.

Project Description: This facility requires repairs to address the broken low flow orifice as well as maintenance to remove the sediment and vegetation. The riprap berm around the riser should also be removed. The site design could be improved by adding a forebay to control sediment inputs. The facility needs to be added to the County inventory, and receive routine inspections.

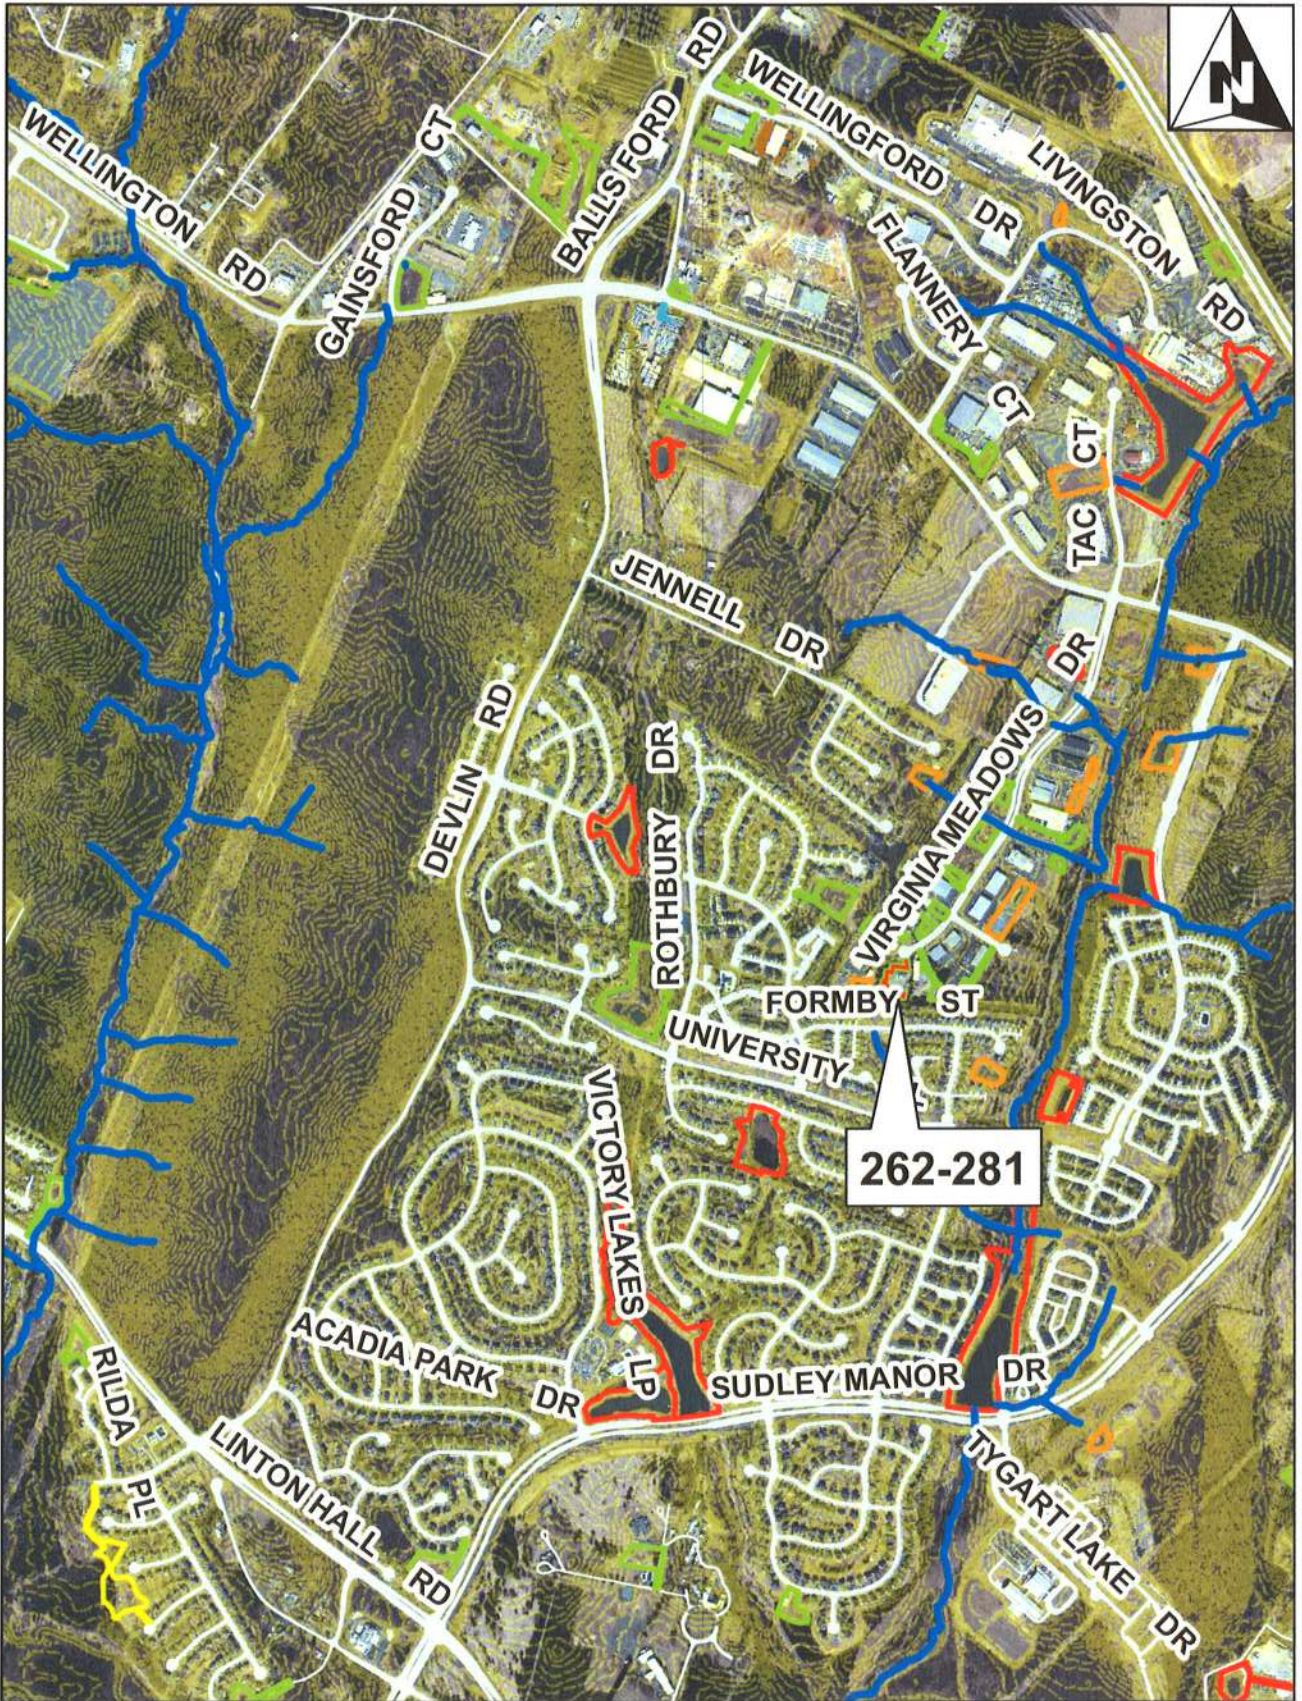
Watershed: Dawkins Branch
Site ID#: 262-281
BMP #: 281
ADC Map (25th edition): Map 8, Page 13, grid coordinate B6

Problem Description: This dry basin BMP was added to the County database in 2000, and includes a note that the County is responsible for maintenance. The database indicates that this facility does not have a riser, and none was found during the site visit. However, the GIS indicates that there should be a 15 inch culvert outlet. Based on the SWM easement in the GIS, the site appears to have been partially filled by expansion of the adjacent gravel parking area. The facility has also been encroached upon by storage of materials. There is no evidence of recent maintenance of this facility. However, there is a depressed area that has cattails and receives runoff.

Project Description: It is recommended that the entire facility be reconstructed to current standards for size, storage, inlet controls and outlet design. Based on the drainage area (1.3 ac.) and impervious surface area (0.9 ac.), if the facility were reconstructed as a Level 1 bioretention facility, a basin of 2,100 sq.ft. designed for 6" of ponding would accommodate the treatment volume with additional capacity available for channel protection volume.

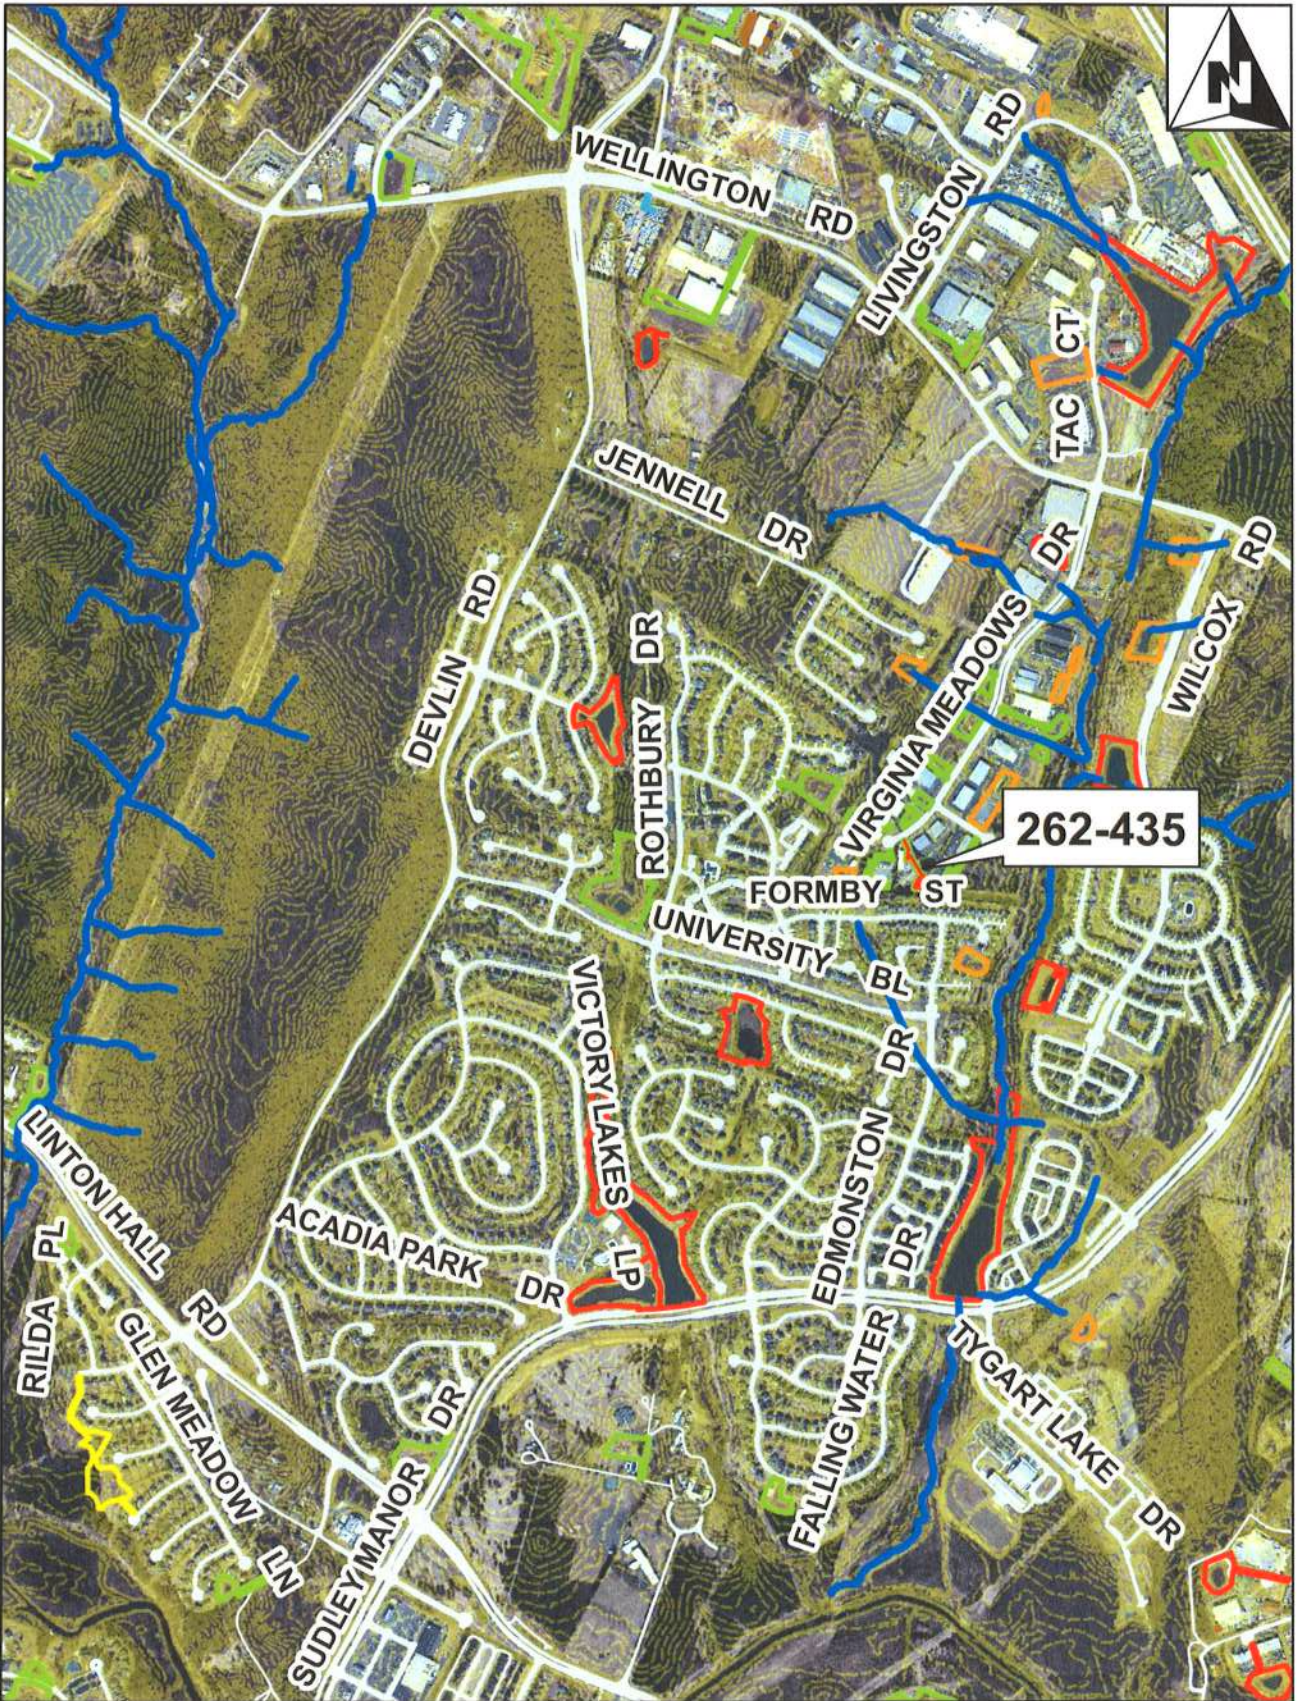
Watershed: Dawkins Branch
Site ID#: 262-435
BMP #: 435
ADC Map (25th edition): Map 8, Page 13, grid coordinate B6

Problem Description: This facility was added to the County database in 2003 and indicates it has a 48 inch riser. GIS database indicates a 15 inch outlet pipe. Based on the stormwater easement shown in the County's GIS data, the facility may have been significantly larger when designed than its current size. The adjacent gravel parking area appears to have been expanded into the facility's original footprint. The riser is relatively intact but has a broken PVC inlet. The basin bottom is covered with heavy vegetation growth and requires maintenance. The riser is less than 2 feet above the basin bottom, so the facility has very shallow detention. Inflow appears to be sheet flow from the parking lot. The facility is significantly degraded in its present state.

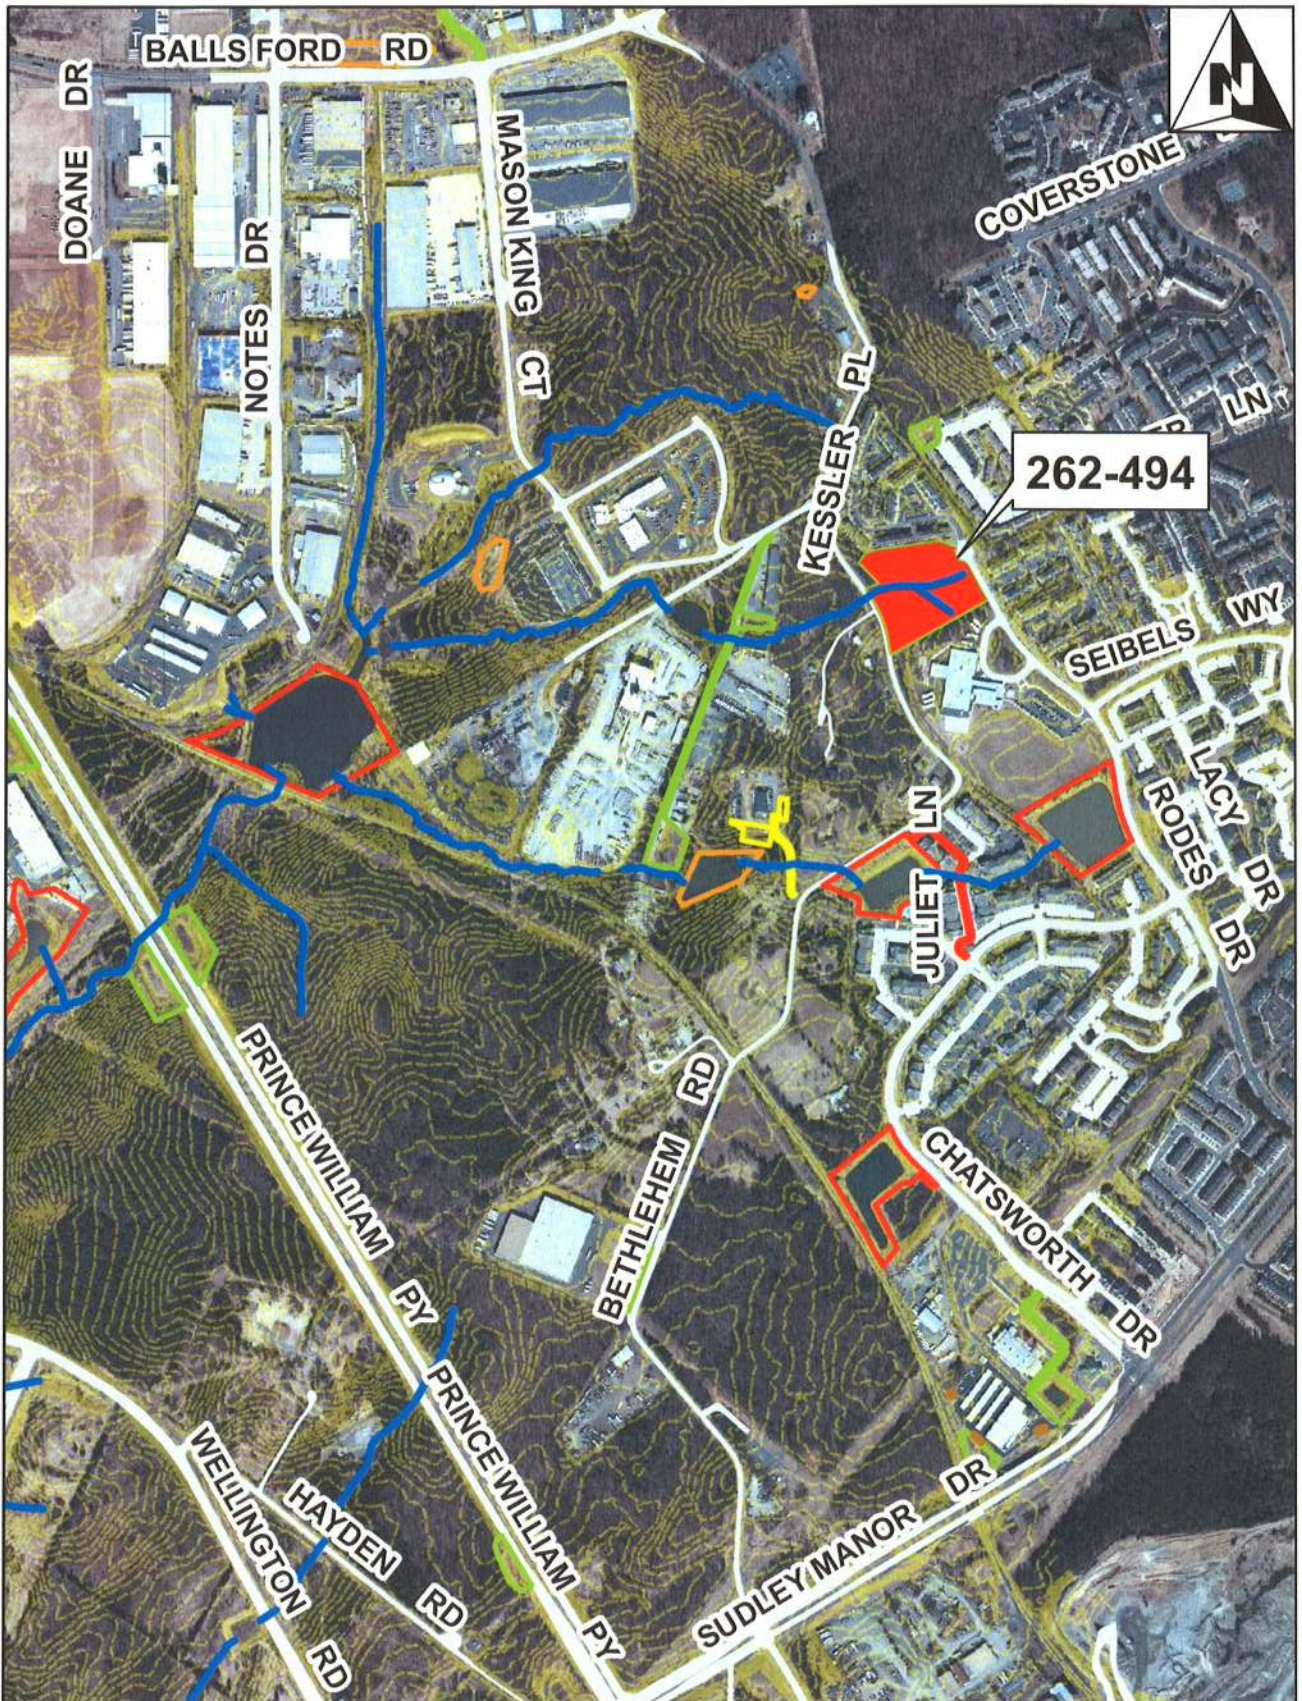
Watershed: Dawkins Branch
Site ID#: 262-494
BMP #: 494
ADC Map (25th edition): Map 8, Page 13, grid coordinate F3

Project Description: The existing ponding and wetlands are a function of complete clogging of the low flow orifice by sediment. Given the large size of this facility and its demonstrated ability to hold water and support wetlands, it is recommended that the facility be retrofitted into a constructed wetland facility. A retrofit would include disrupting the channelized flow directly from the inlets to the riser, increasing the flow path with berms, and creating a permanent micropool at the riser. The riser would be modified with a subsurface intake to minimize clogging. Forebays would be constructed at the two primary inlets to contain sediment inputs. Any work on this facility should include a HOA education and maintenance plan so that its functioning is not impaired by future maintenance.

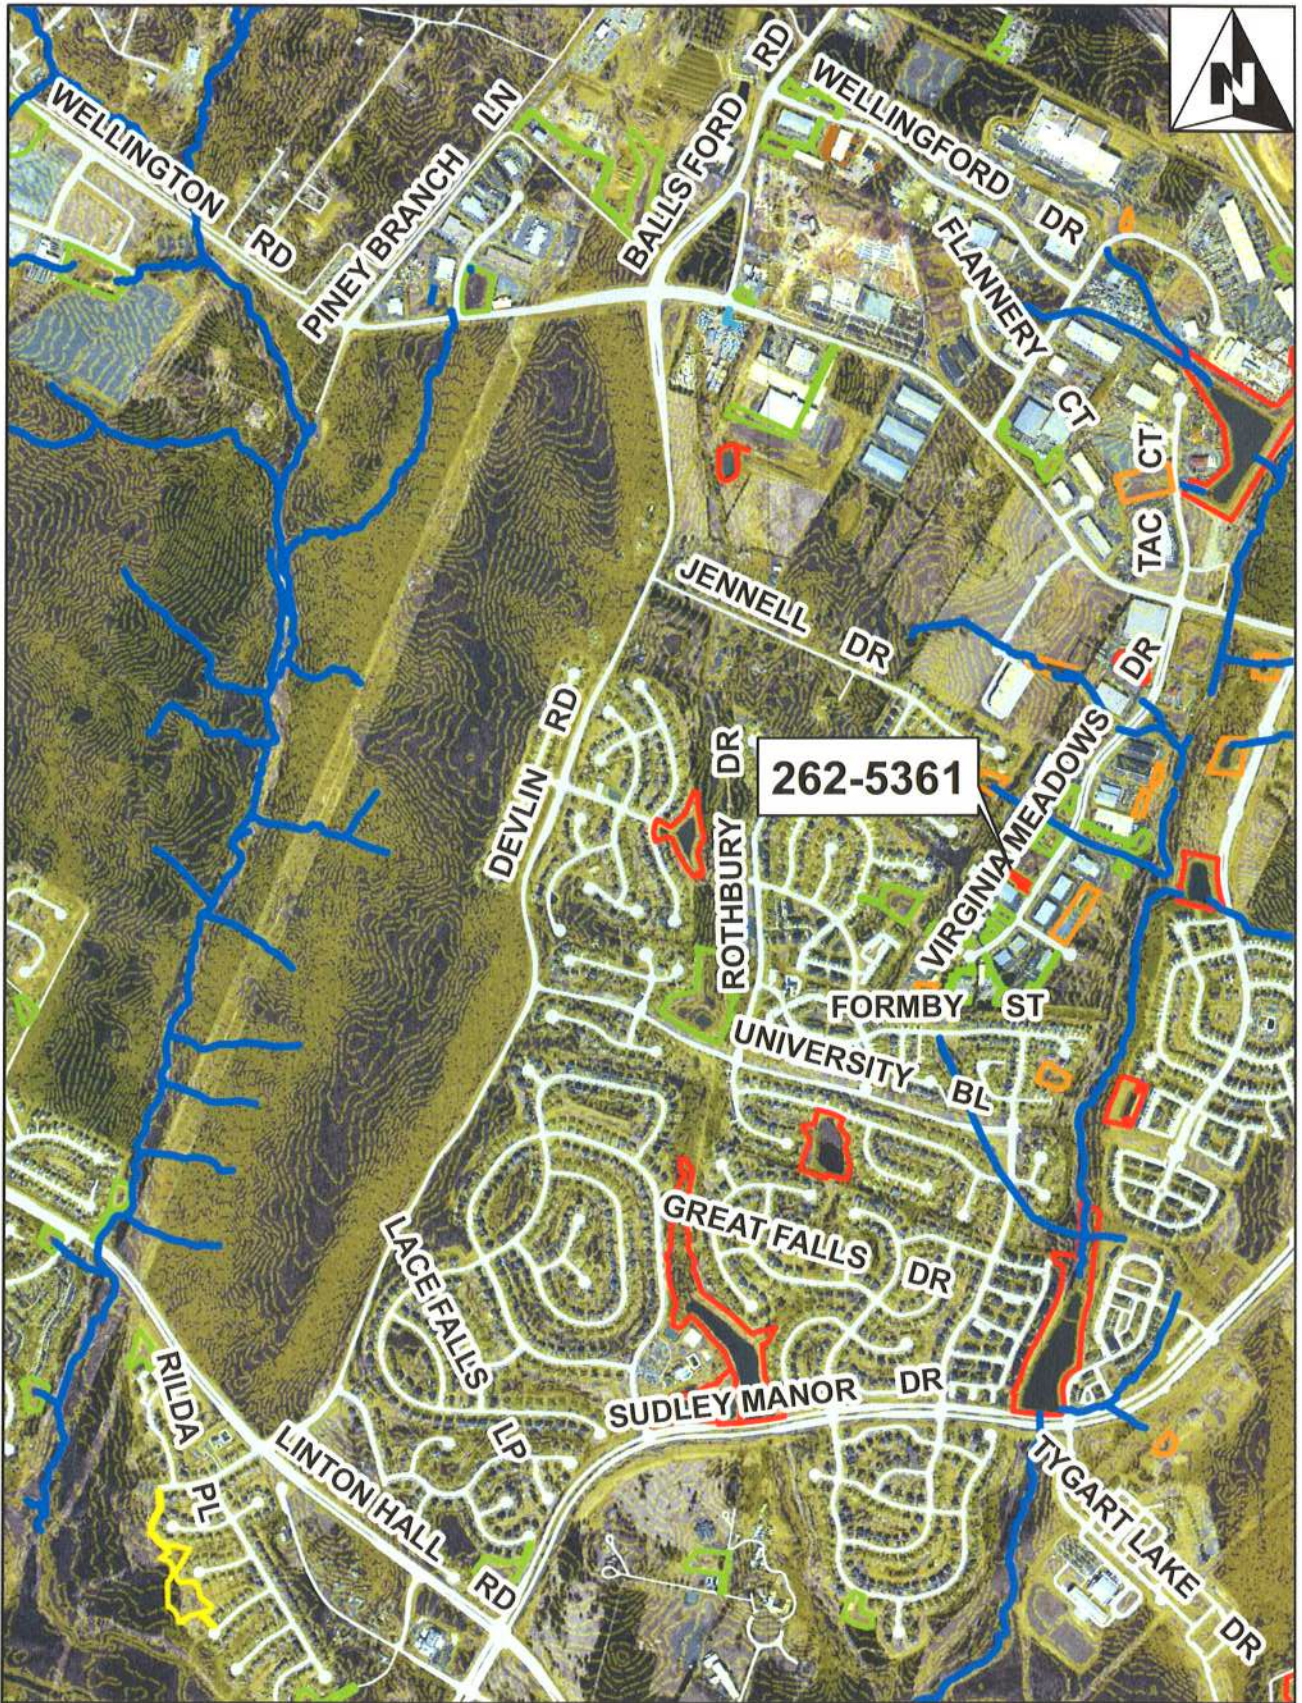
Watershed: Dawkins Branch
Site ID#: 262-5361
BMP #: 5361
ADC Map (25th edition): Map 8, Page 13, grid coordinate B6

Problem Description: This dry basin is located in commercial property and is maintained by the County. It was built prior to 2003 and has a 48 riser with a RCP outlet pipe, and no spillway. Initially the CSWMP/BMP appears well maintained, but closer inspection indicates that soil is piping through the embankment and into the outlet pipe (see photo). There is grout around the soil piping hole from past repair attempts. This type of piping would require significant head pressure. A more detailed inspection of the riser indicated that the constrictor plate installed in the low flow orifice is solid – it lacks a low flow orifice. This pond appears to pond deeply between storms, and the primary outlet for the ponded water is through the outlet pipe instead of the riser. Significant rust on the trash rack also supports the possibility of long ponding durations. One small PVC pipe discharges to the BMP which may not be stormwater. The BMP does not have a forebay and there is minor sediment accumulation at one end of the facility.

Project Description: A detailed inspection of the riser and outlet pipe should be conducted, and repairs completed to eliminate the causes for the soil piping into the outlet pipe. Due to the angle of the outlet pipe through the embankment, there is very shallow fill over the pipe, which should be addressed in any repairs.
