Appendix D Index

SWM/BMP Facility Site Photographs

Appendix D
SWM/BMP Facility Site Photographs
Occoquan Watershed – Study of Four Subsheds
WSSI #25156.01

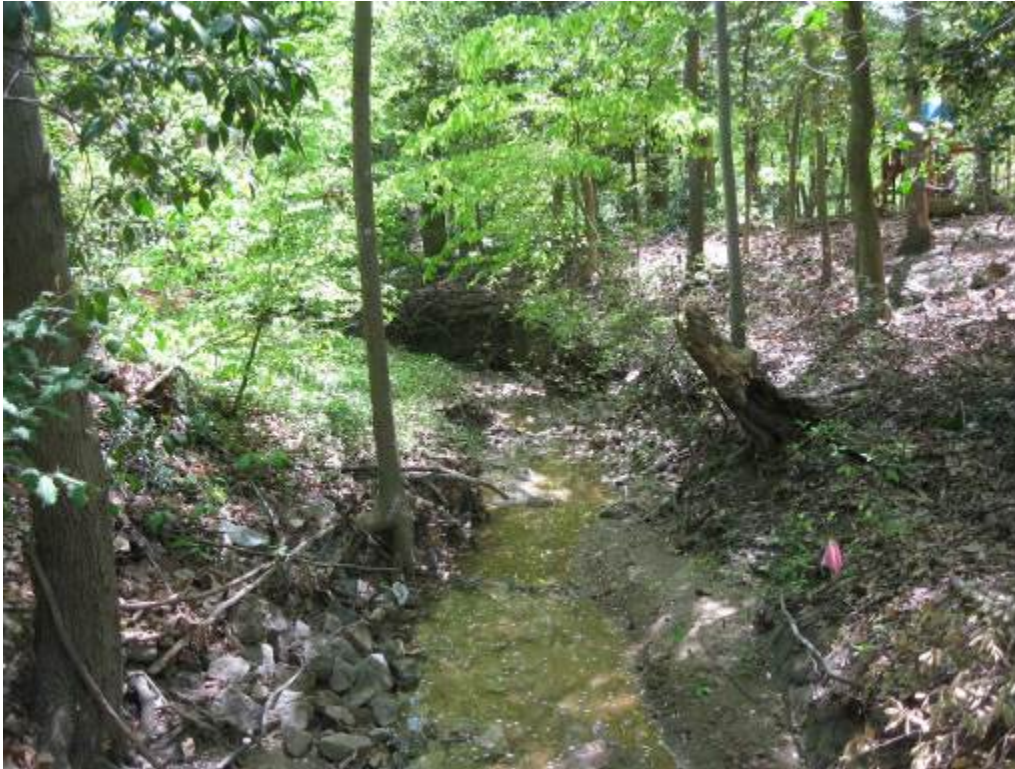
53. Facility 465. Looking downstream at incised channel showing active signs of erosion. Notice proximity of adjacent residences.
