APPENDIX A –REACH DESCRIPTIONS

Basin 615, South Fork of Quantico Creek - Project Reach Descriptions

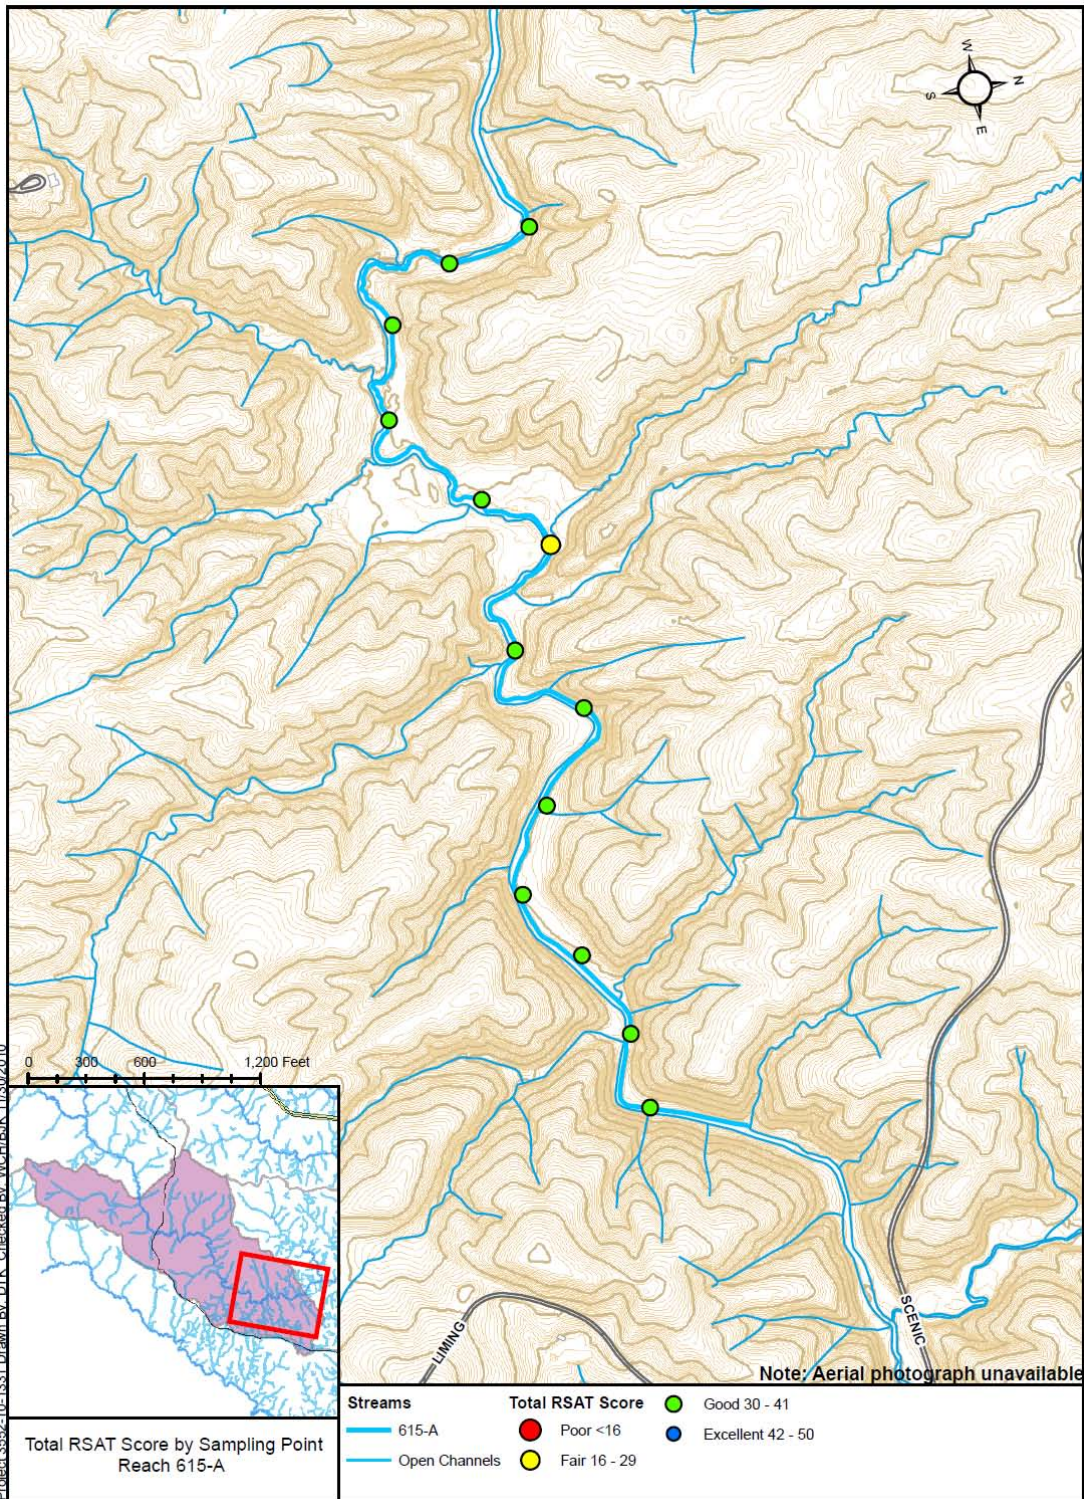
Reach Name: 615-A

geomorphically stable. Approximately 80% of streambanks are stable, with only minor bank scouring, occurring opposite of gravel point bars. Approximately 25-49% of bed material is embedded gravel and cobble, with well-formed pools and riffles, and depositional point bars comprised of coarse gravel with minimal sand deposits.

Riparian habitat is in excellent condition along this reach, with a wide forested buffer in excess of 200ft on either side of the channel. Canopy cover is dense, providing greater than 80% shading over the stream. In addition, the biological indicator scores are excellent, corresponding to the rich diversity and large quantities of macroinvertebrates, including mayflies, stoneflies, and caddisflies. Water quality along Reach 615-A is good, with an average score of 5, indicative of light substrate fouling, low TDS, and visibility to depths greater than 1.5ft, despite large amounts of leaf litter and organic debris from the surrounding riparian forest.

None

None

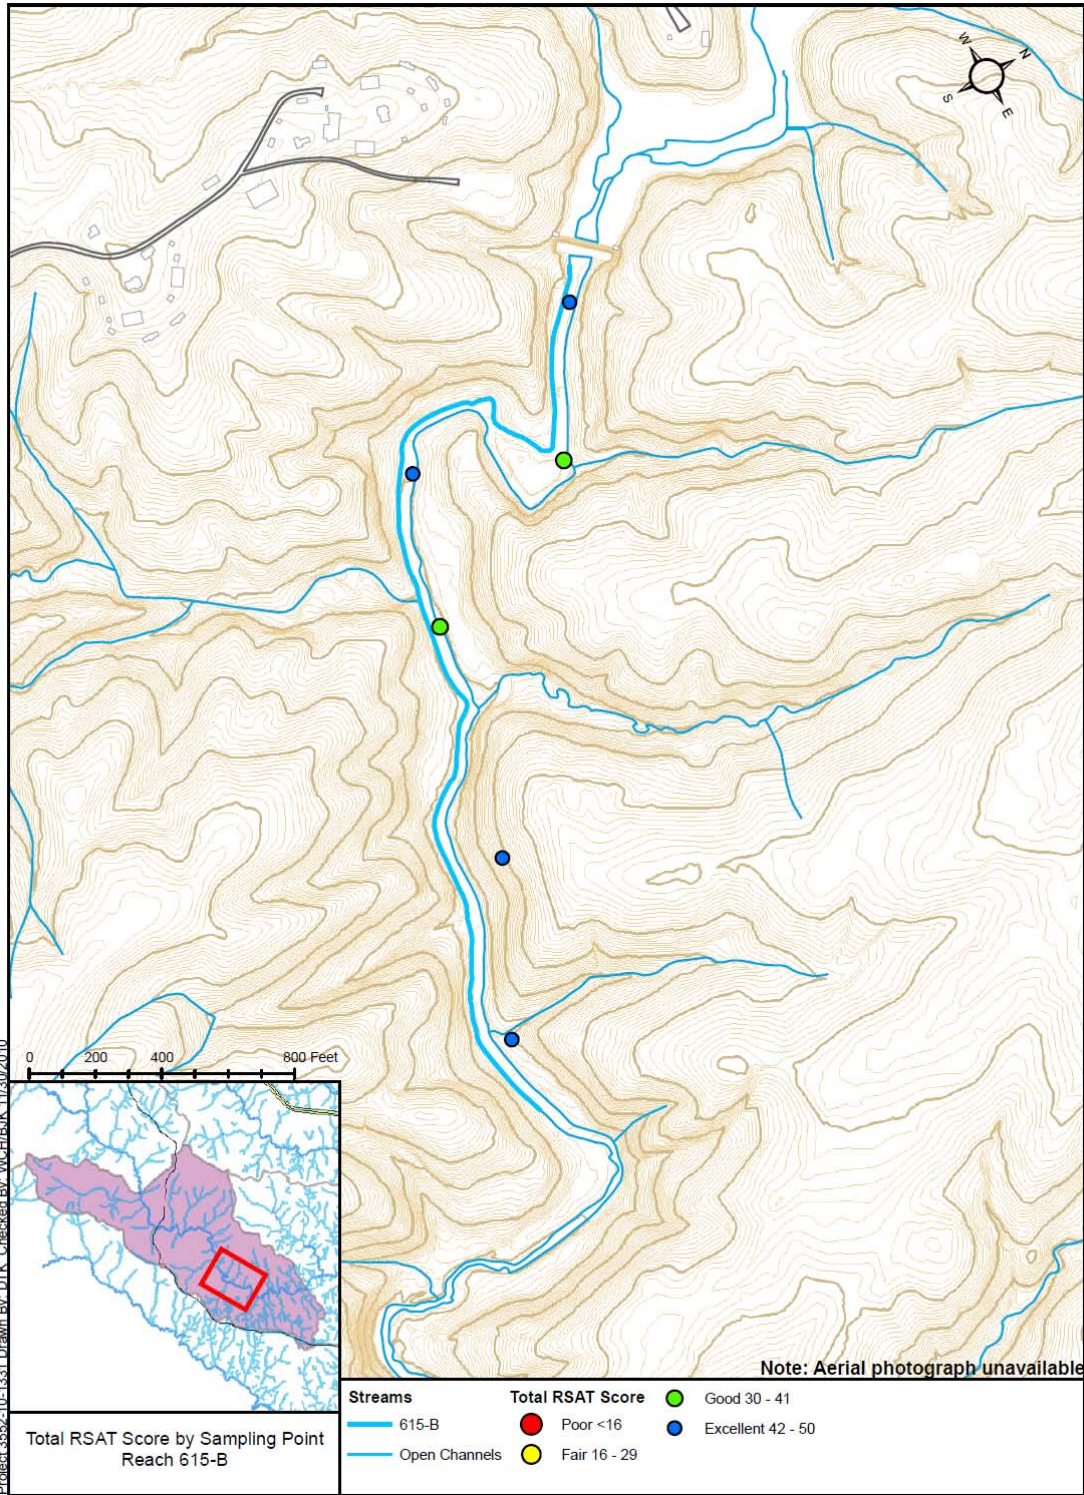
Reach Name: 615-B

Riparian habitat remains in excellent condition, with a wide forested buffer in excess of 200ft on either side of the channel. Canopy cover is dense, providing greater than 80% shading over the stream. In addition, the biological indicator scores are excellent, corresponding to the rich diversity and large quantities of macroinvertebrates. Water quality along Reach 615-A is good, with an average score of 5, indicative of light substrate fouling, low TDS, and visibility to depths greater than 1.5ft, despite large amounts of leaf litter and organic debris from the surrounding riparian forest.

None

None

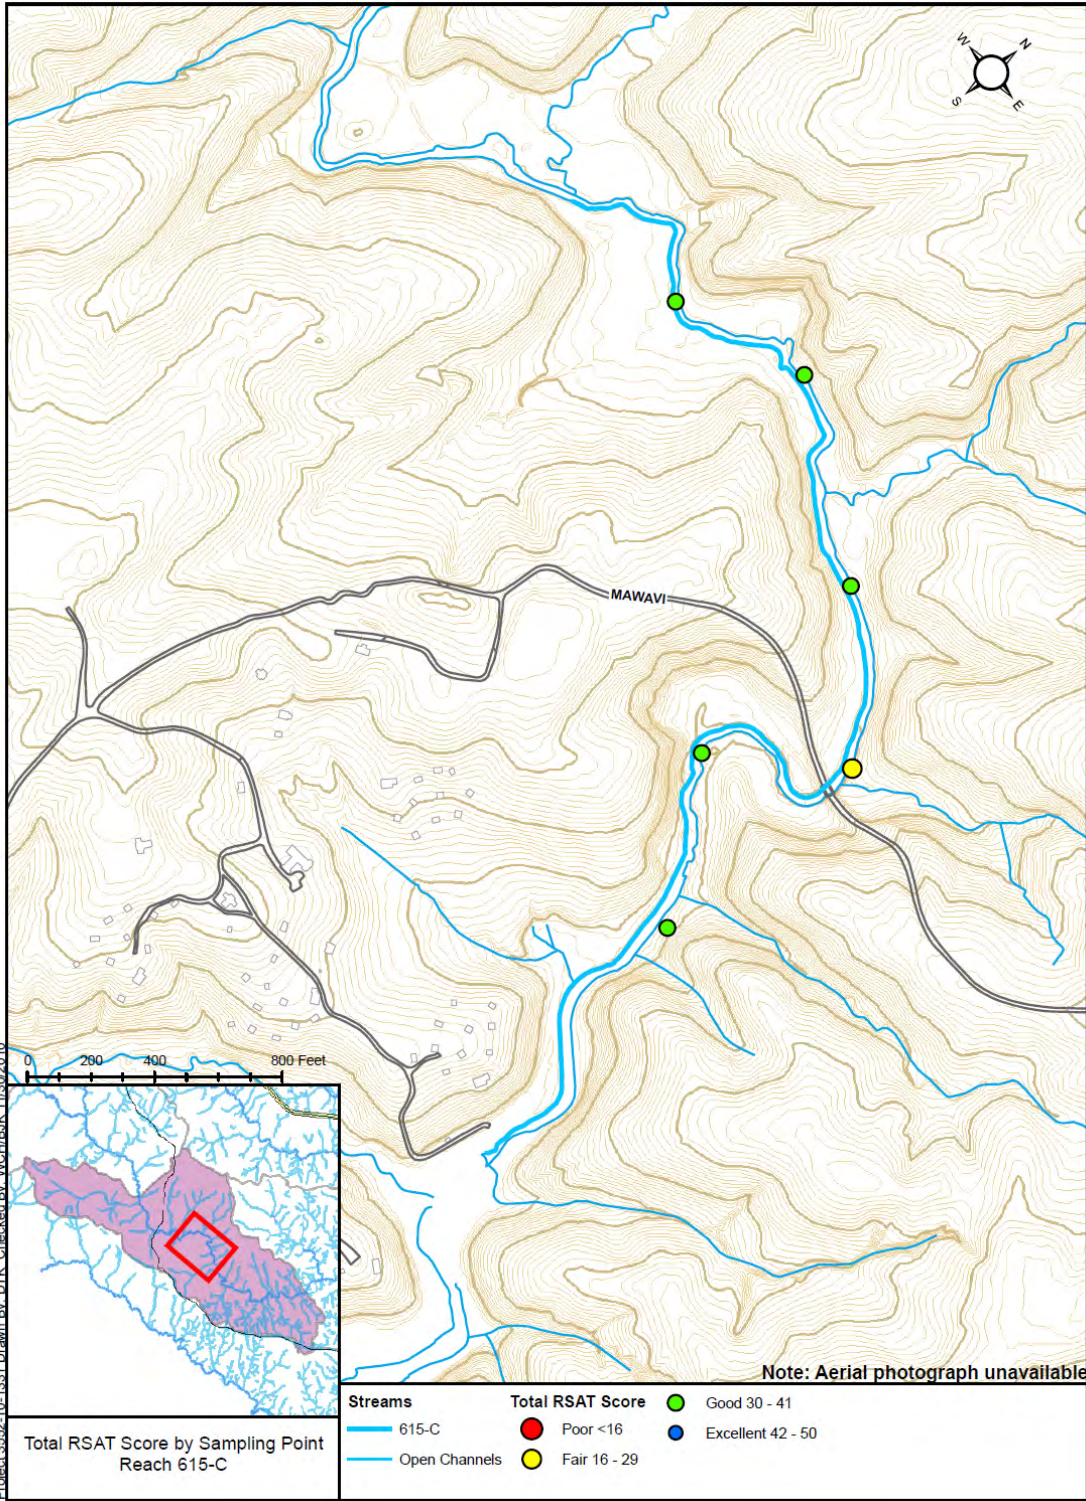
Reach Name: 615-C

Riparian habitat remains in excellent condition, with a wide forested buffer in excess of 200ft on either side of the channel. Canopy cover is dense, providing greater than 80% shading over the stream. However, biological indicator and water quality ranked fair, corresponding to a reduced diversity and quantity of macroinvertebrates, coupled with an increase in substrate fouling, TDS, and reduced depth of visibility.

None

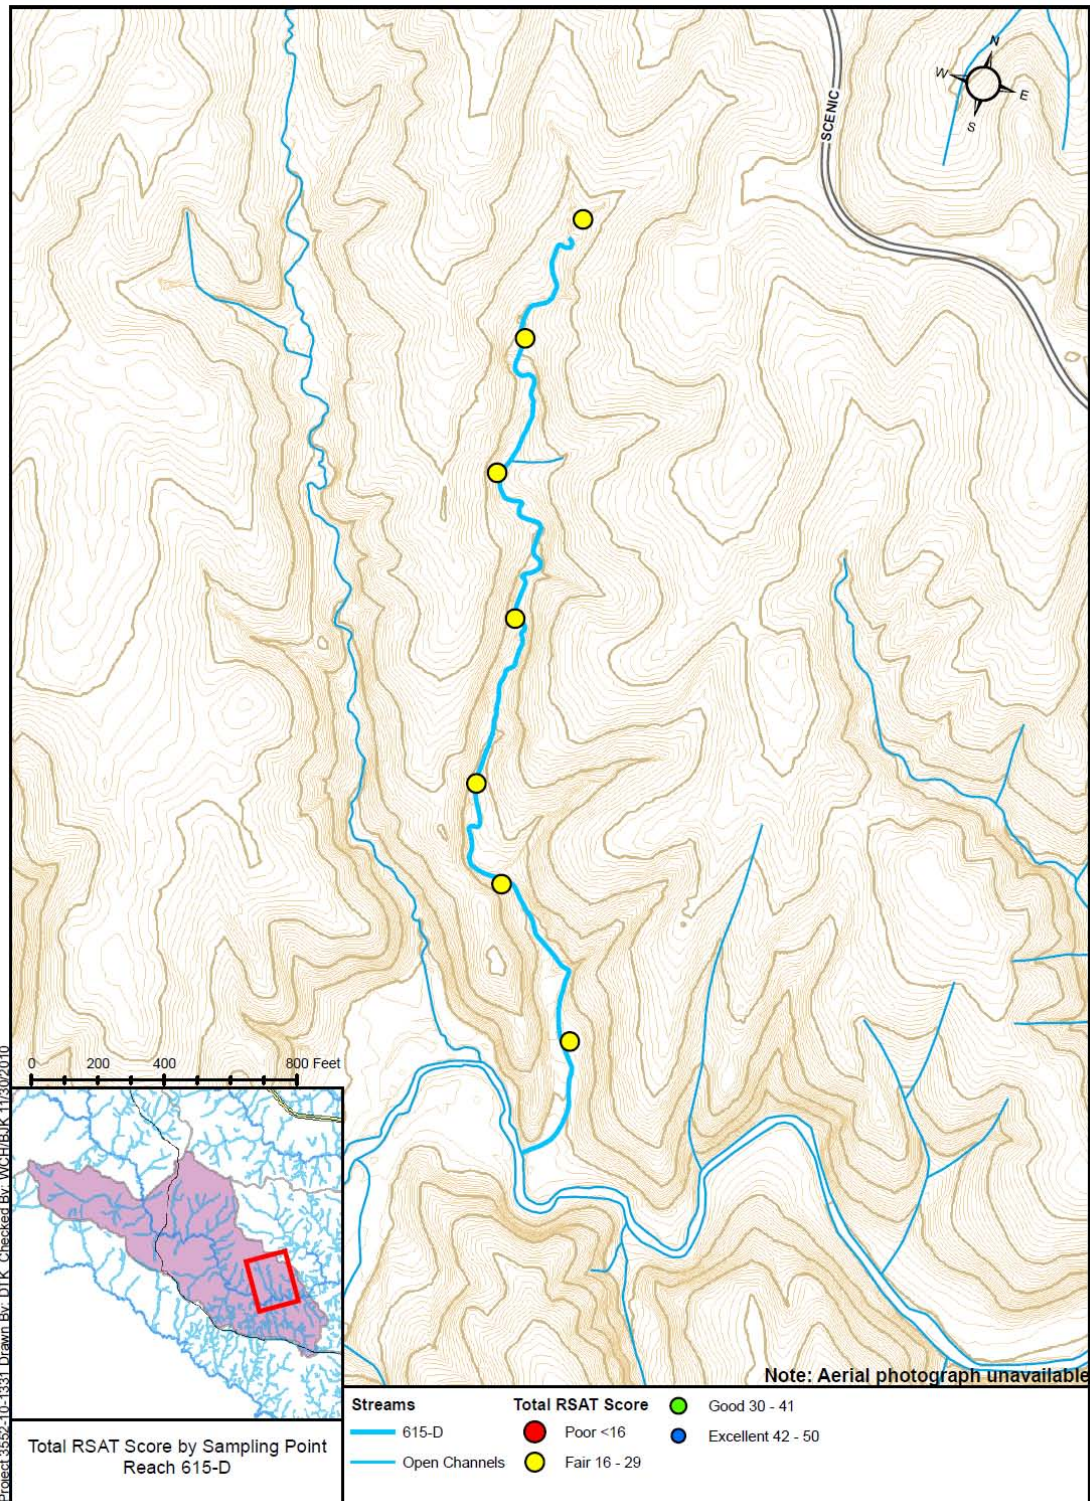
Reach Name: 615-D

Riparian habitat is in excellent condition, with a wide forested buffer in excess of 200ft on either side of the channel, and canopy cover is dense, providing greater than 80% shading. Biological indicators are absent along this reach (resulting in a score of 0), as the flow is shallow and intermittent. Water quality is fair, with a moderate level of substrate fouling (21-50%), increased TDS, and reduced depth of visibility.

None

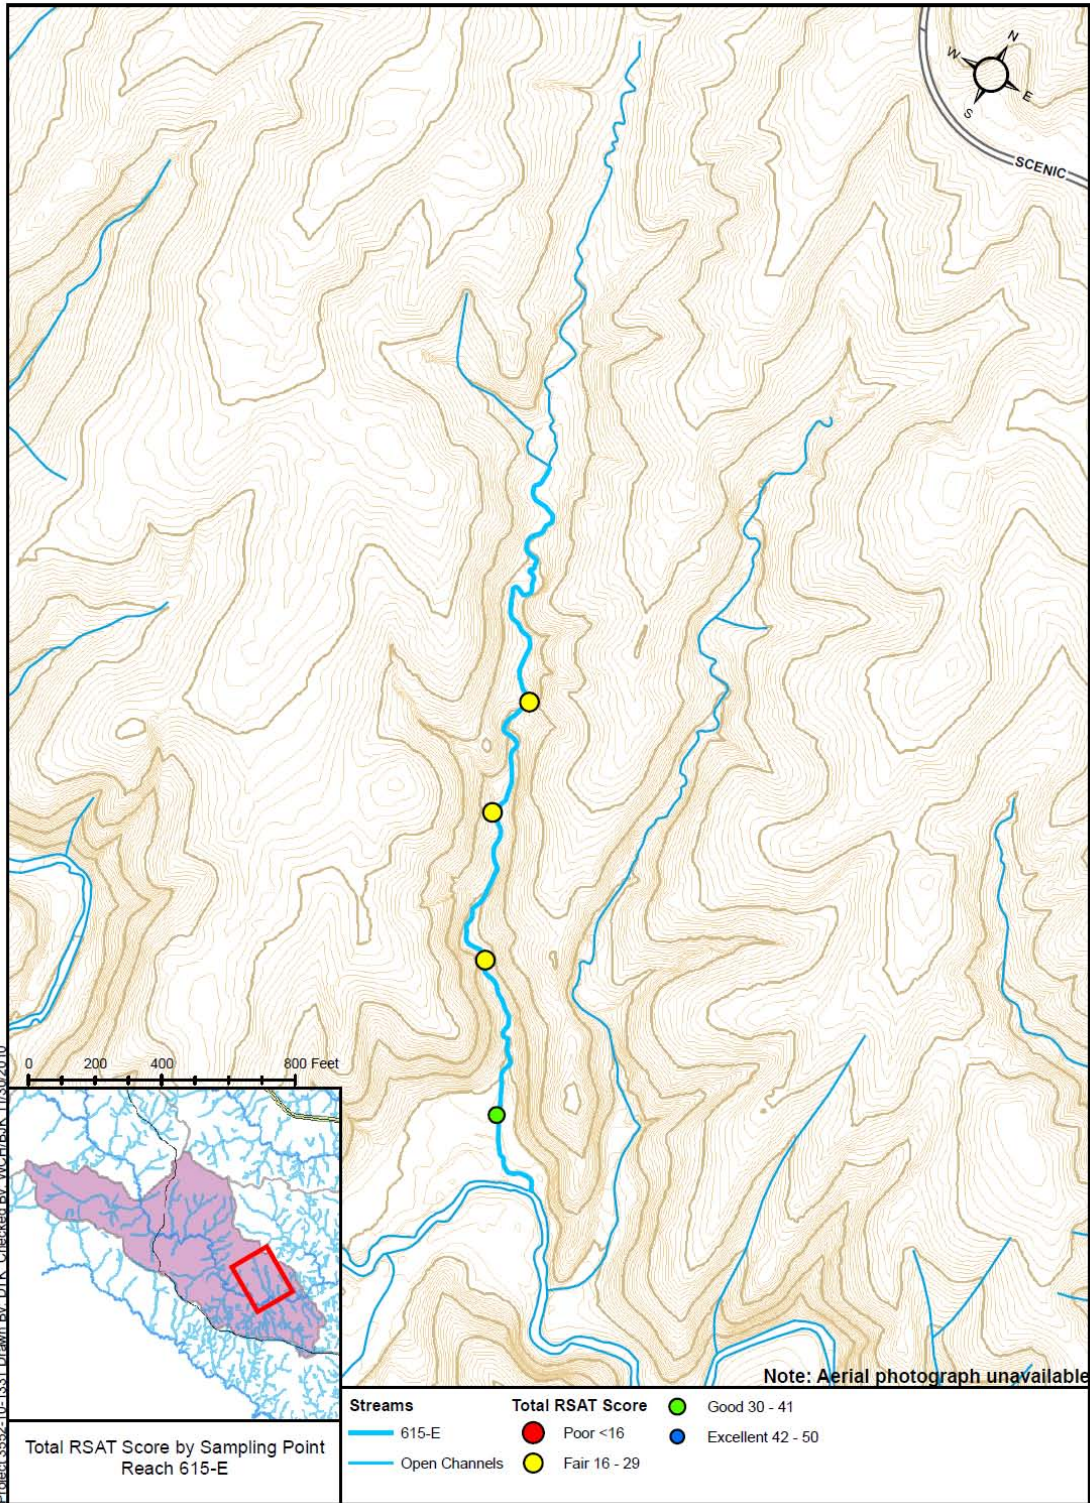
Reach Name: 615-E

Riparian habitat is in excellent condition, with a wide forested buffer in excess of 200ft on either side of the channel, and canopy cover is dense, providing greater than 80% shading. Biological indicators are poor, with a nearly depauperate population of midgeflies and snails. Water quality is fair, with a moderate level of substrate fouling, increased TDS, and reduced depth of visibility.

None

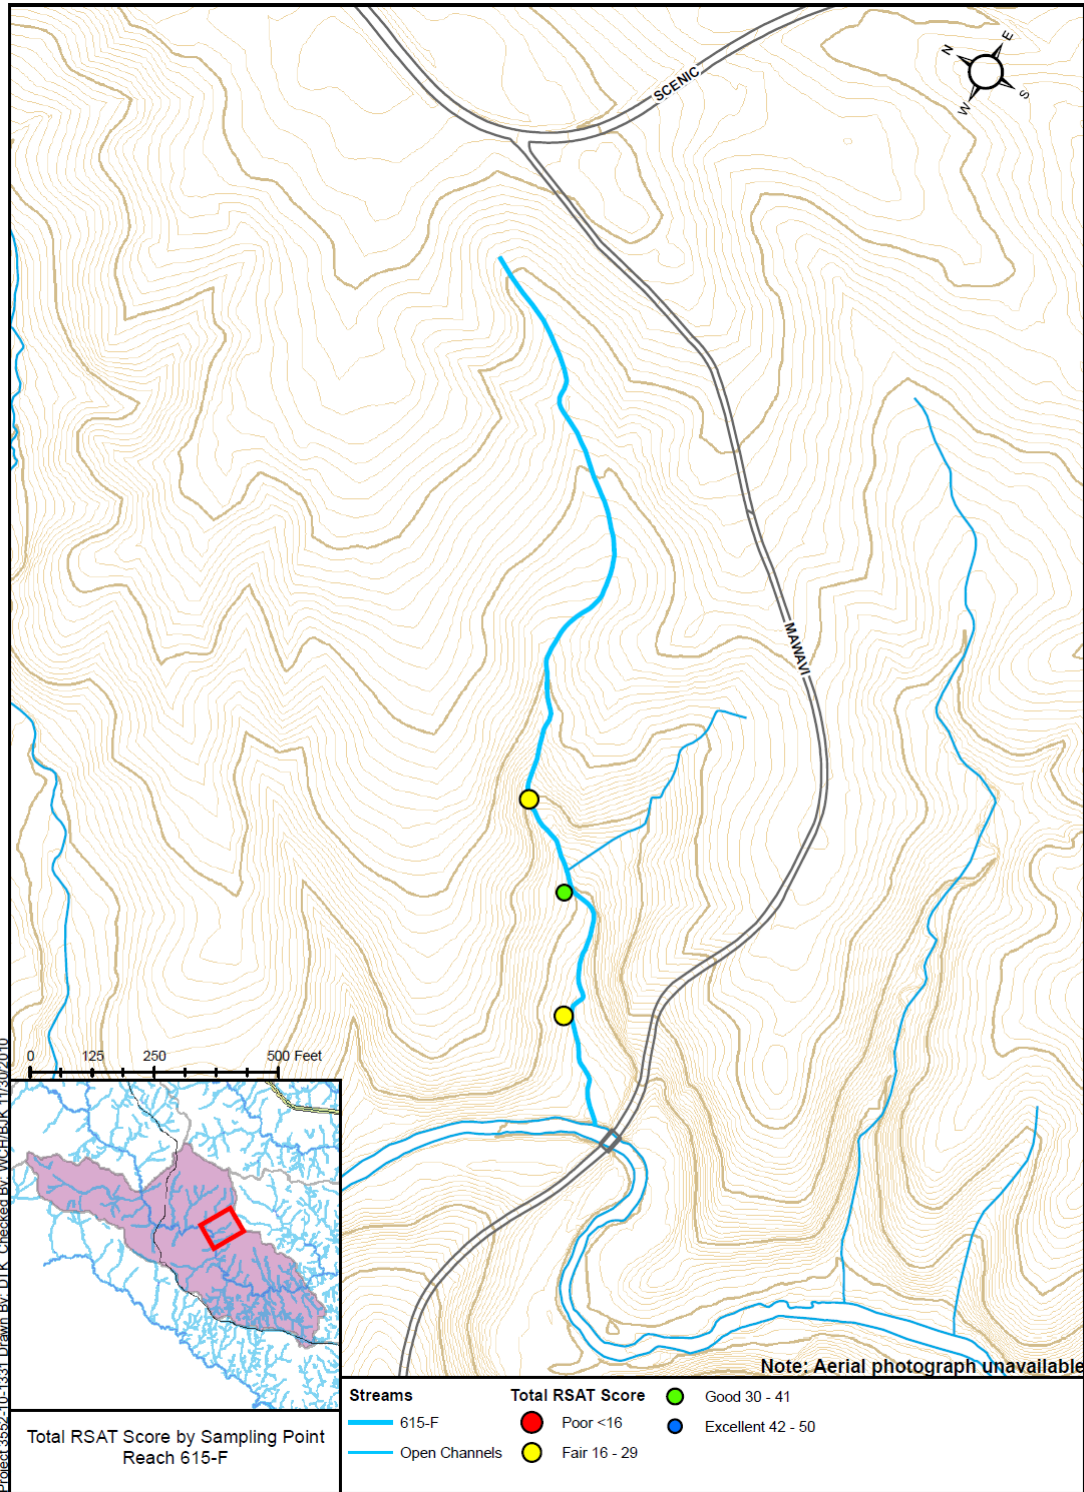
Reach Name: 615-F

Riparian habitat is in excellent condition, with a wide forested buffer in excess of 200ft on either side of the channel, and canopy cover is dense, providing greater than 80% shading. Biological indicators are fair, with a few pollution-tolerant species, such as caddisfly and midge fly. Water quality is fair, with a moderate level of substrate fouling, increased TDS, and reduced depth of visibility.

None

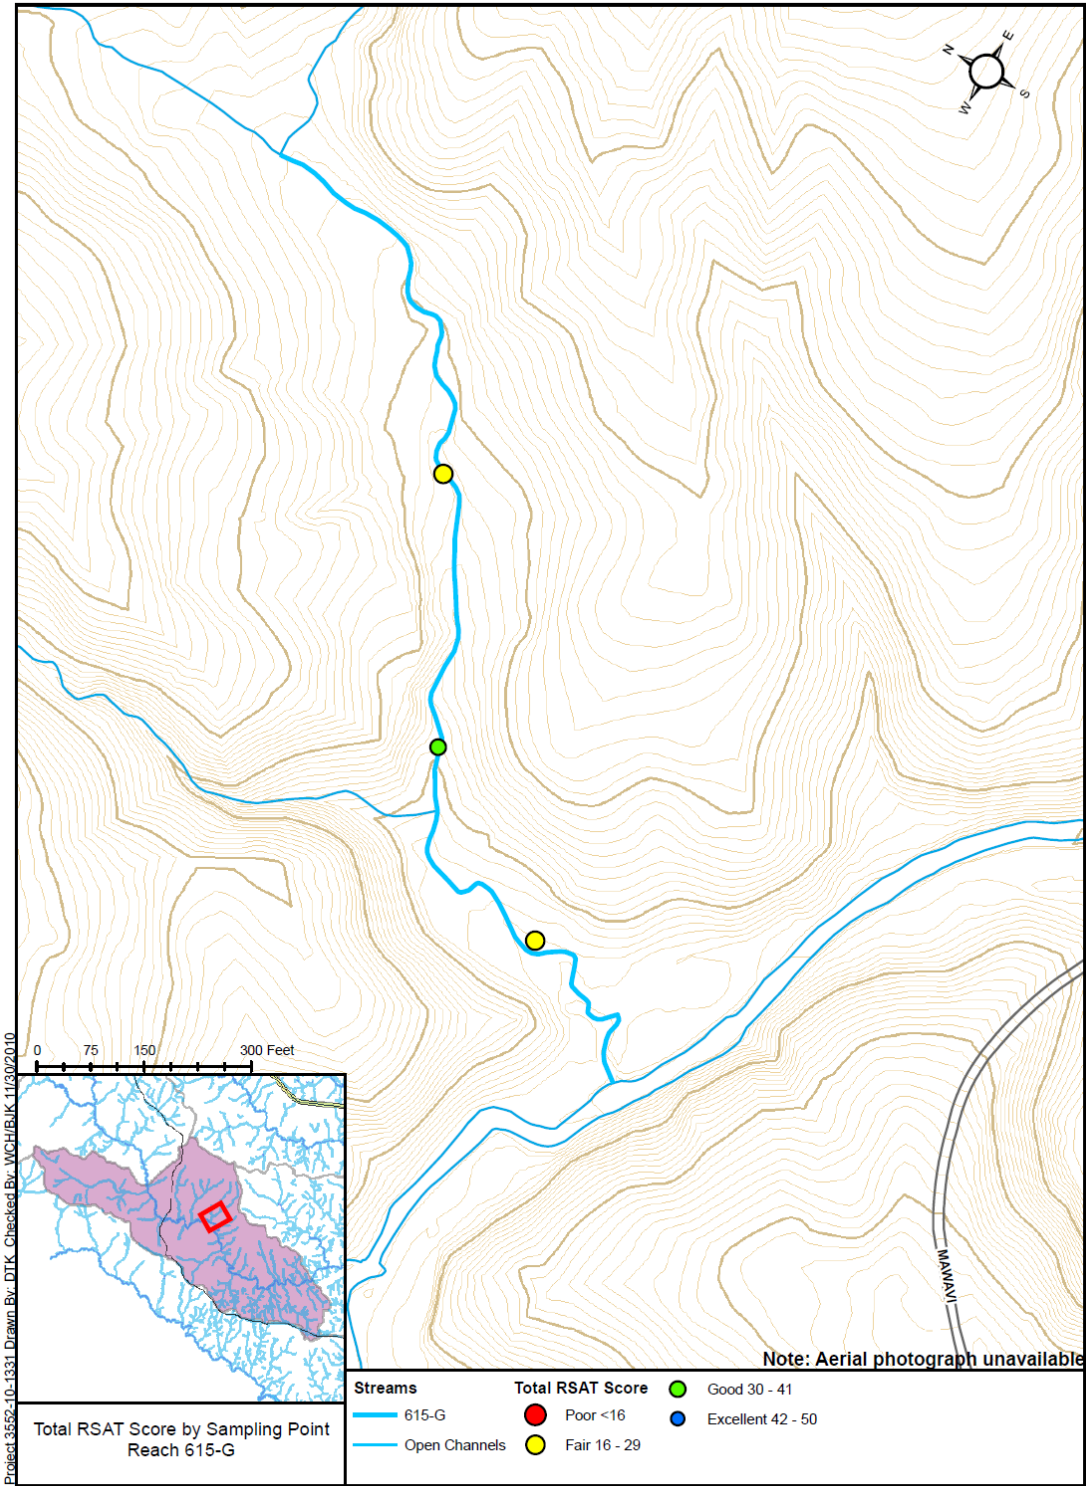
Reach Name: 615-G

Riparian habitat is in excellent condition, with a wide forested buffer in excess of 200ft on either side of the channel, and canopy cover is dense, providing greater than 80% shading. Biological indicators are fair, with a few pollution-tolerant species, such as caddisfly and midge fly. Water quality is fair, with a moderate level of substrate fouling, increased TDS, and reduced depth of visibility.

None

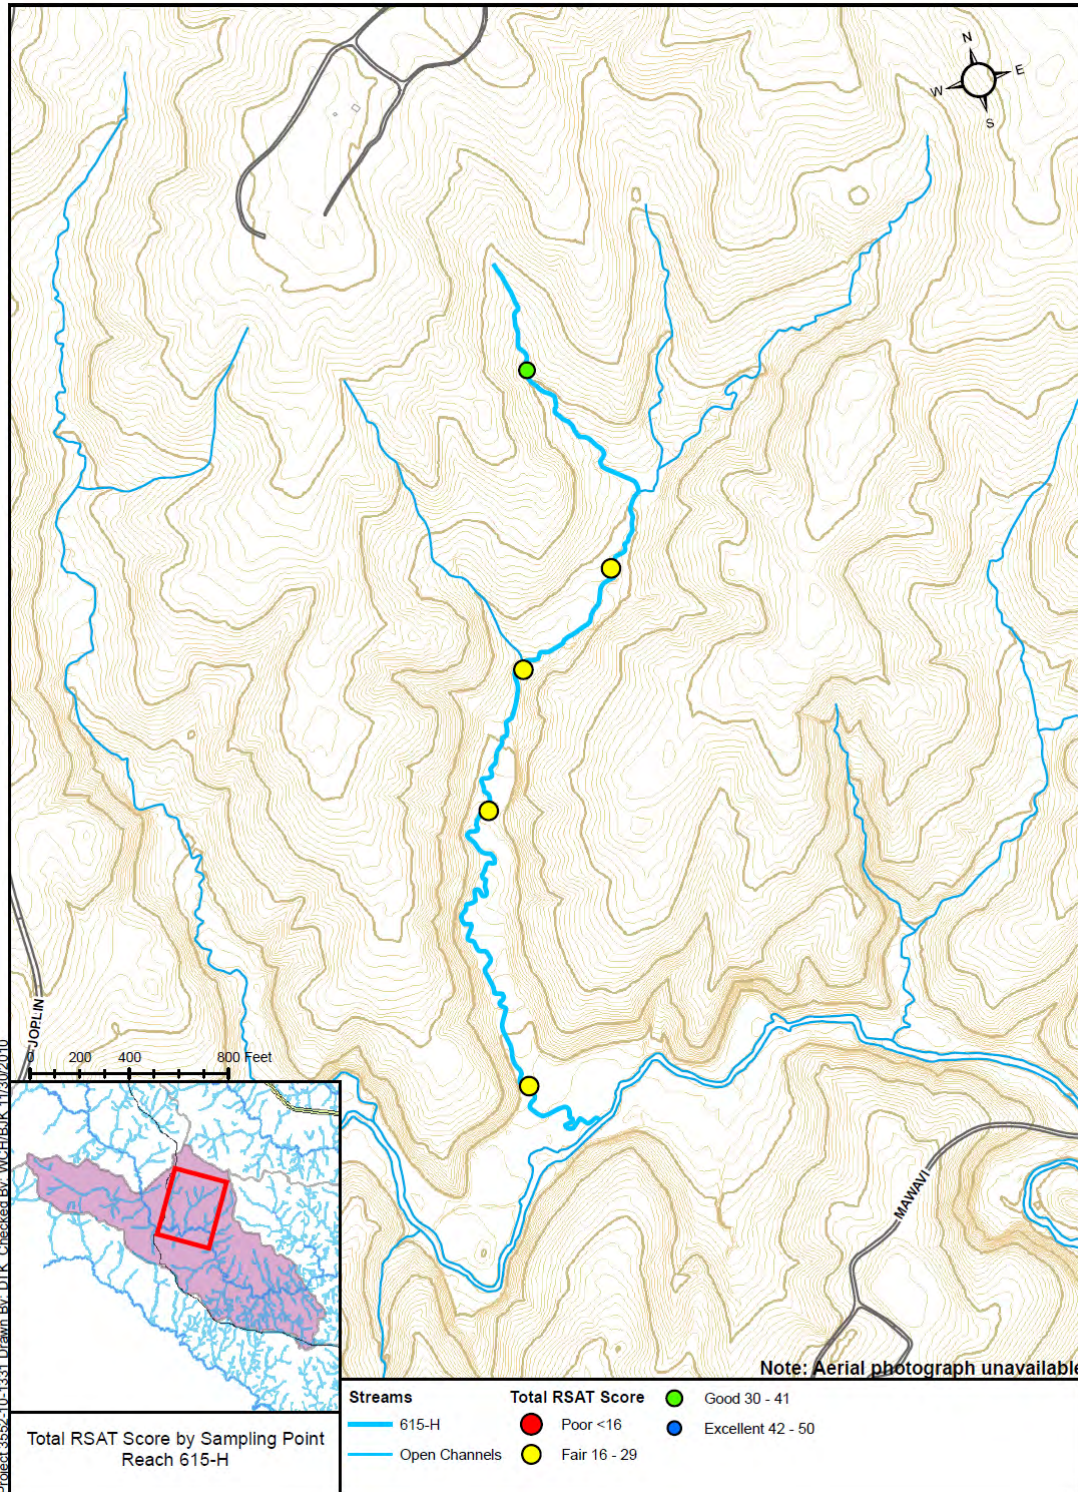
Reach Name: 615-H

Riparian habitat is in excellent condition, with a wide forested buffer in excess of 200ft on either side of the channel, and canopy cover is dense, providing greater than 80% shading. Biological indicators are poor, with a depauperate population of midgeflies. Water quality is fair, with a moderate level of substrate fouling, increased TDS, and reduced depth of visibility.

None

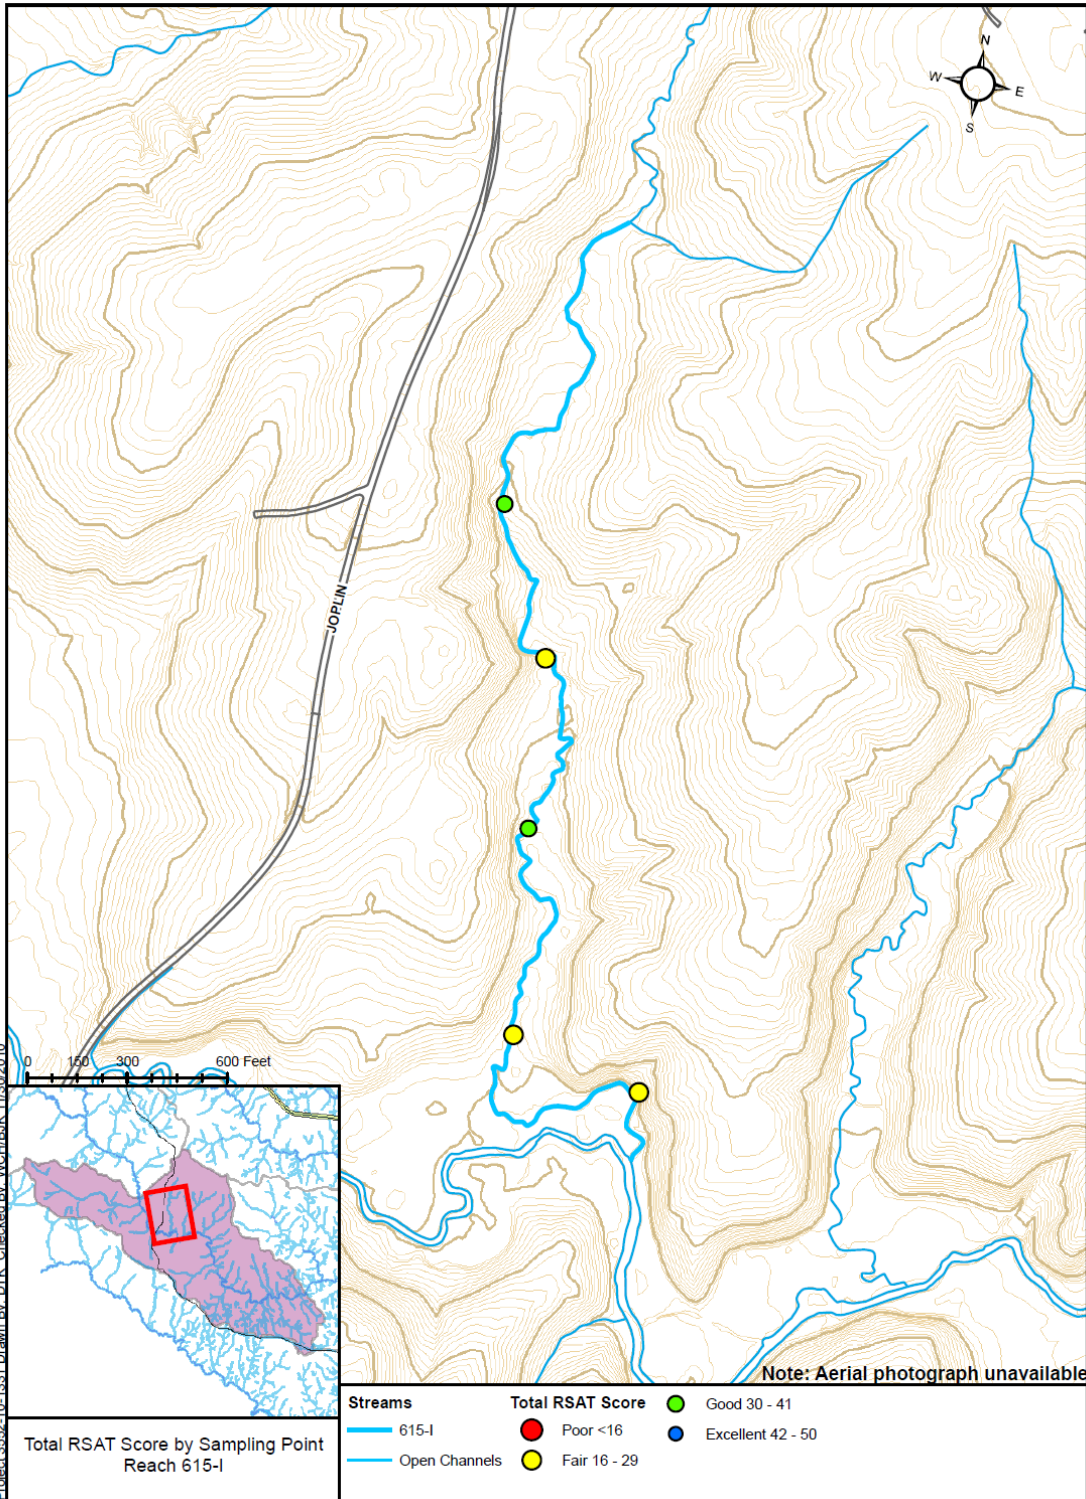
Reach Name: 615-I

Riparian habitat is in excellent condition, with a wide forested buffer in excess of 200ft on either side of the channel, and canopy cover is dense, providing greater than 80% shading. Biological indicators are fair, with a few pollution-tolerant species, such as caddisfly and midgefly. Water quality is fair, with a moderate level of substrate fouling, increased TDS, and reduced depth of visibility.

None

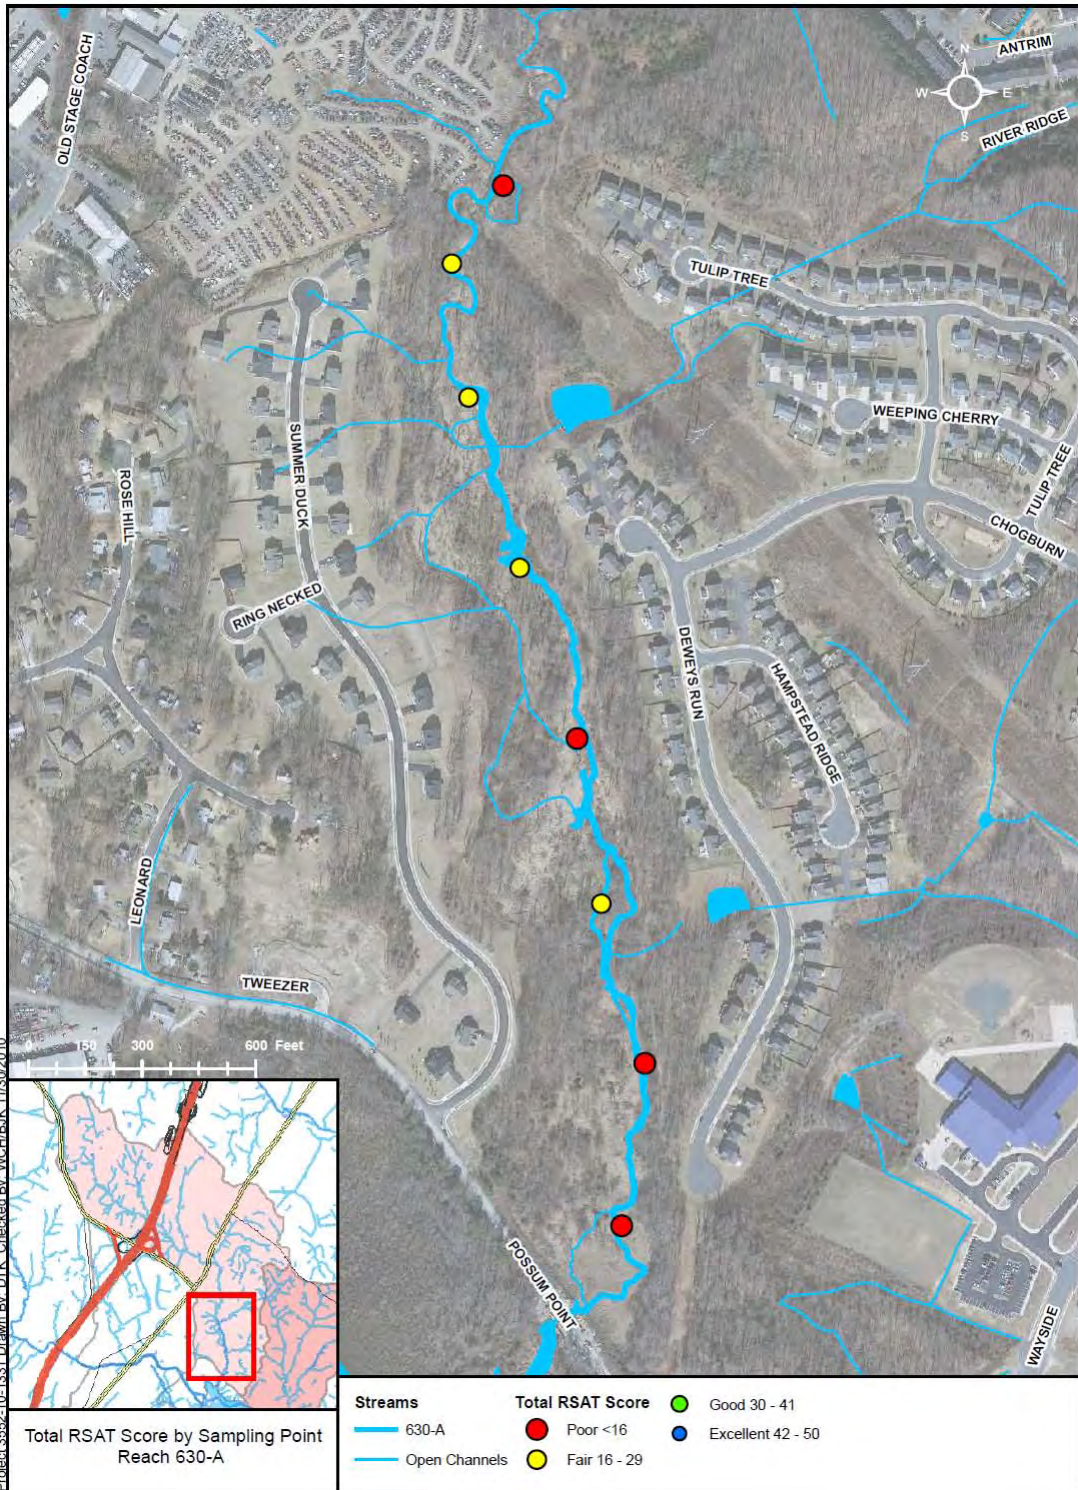
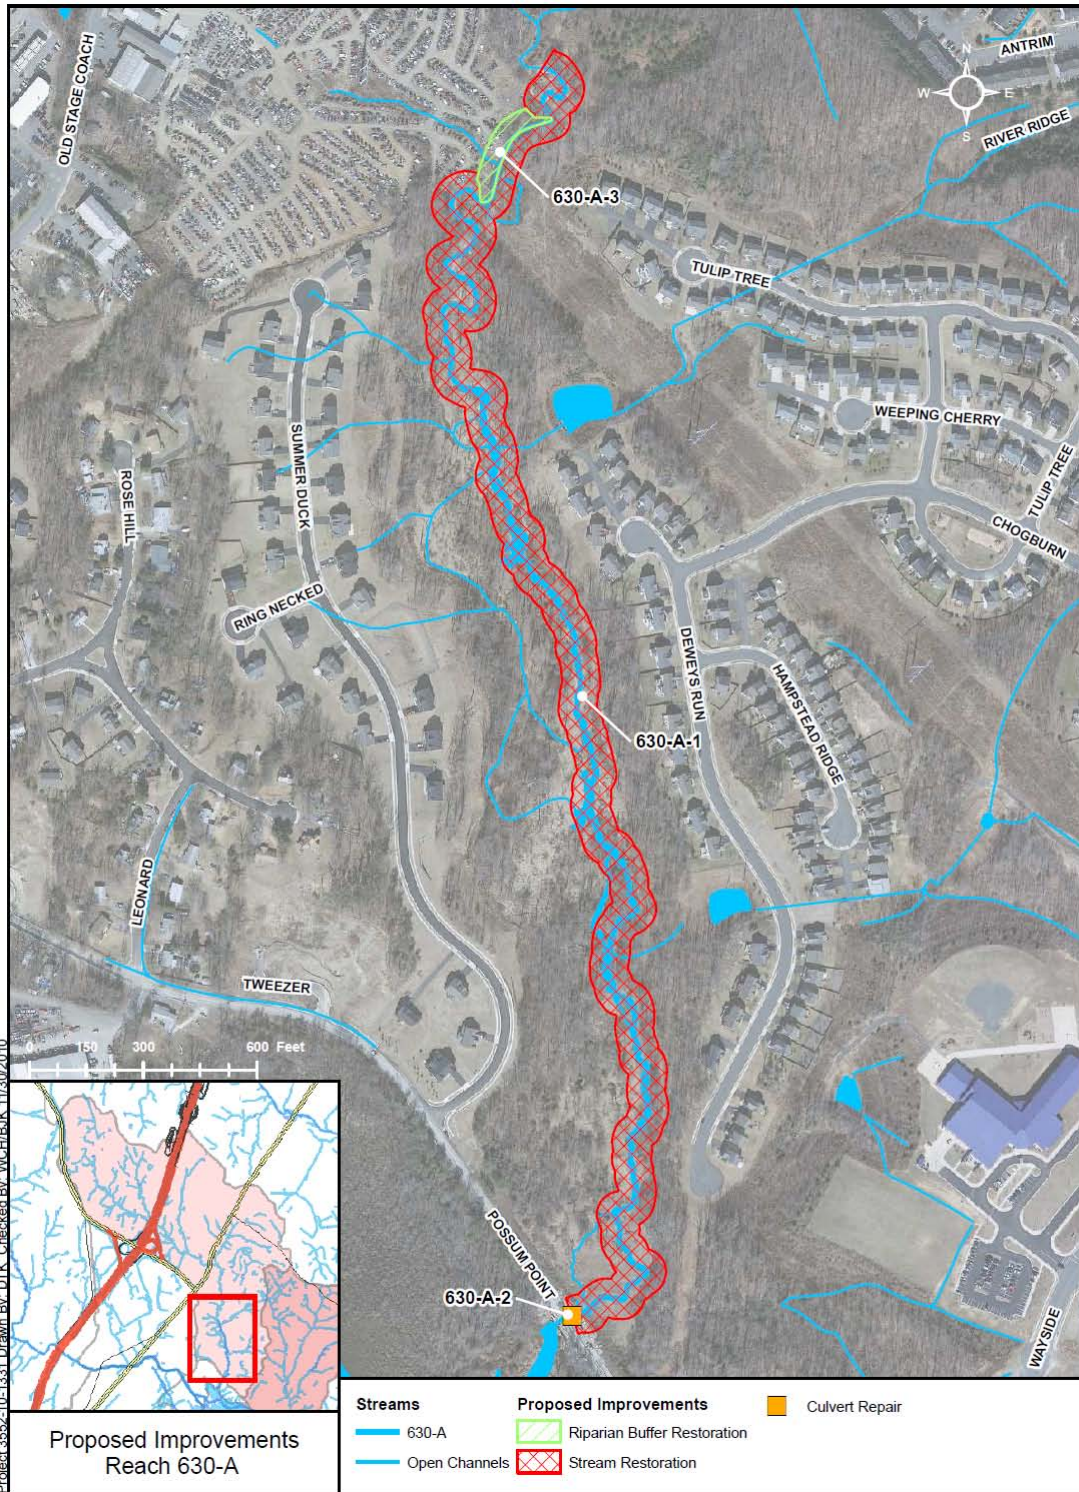
Reach Name: 630-A

Riparian habitat is in fair condition, with a predominantly wooded corridor, but with large gaps in woody vegetation and canopy coverage. Biological indicators are absent along this reach (resulting in a score of 0). Water quality is fair, with a moderate level of substrate fouling, increased TDS, and a depth of visibility no more than 1ft.

- Remove debris and rubble from the streambanks behind Skip's Auto Parts (at the intersection of Jefferson Davis Highway and Old Stage Coach Road) and restore the riparian buffer zone with seed, straw and container plants (at a planting density of up to 1200 stems/acre) along 250 linear feet of channel. Establish a conservation easement, or permanent deed restriction area, to protect the buffer zone to a minimum of 100ft from the channel.

- Repair or retrofit the culvert at Possum Point Road with up to 4 rock weirs or wing deflectors and a floating trash rack to focus the flow, enhance sediment transport, trap woody debris, and prevent siltation of the culverts.

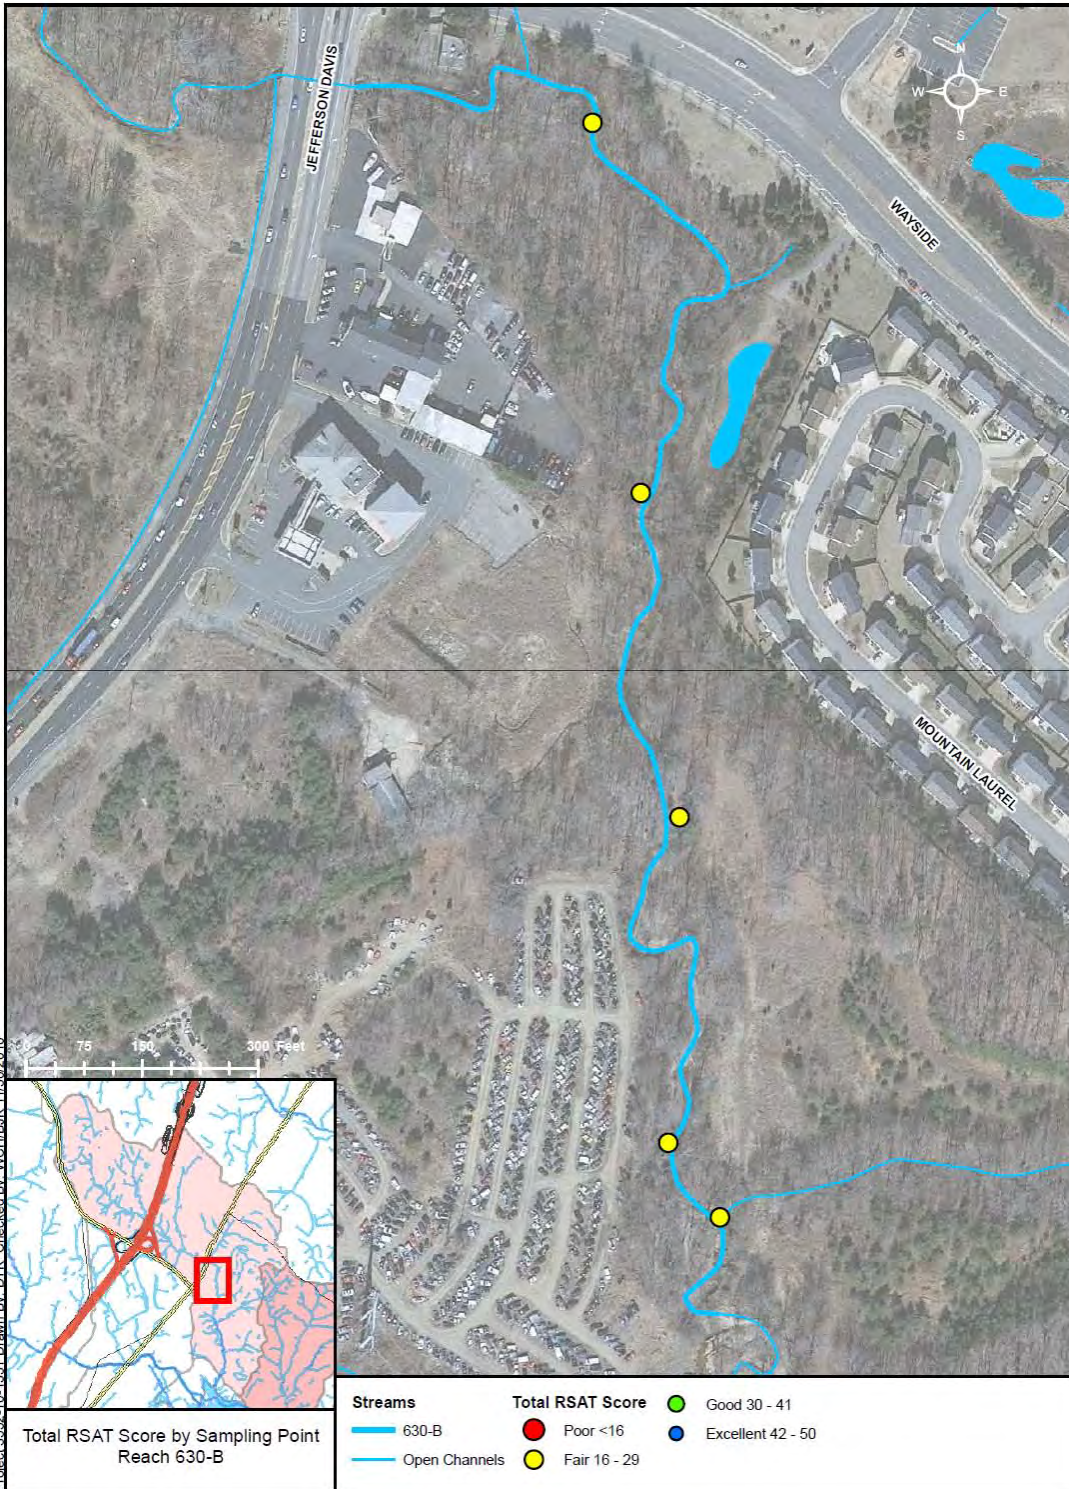
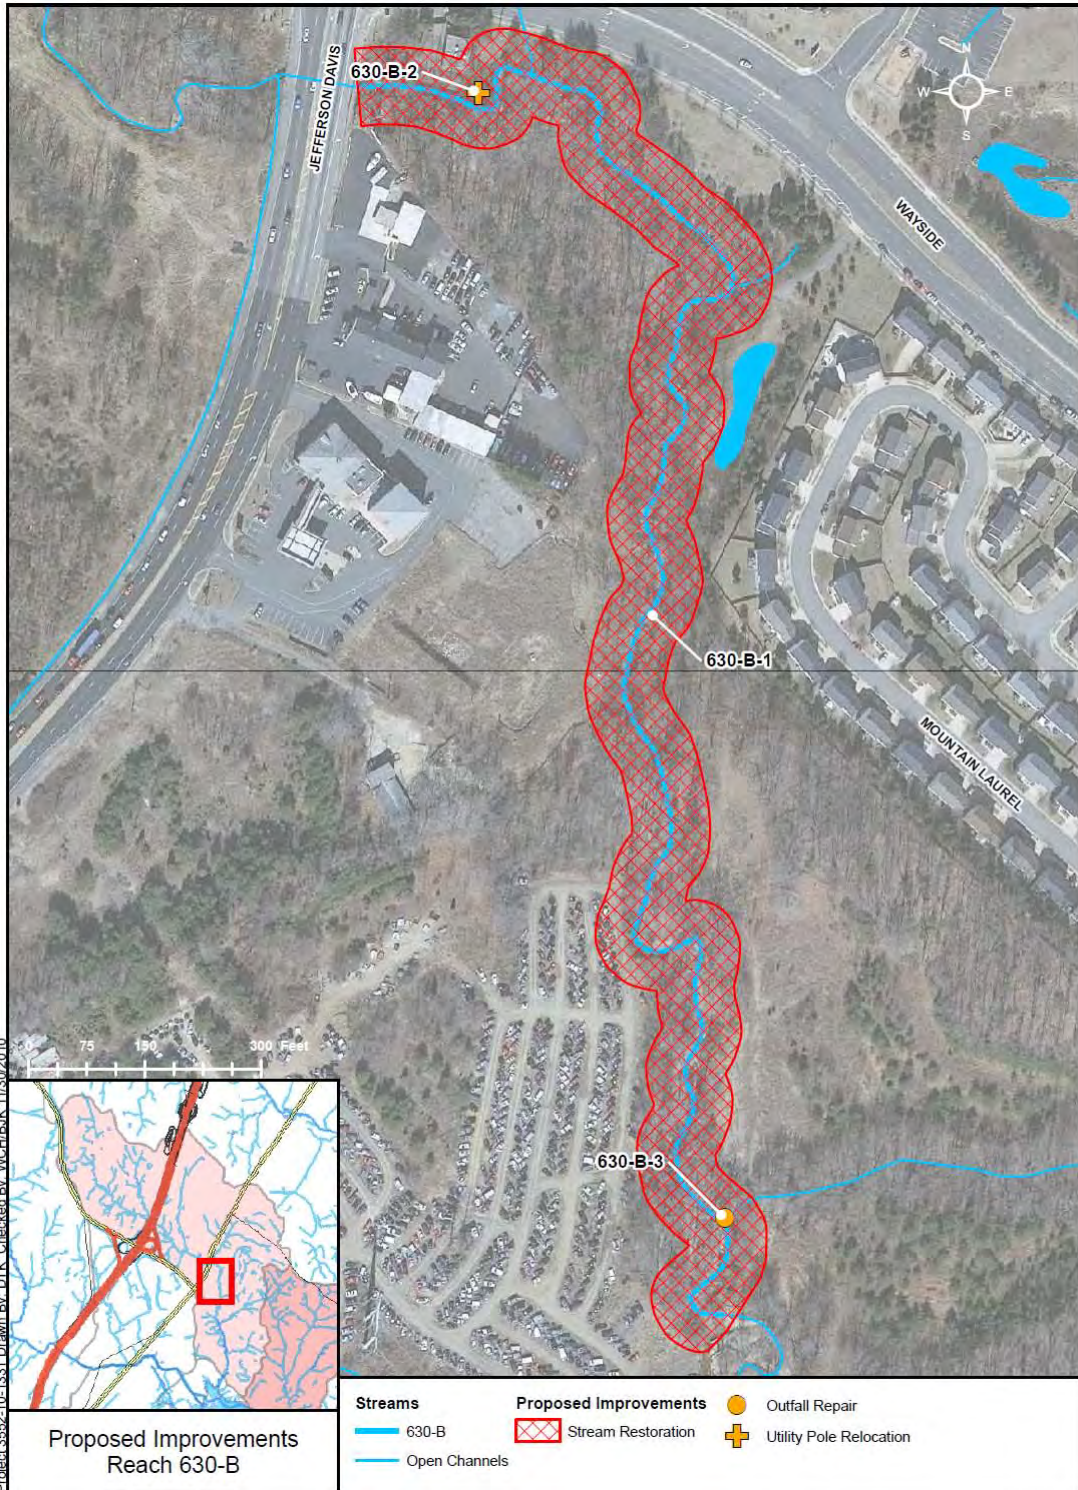
Reach Name: 630-B

Reach 630-B is a fair quality stream, with an average total RSAT score of 22. Channel widening is responsible for low channel stability scores (with an average value of 4) and widespread bank erosion along approximately 50% of the reach. Channel scouring/deposition scores were fair, with increased deposition of sand and sediment and increased embeddness of riffle material. Physical instream habitat was in good condition, despite systemic erosion and subsequent deposition downstream. A good mix of riffles, runs and pools is present, along with a heterogeneous mix of bed materials, consisting of cobbles, gravel, sand and sediment.

Riparian habitat is in good condition, with a forested buffer of at least 100ft on either side of the channel, and dense canopy cover, providing approximately 60-79% shading. Biological indicators are poor, with a small population of the most pollution-tolerant macroinvertebrates. Water quality is fair, with a moderate level of substrate fouling, increased TDS, and reduced depth of visibility.

- Restore more than 2300ft of stream, from Jefferson Davis Highway to Tulip Tree Place, using fabric and plant bank treatment with rock toe to stabilize eroding streambanks, and up to 6 rock riffles for permanent grade stabilization.
 - Relocate an undermined utility pole along the left descending (north) bank, remove a large woody debris jam, and restore approximately 100 feet of eroded streambank downstream from Jefferson Davis Highway.
 - Stabilize 200ft of tributary, south of Wayside Drive and west of Mountain Laurel Loop, using fabric and plant bank treatment with rock toe, and replace the undermined pipe outfall and headwall.
