APPENDIX A –REACH DESCRIPTIONS

Basin 615, South Fork of Quantico Creek - Project Reach Descriptions

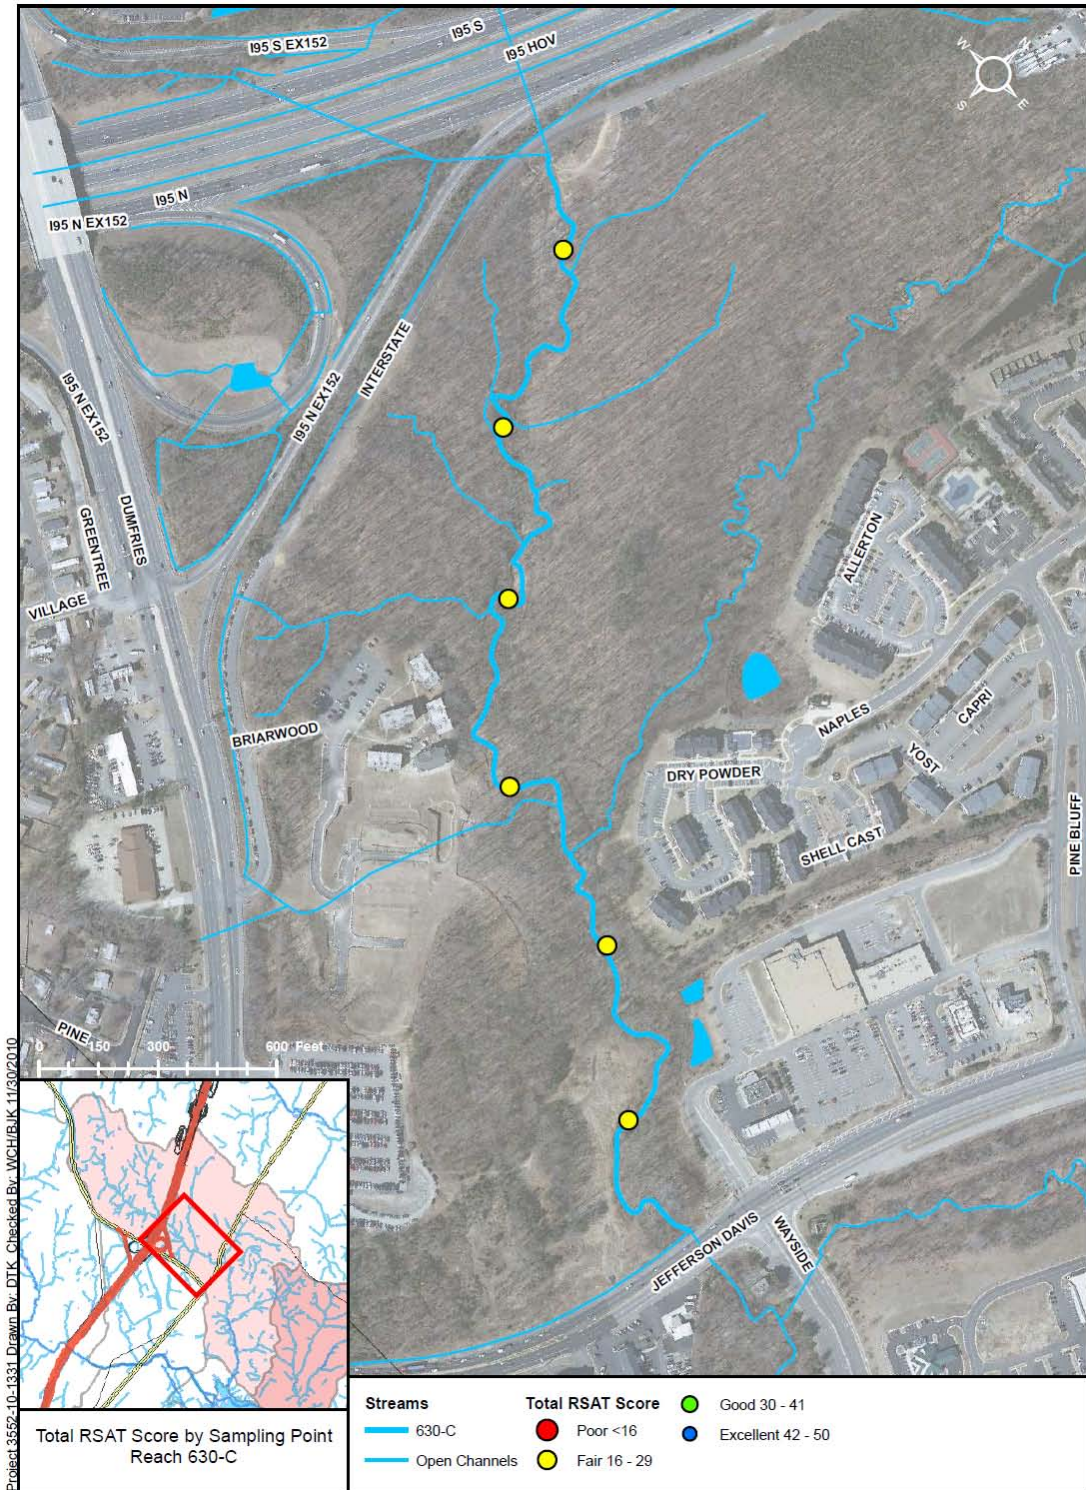
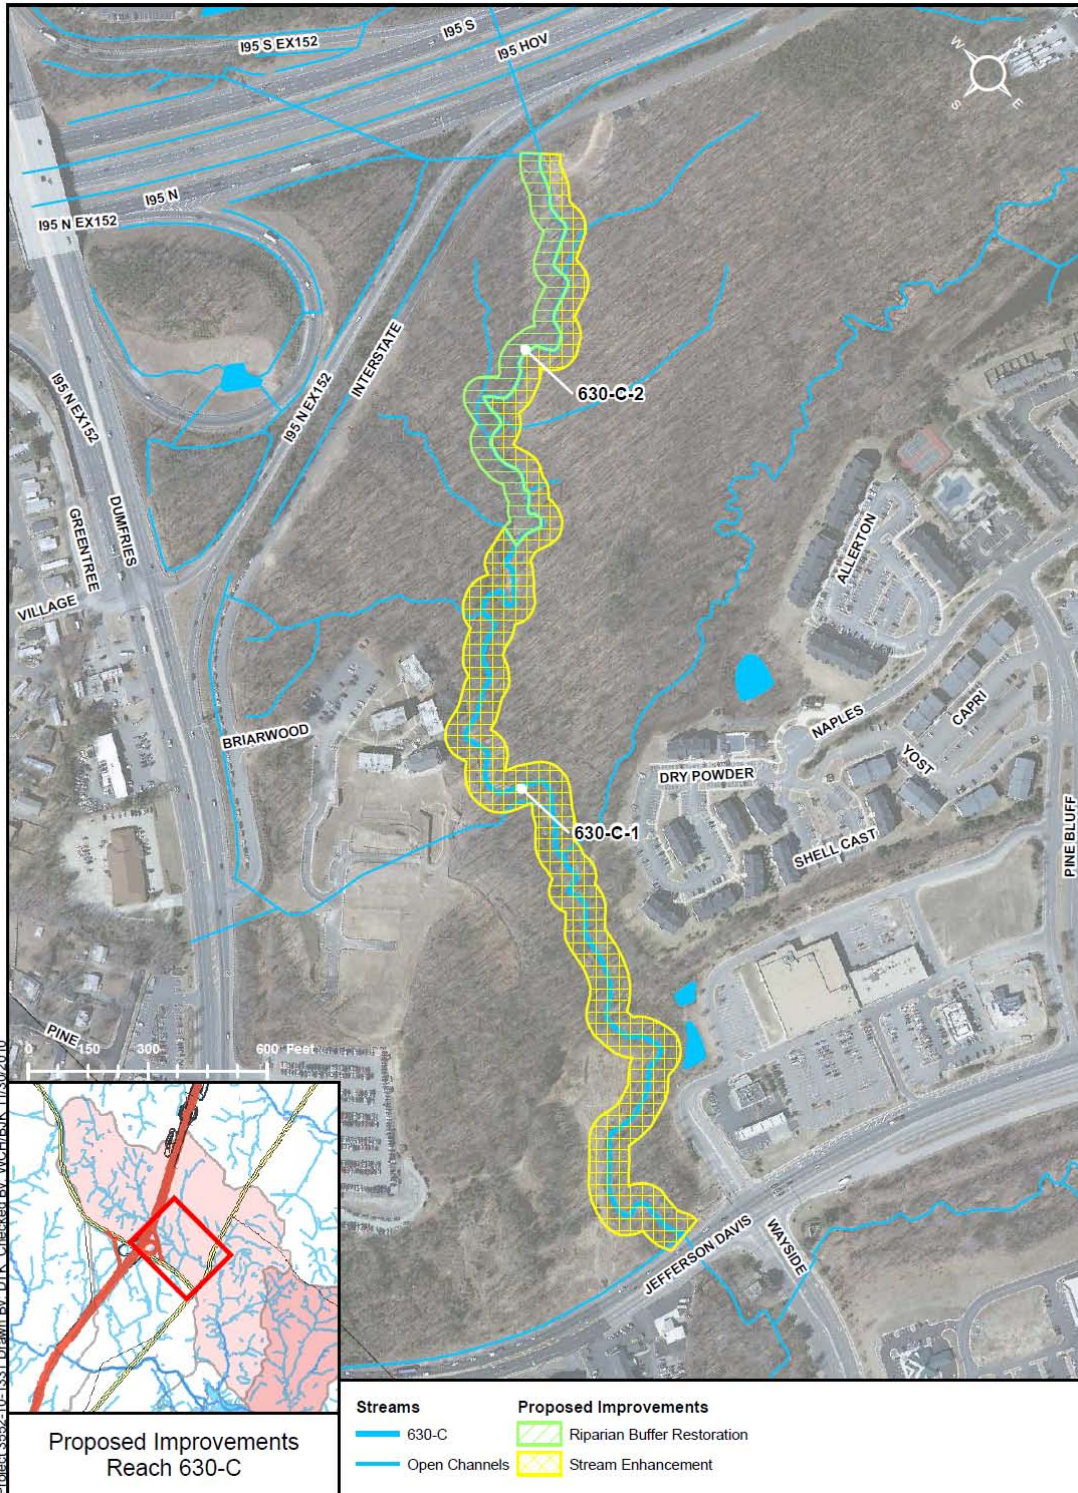
Reach Name: 630-C

Reach 630-C is a fair quality stream, with an average total RSAT score of 26. Reach 630-C has good channel stability, with relatively stable streambanks, little bank sloughing or erosion, and resistant bed and bank materials. Channel scouring/deposition scores were fair, with increased deposition of sand and sediment and increased embeddness of riffle material. Physical instream habitat was in good condition, with a mix of riffles, runs and deep pools present, along with a heterogeneous mix of bed materials, consisting of cobbles, gravel, sand and sediment.

Riparian habitat is in good condition, with a forested buffer of at least 100ft on either side of the channel, and dense canopy cover, providing approximately 60-79% shading. Biological indicators are poor, with only a small population of pollution-tolerant macroinvertebrates. Water quality is good, with a low level of substrate fouling, moderate TDS, and visibility to a depth of nearly 3ft.

- Enhance nearly 3800ft of degraded stream, from Interstate 1-95 to Jefferson Davis Highway, using fabric and plant bank treatment and up to 12 rock weirs or wing deflectors to reduce bank scouring.

- Restore the riparian buffer zone with seed, straw and container plants (at a planting density of up to 1200 stems/acre) along 1000 linear feet of channel, downstream of Interstate Drive to Dry Powder Circle. Establish a conservation easement, or permanent deed restriction area, to protect the buffer zone to a minimum of 100ft from the channel.

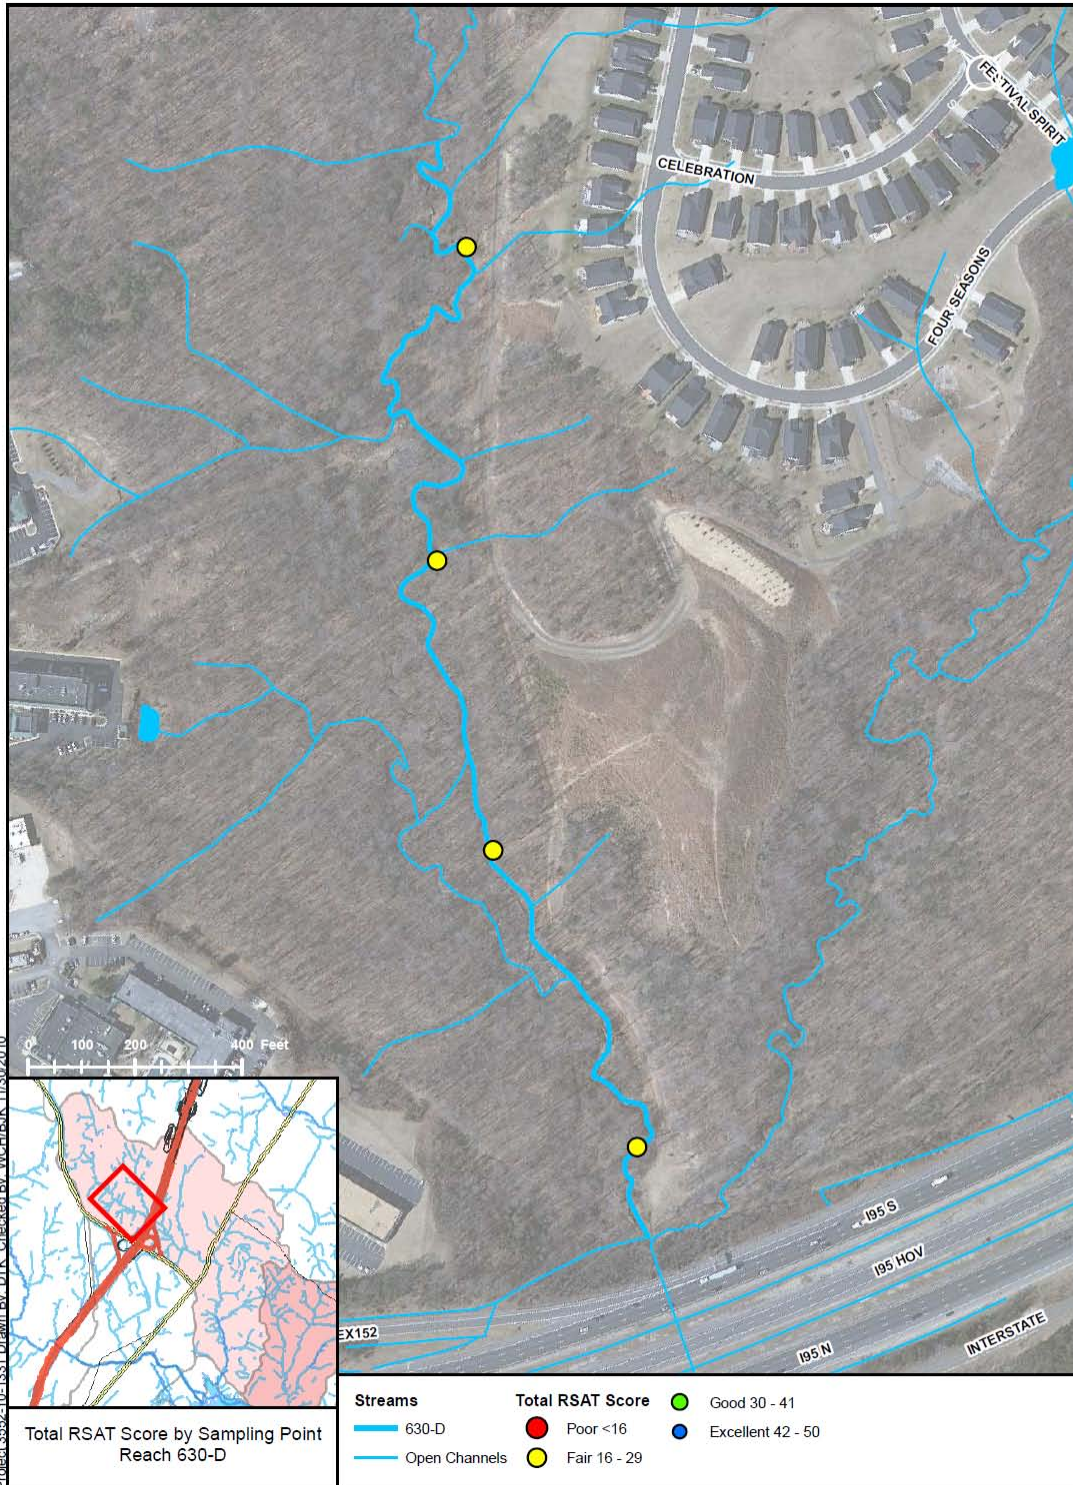
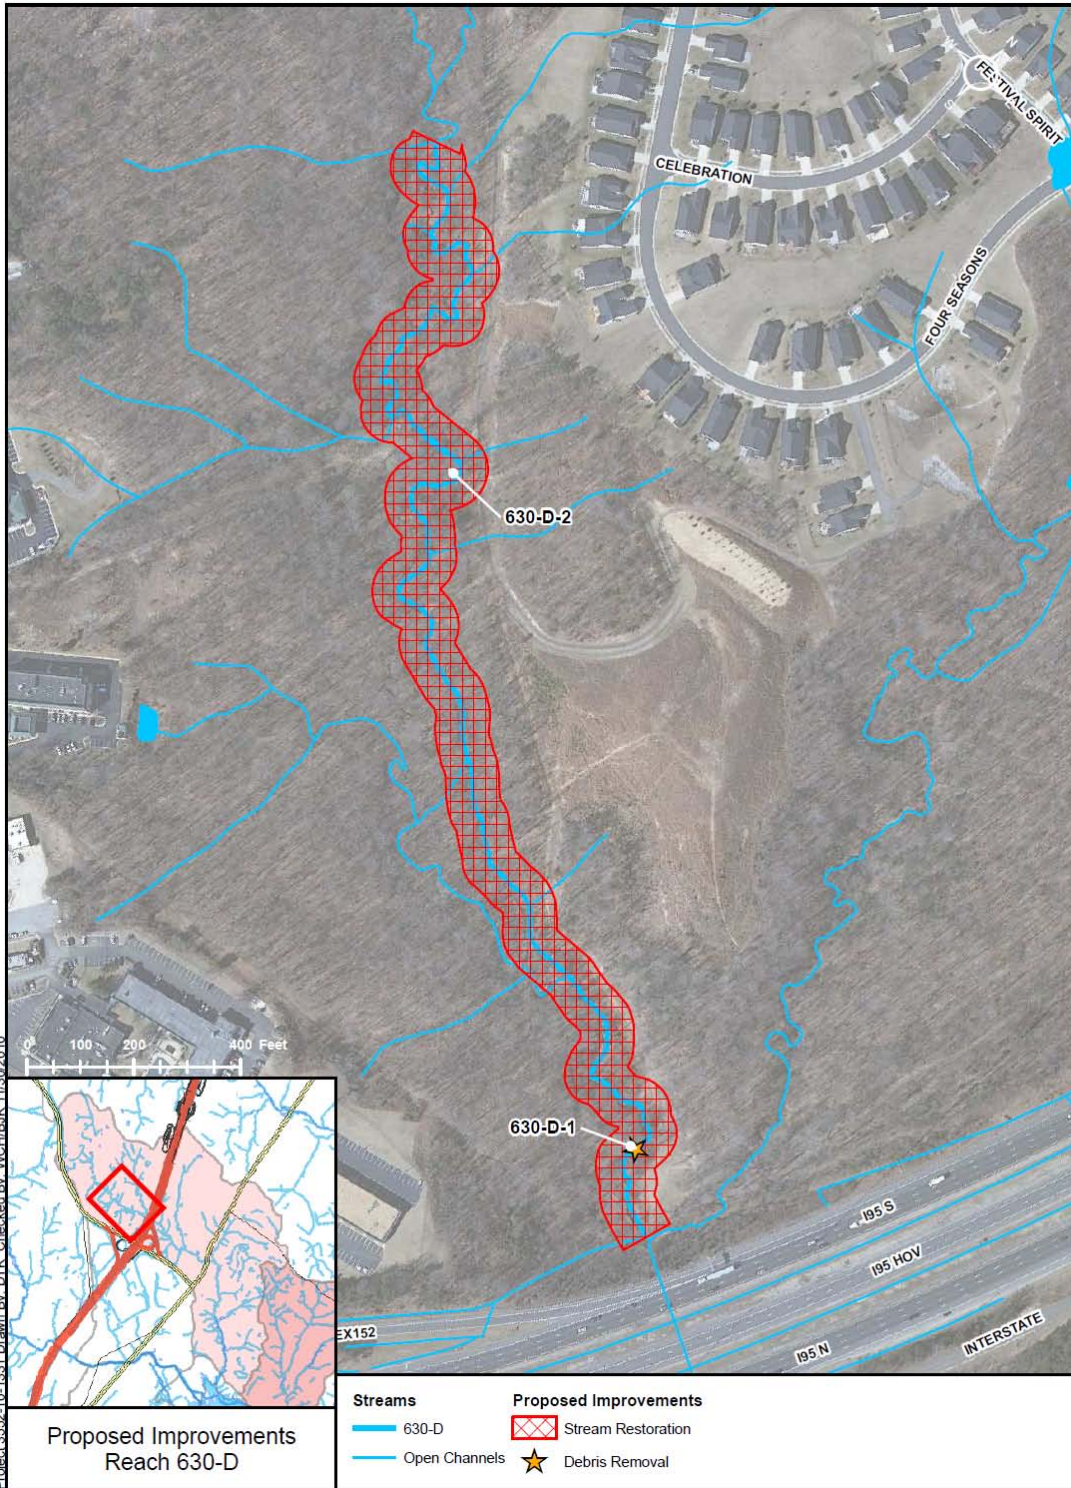
Reach Name: 630-D

Riparian habitat is in good condition, with a forested buffer of at least 100ft on either side of the channel, and dense canopy cover, providing approximately 60-79% shading. Biological indicators are fair, with a few pollution-tolerant species, such as caddisfly and midgefly. Water quality is fair, with a moderate level of substrate fouling, increased TDS, and reduced depth of visibility.

- Realign and restore more than 2800ft of stream channel, along the sewer line south of Four Seasons Drive to the culvert at Interstate I-95, using fabric and plant bank treatment with rock toe to stabilize eroding streambanks, and up to 7 rock riffles for permanent grade stabilization.
 - Remove dumped rubble, tires and other debris, creating an impoundment near the access road from Old Stage Road, prior to restoration.

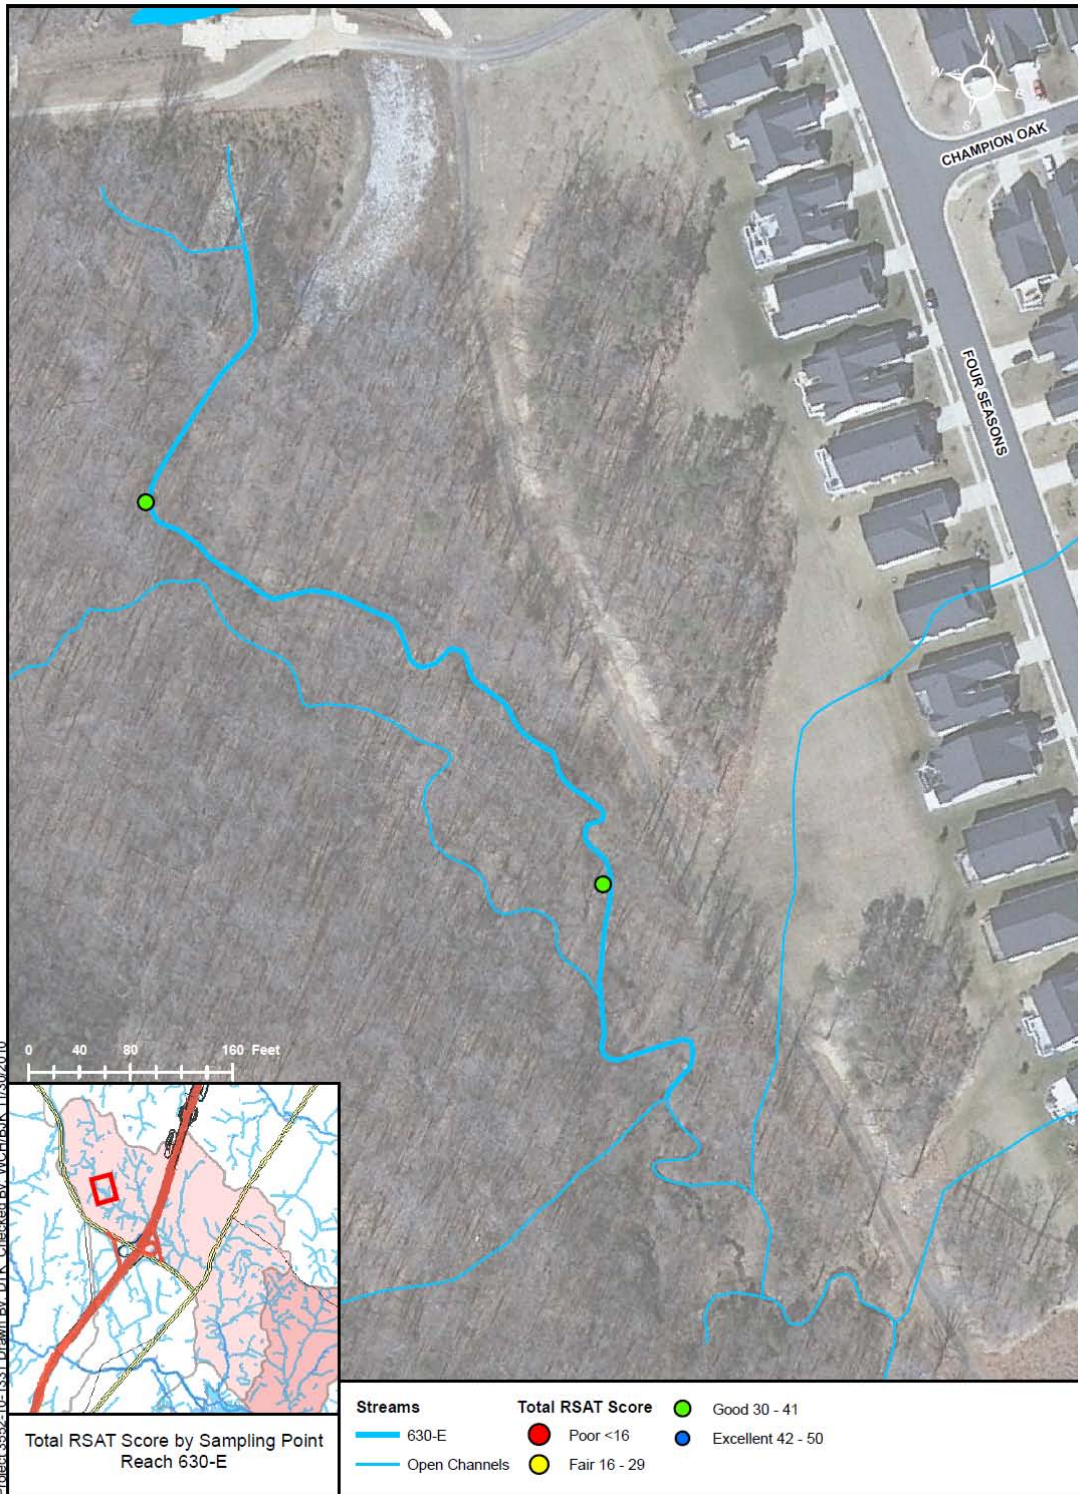
Reach Name: 630-E

Riparian habitat is in excellent condition, with a wide forested buffer in excess of 200ft on either side of the channel, and canopy cover is dense, providing greater than 80% shading. However, biological indicators are poor, with a limited population of pollution-tolerant midgeflies and snails. Water quality is fair, with a moderate level of substrate fouling, increased TDS, and reduced depth of visibility.

None

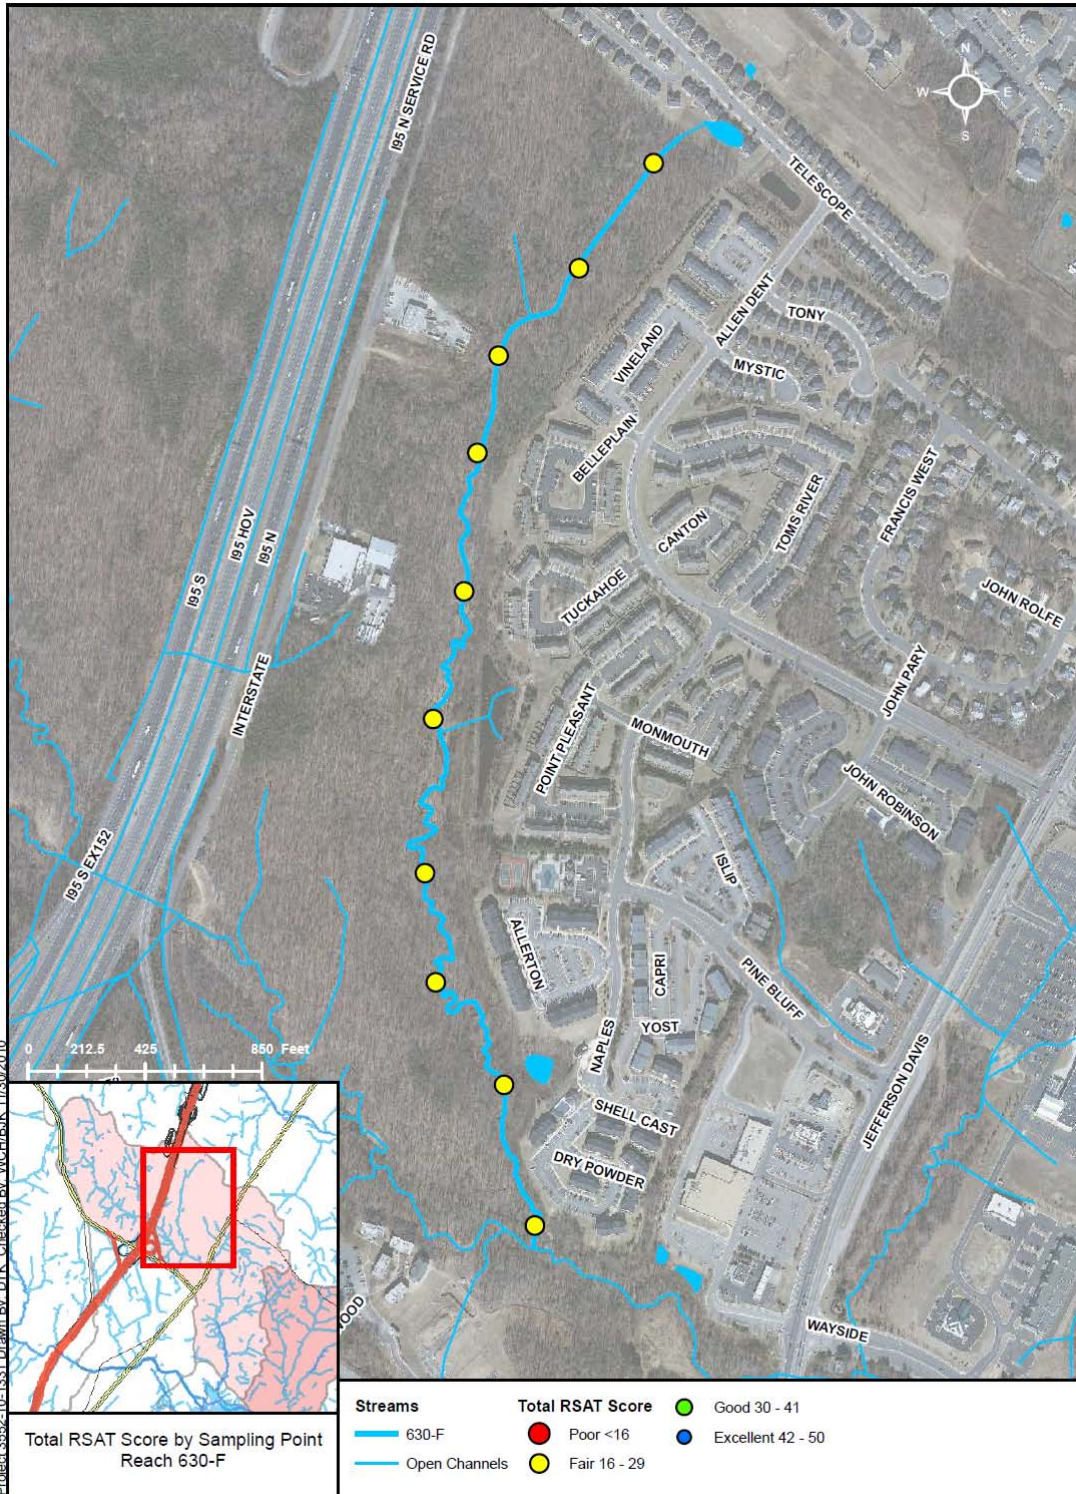
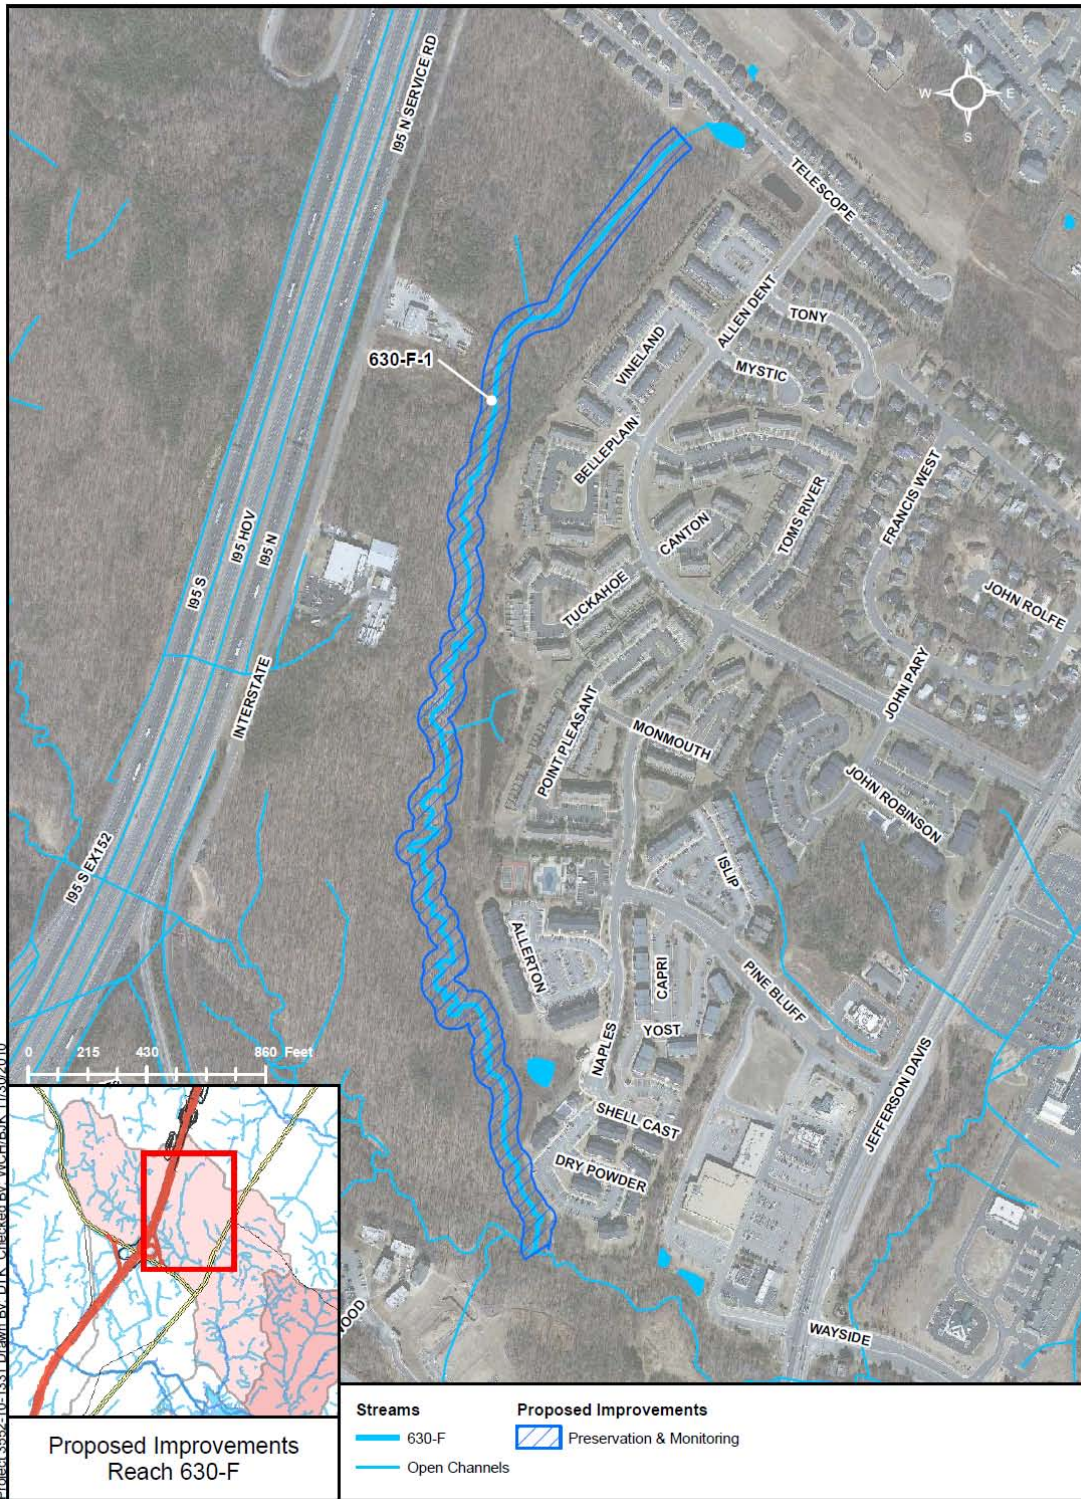
Reach Name: 630-F

Riparian habitat is in good condition, with a forested buffer of at least 100ft on either side of the channel, and dense canopy cover, providing more than 60% shading. Biological indicators are poor, with only a few midgeflies found throughout the reach. Water quality is fair, with a moderate level of substrate fouling, increased TDS, and reduced depth of visibility.

- Purchase, preserve and monitor the existing riparian corridor with a permanent deed restriction or conservation easement, along more than 5300ft of stream, from the upstream end of the reach at Telescope Lane, to the confluence with Reach 630-C near Dry Powder Circle.

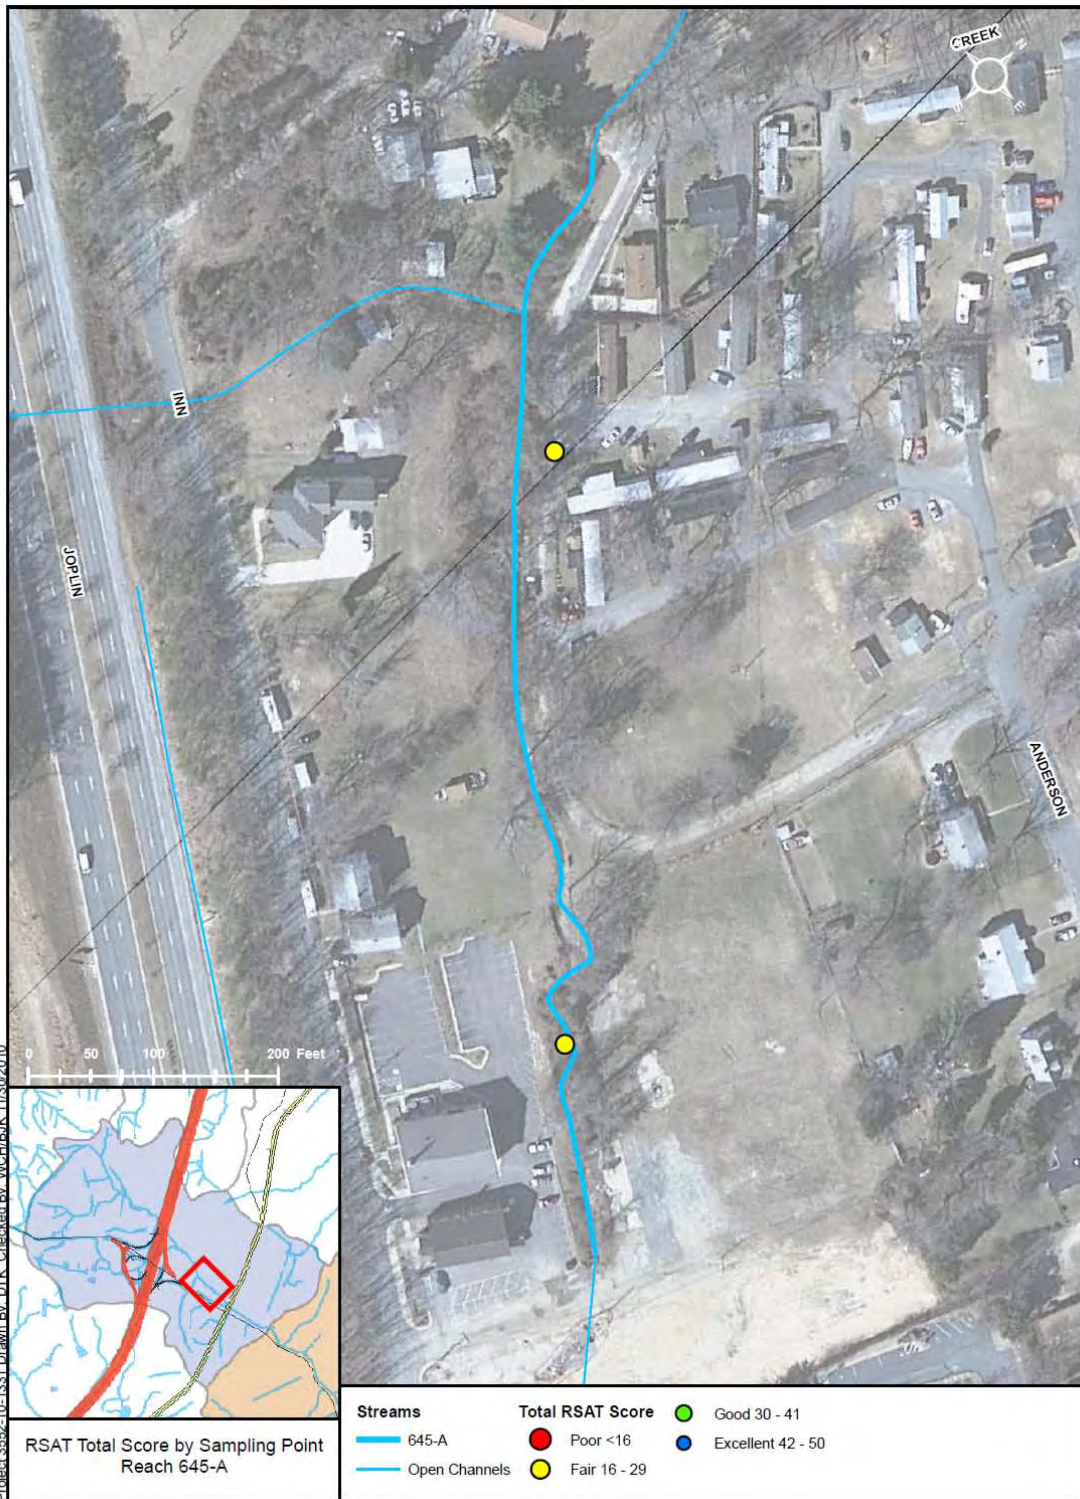
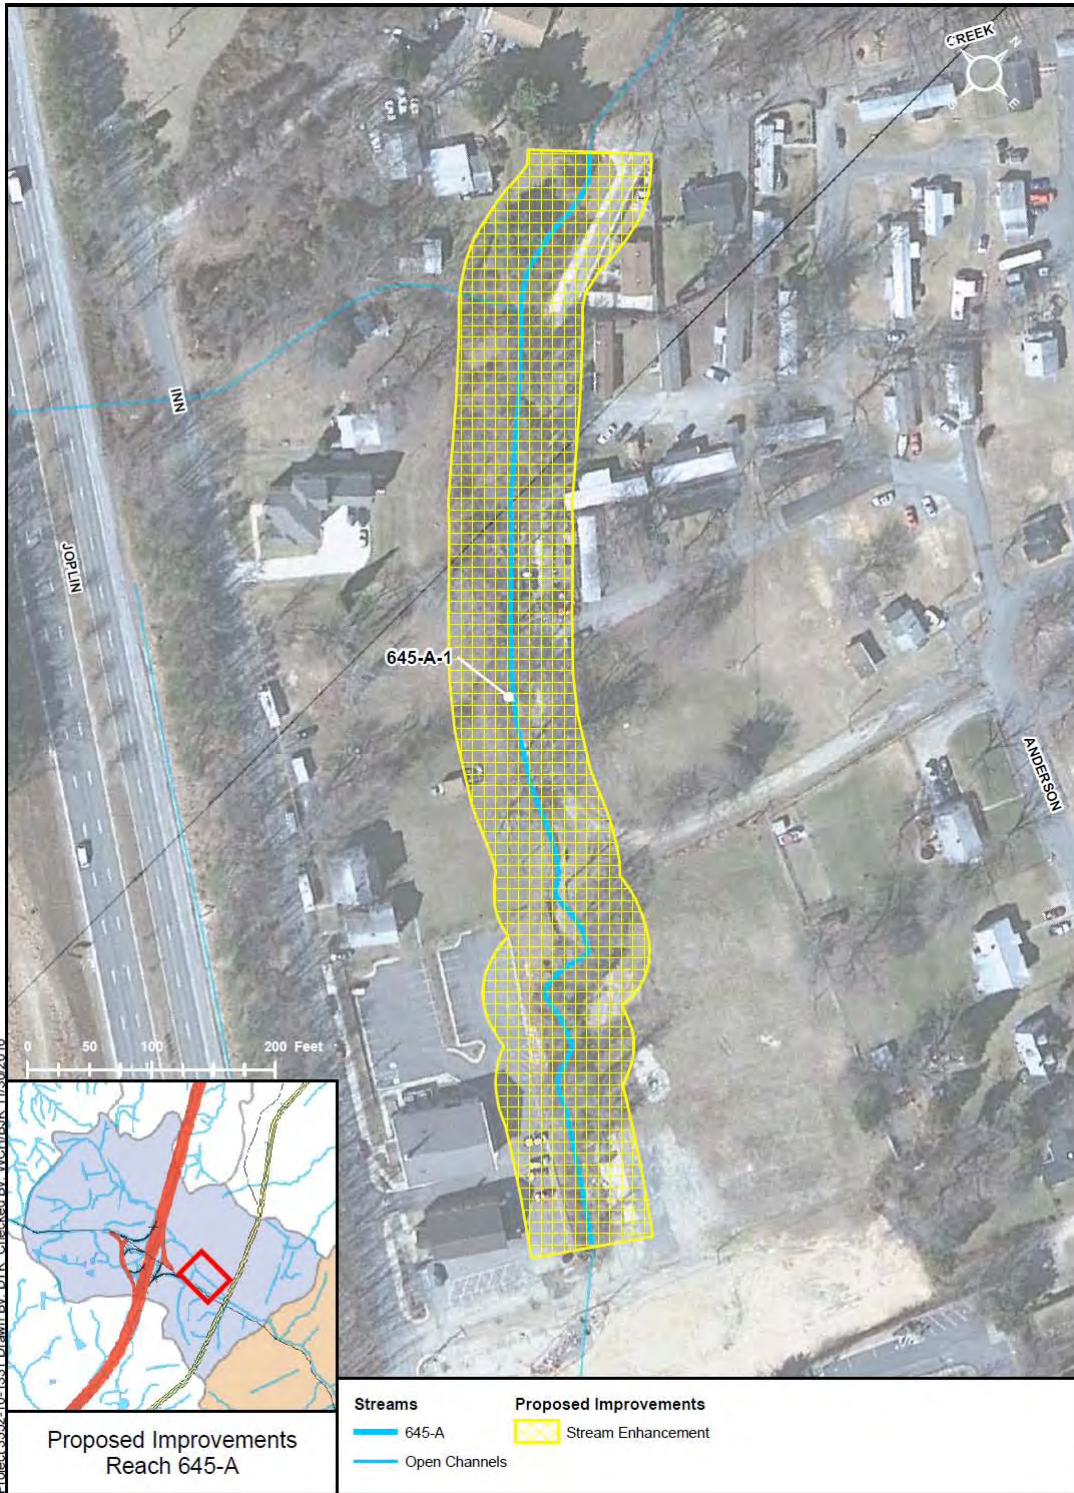
Riparian habitat is in poor condition, with only a narrow band of trees and very little woody vegetation near Creek Road and adjacent to the parking lot at First Assembly of God Church. Biological indicators are poor, with only a few midgeflies found throughout the reach. Water quality is fair, with a moderate level of substrate fouling, increased TDS, and a depth of visibility no more than 1ft.

- Enhance approximately 950ft of degraded stream, from Creek Road to the parking lot at First Assembly of God Church, using fabric and plant bank treatment and up to 3 rock weirs or wing deflectors to reduce bank scouring.

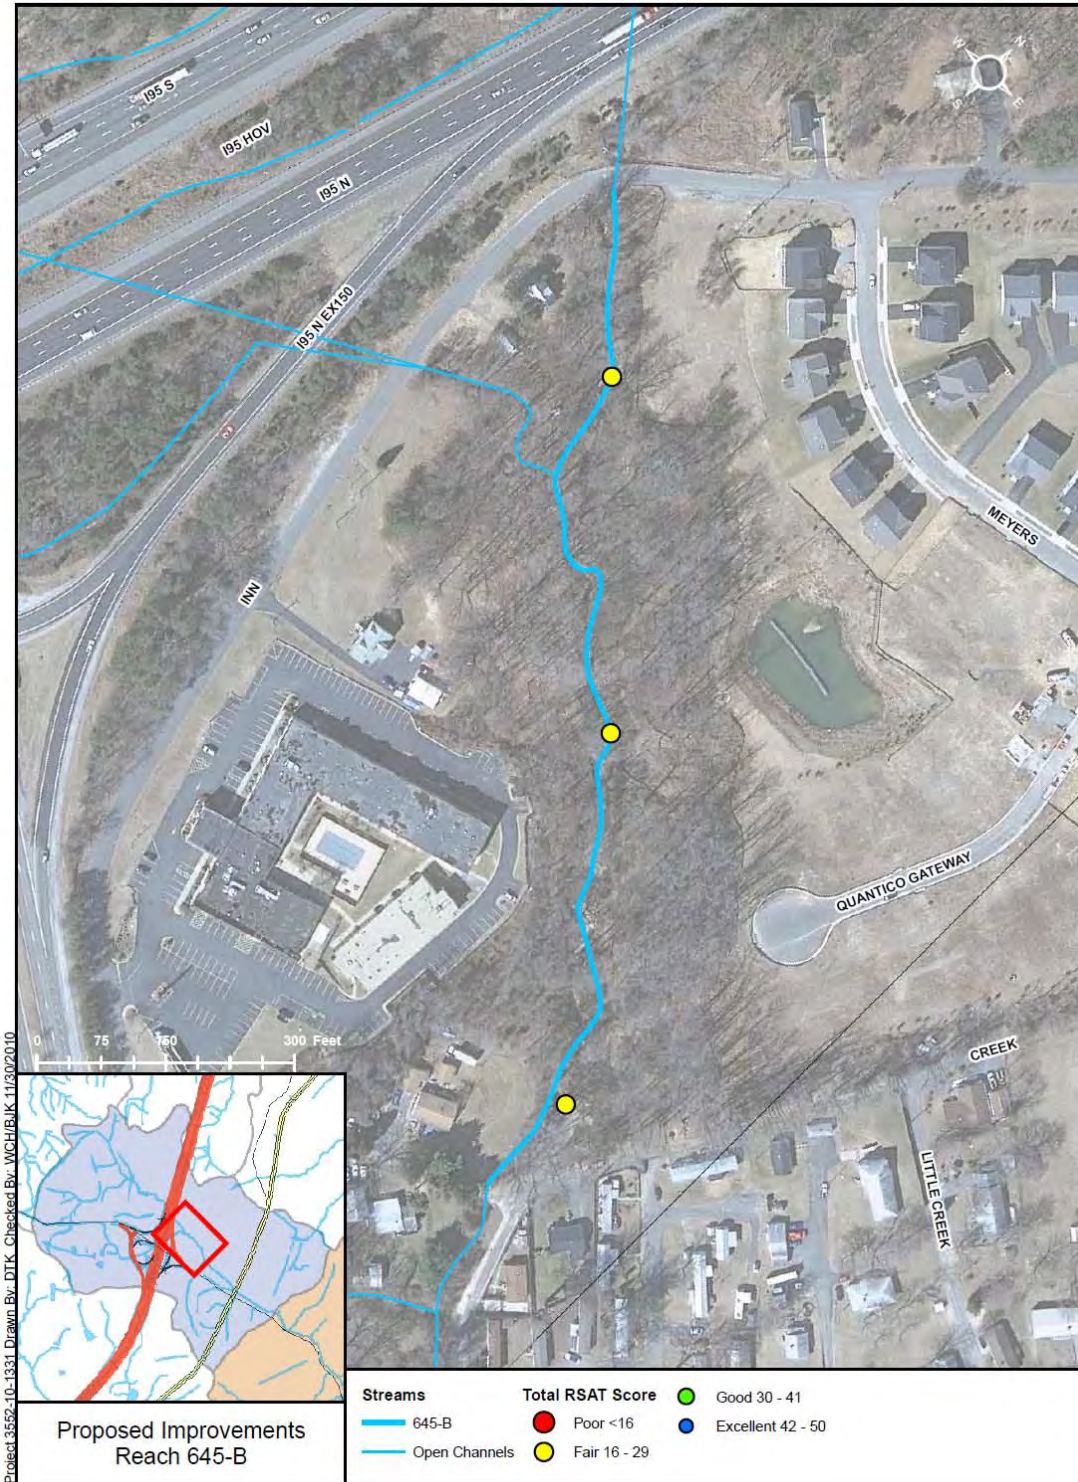
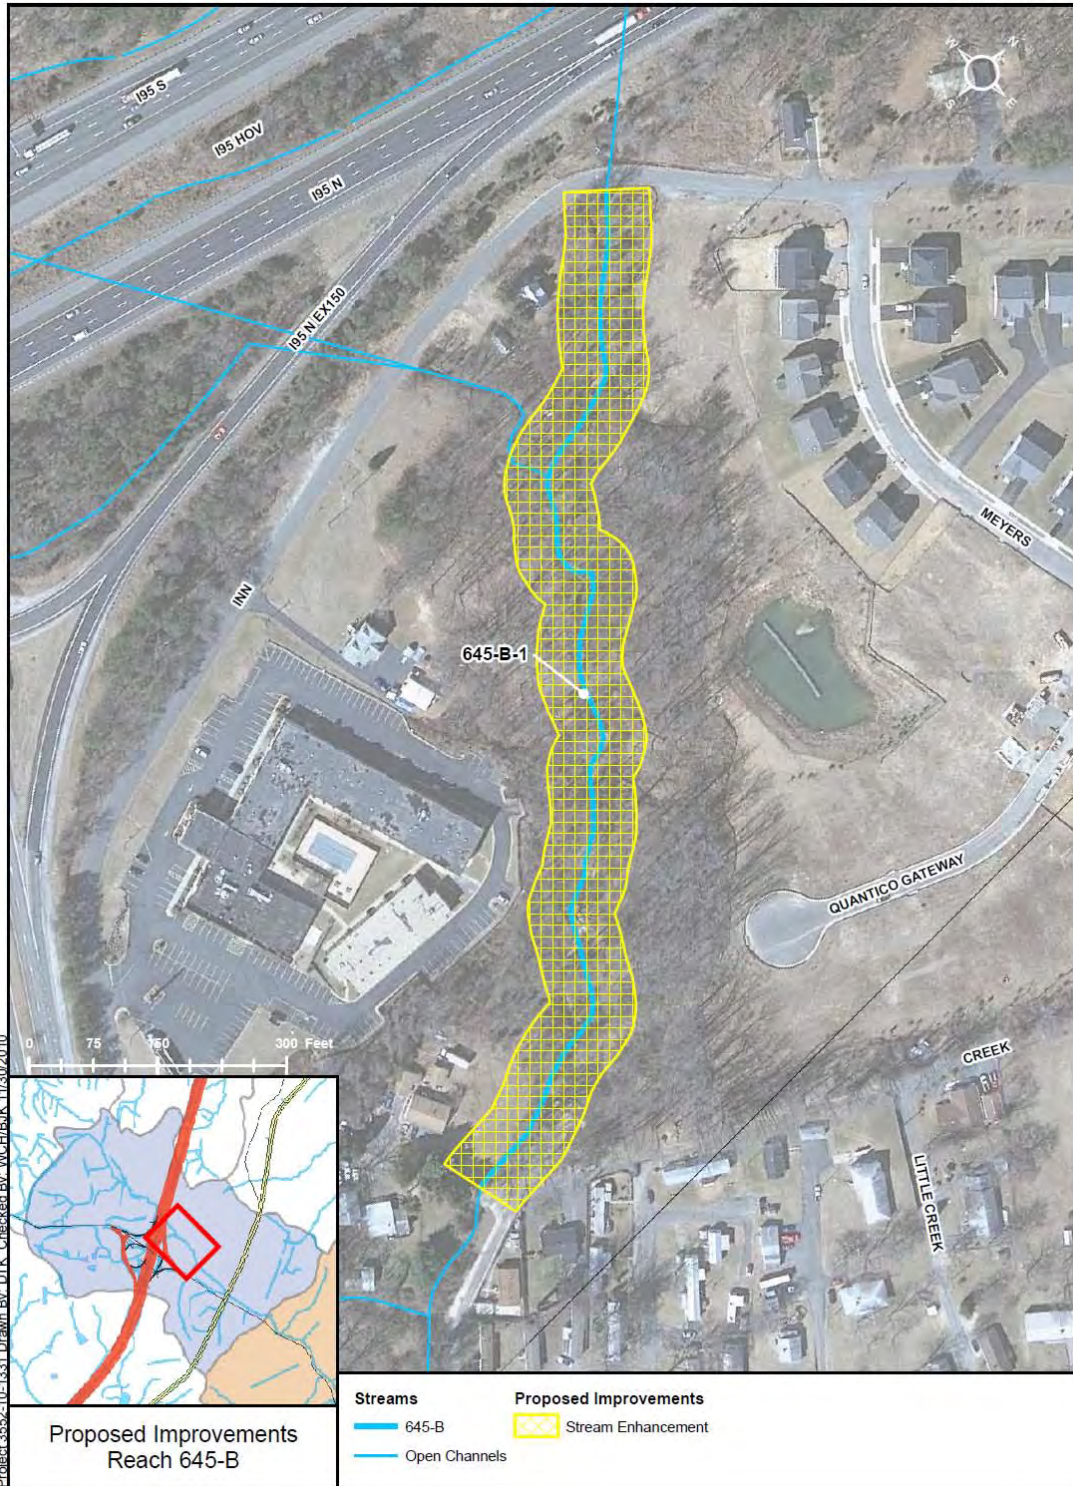
Reach Name: 645-B

Riparian habitat is in fair condition, with a predominantly wooded corridor, but with large gaps in woody vegetation and canopy coverage. Biological indicators are poor, with only a few midgeflies found throughout the reach. Water quality is fair, with a moderate level of substrate fouling, increased TDS, and a depth of visibility to approximately 1.5ft.

- Enhance nearly 1300ft of degraded stream, upstream from Creek Road to the culvert at Interstate I-95, using fabric and plant bank treatment and up to 4 rock weirs or wing deflectors.

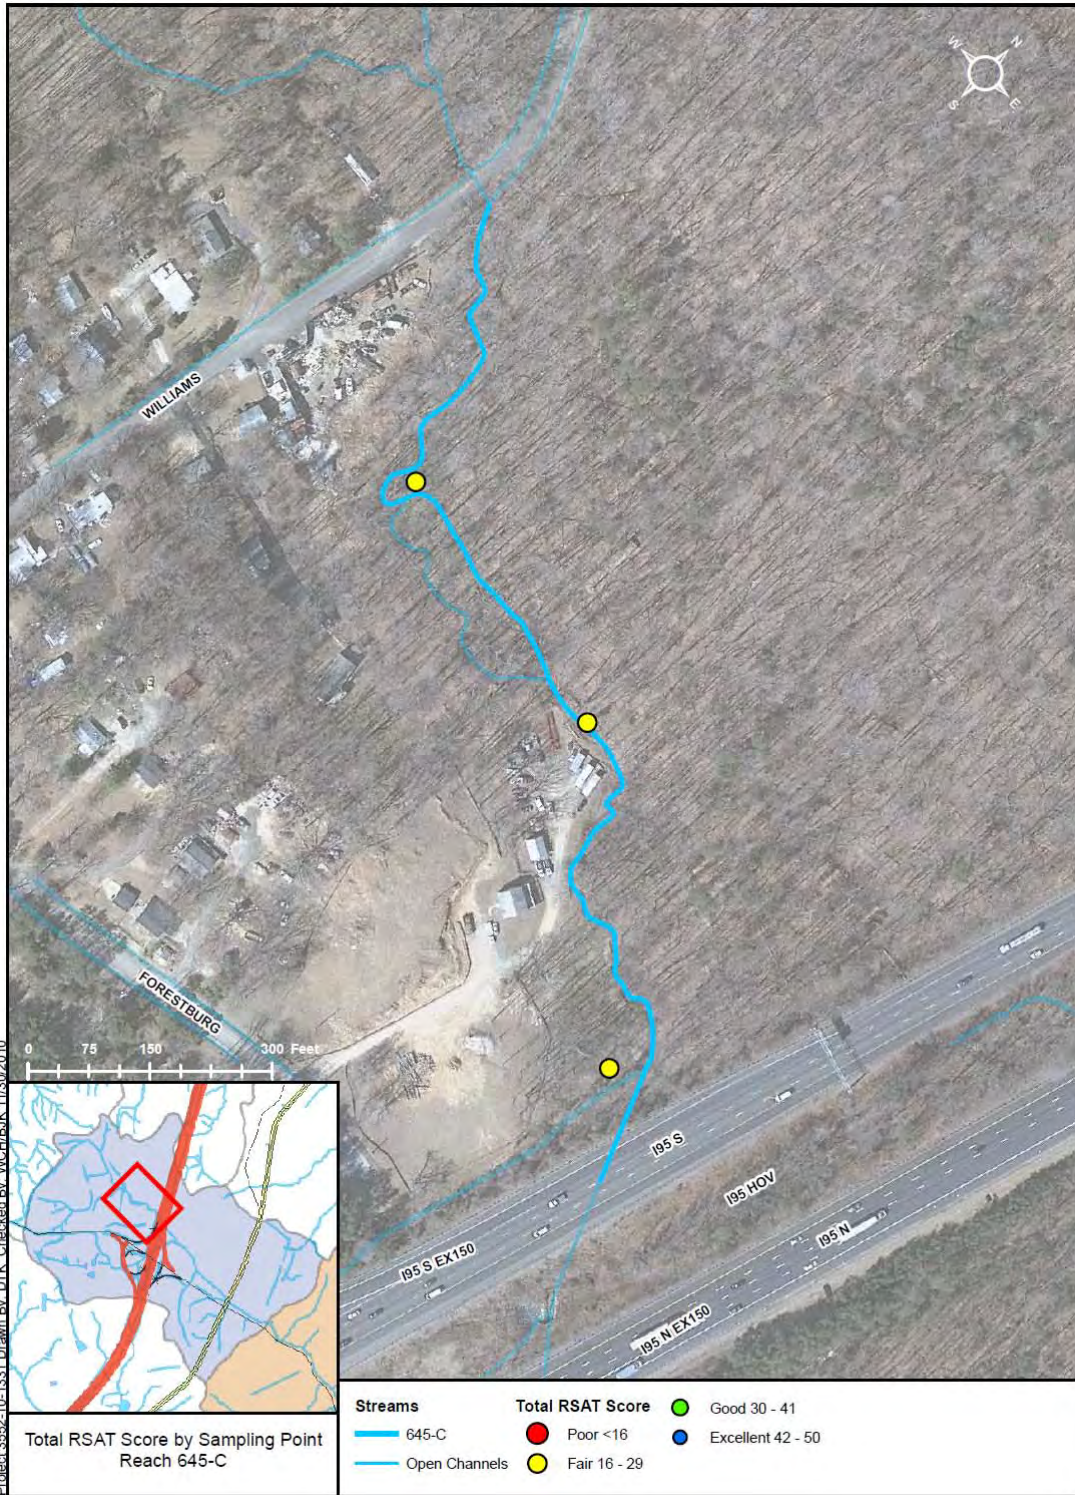
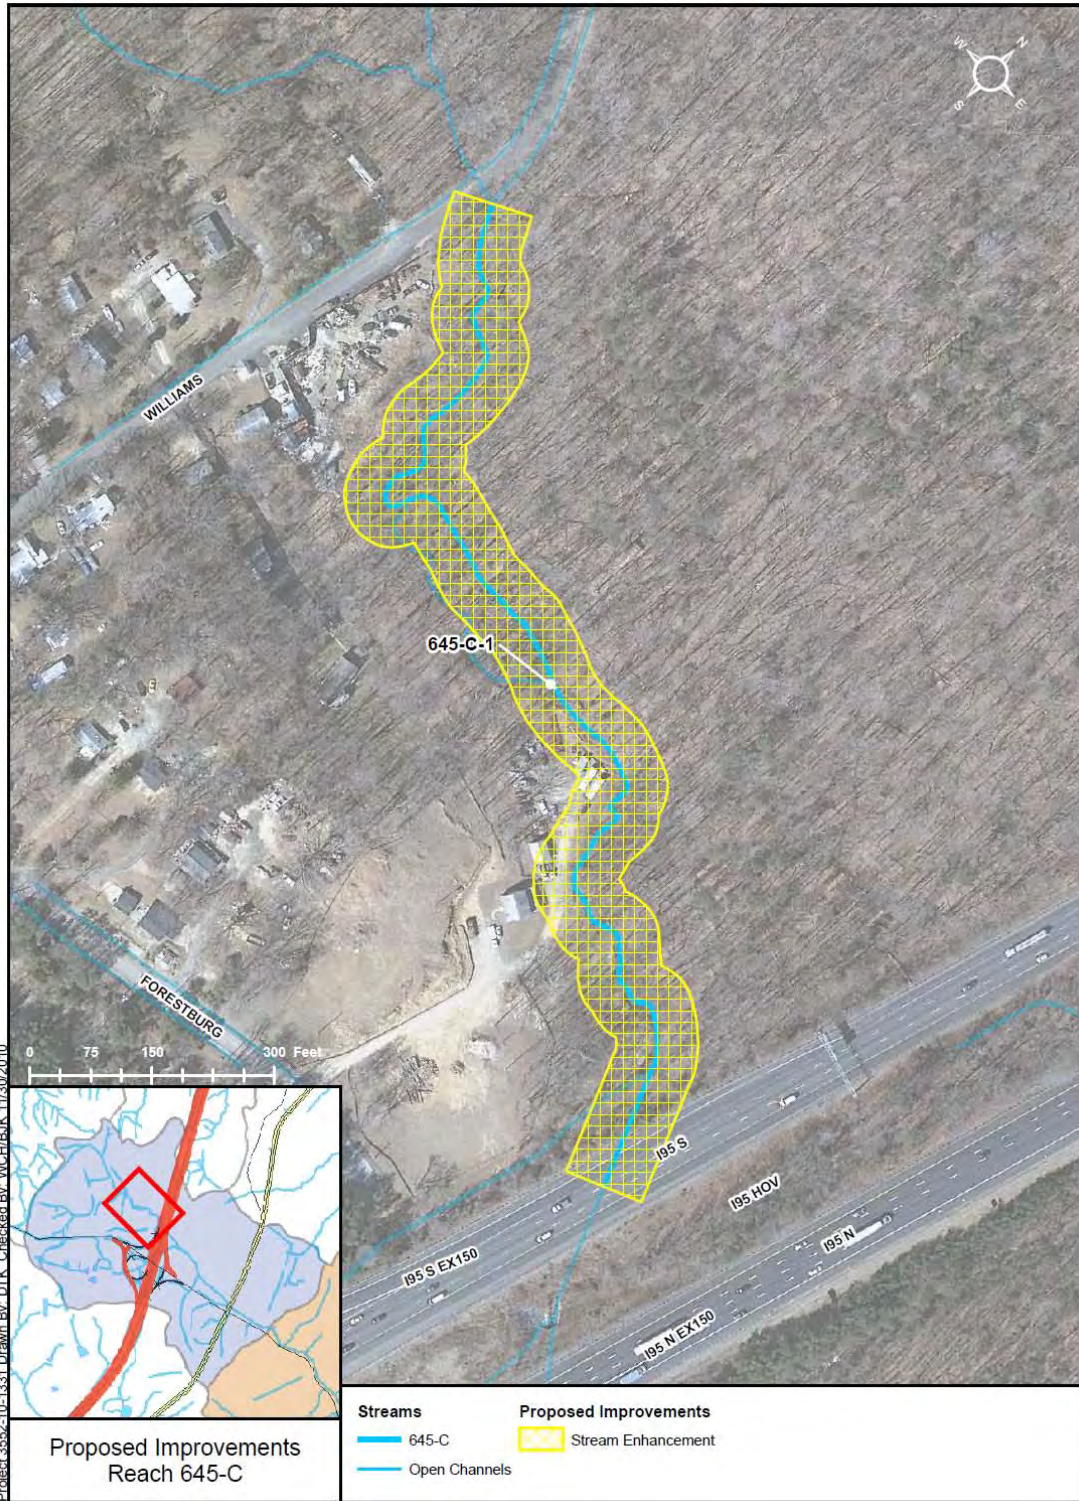
Reach Name: 645-C

Riparian habitat is in fair condition, with large gaps in woody vegetation and canopy coverage. Biological indicators are poor, with only a handful of pollution tolerant species found throughout the reach. Water quality is fair, with a moderate level of substrate fouling, increased TDS, and a depth of visibility to approximately 1.5ft.

- Enhance approximately 1500ft of degraded stream, upstream from Interstate I-95 to Williams Road, using fabric and plant bank treatment and up to 5 rock weirs or wing deflectors.
