Occoquan Watershed

Prince William County, Virginia

WSSI #25156.01

Study of Four Subwatersheds

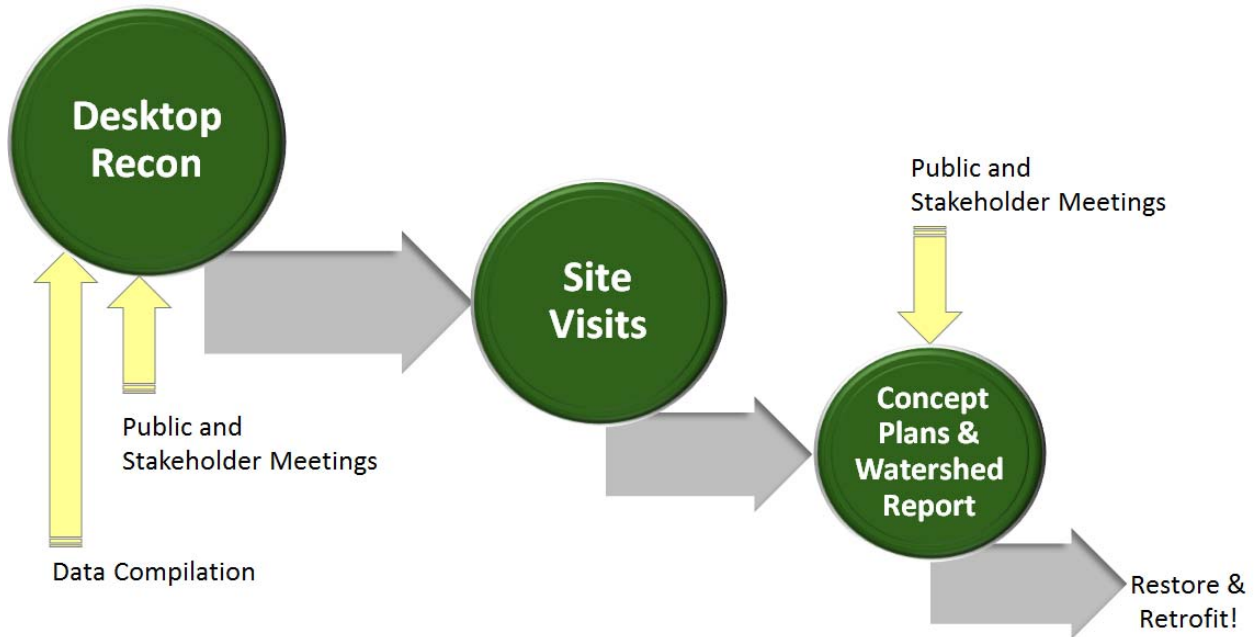
Figure 2.2 Overall Subshed Study Process

Figure 2.2 illustrates the overall watershed study process. Upon initiating the study, a screening process was implemented that utilized desktop analysis of available GIS information to direct field inspection and assessment efforts of SWM/BMP facilities and stream reaches within the four subsheds. Following these field inspections, the facilities and streams were assigned a rank and prioritized for the development of facility retrofit or stream restoration conceptual plans. Proposed retrofit and restoration projects within the four selected subsheds were focused on publicly and Homeowner Association-maintained properties in an effort to minimize easement and land acquisition constraints. These proposed projects and other recommendations focus on solutions that address watershed degradation, including TMDLs and 303(d) listed impairments. Conceptual plans and cost estimates developed for the selected projects are included as part of this Watershed Study.

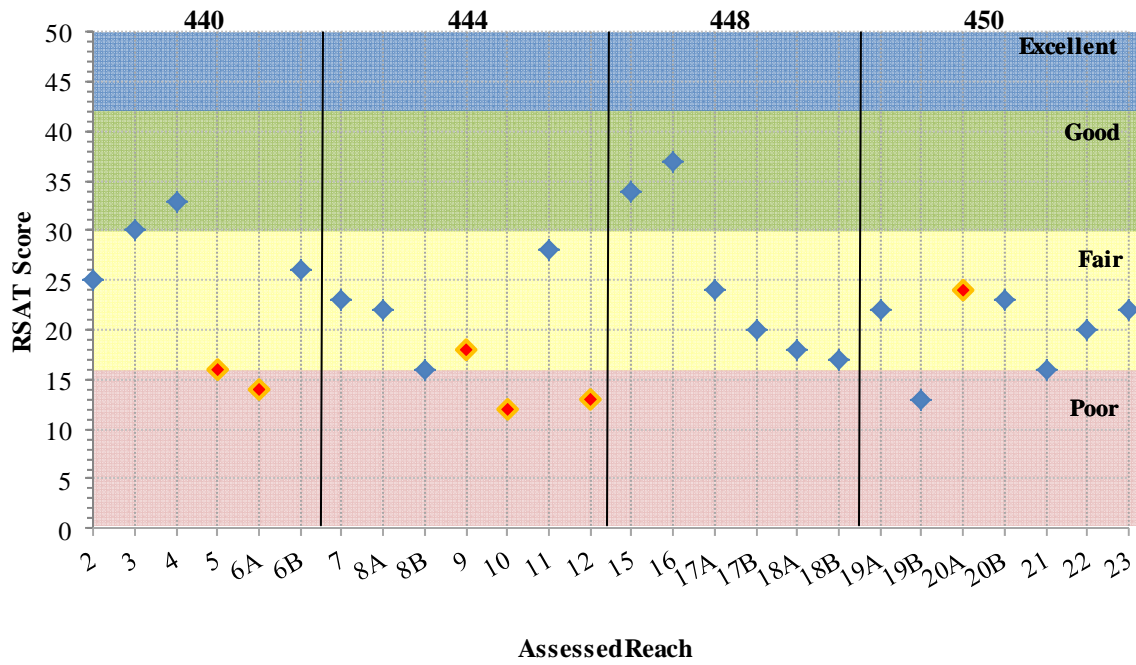
Figure 5.1 Summary of Rapid Assessment Technique (RSAT) Scores by Subshed

The resulting RSAT scores for each assessed reach are summarized in Figure 5.1 and Table 5.3 and ranked according to score, from lowest score (poor quality streams) to highest score (excellent quality streams). The RSAT method divides the verbal rankings based on score, as follows: Poor, <16; Fair, 16-29; Good, 30-41; and Excellent, 42-50. Eighty-five (85) percent of the streams scored in the lower two RSAT rankings. No streams were ranked as 'Excellent' with the other streams as follows: 4 'Good', 18 'Fair', and 3 'Poor' rankings. Conceptual stream restoration plans were developed for those identified in red on Figure 5.1.
